| Model: Model K-P2 | Date: 4-Jun-02 | No.: RG073001a |

| Subject: Printer Controller Firmware History | | Prepared by: A. Ishiyama | |

Printer controller firmware history for the Model K-P2 (Kir-P2: G073/G074 model).

| Subject: Problems Using "Verify" in the Firmware Update | | Prepared by: A. Ishiyama | |

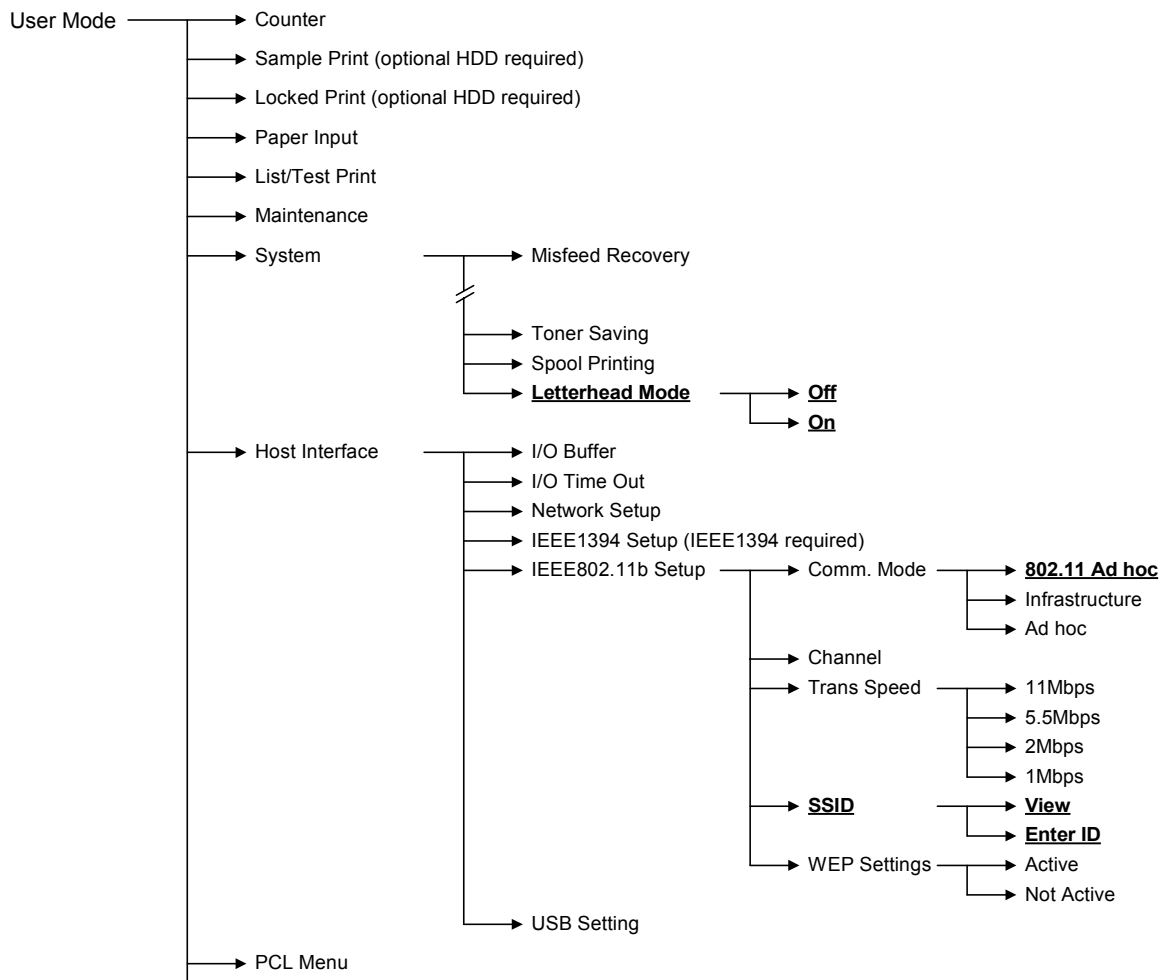
User Mode Tree

Underlined features have been added from version 1.04.
