Model: Fresa		Date: 31-May-99	No.: RG024001
Subject: Service Manual		Prepared by: H. Someya	
From: Technical Service Dept., GTS Division			
Classification:	<input type="checkbox"/> Troubleshooting	<input type="checkbox"/> Part information	<input type="checkbox"/> Action required
	<input type="checkbox"/> Mechanical	<input type="checkbox"/> Electrical	<input type="checkbox"/> Service manual revision
	<input type="checkbox"/> Paper path	<input type="checkbox"/> Transmit/receive	<input type="checkbox"/> Retrofit information
	<input checked="" type="checkbox"/> Other ()

Although the Fresa engine service manual is based on the Fresa Win model, it may also be used for reference regarding the PS model as well. This is due to the fact that nearly all parts for the engine are identical, with a few exceptions such as the operation panel, some exterior parts and some decals.

Model: Fresa		Date: 31-Aug-99	No.: RG024003
Subject: Gradation Image Printing with PCL Printer		Prepared by: Y. Tamaoka	
From: Technical Service Dept., GTS Division			
Classification:	<input checked="" type="checkbox"/> Troubleshooting	<input type="checkbox"/> Part information	<input type="checkbox"/> Action required
	<

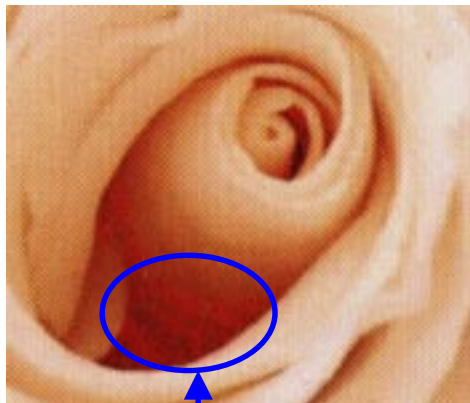
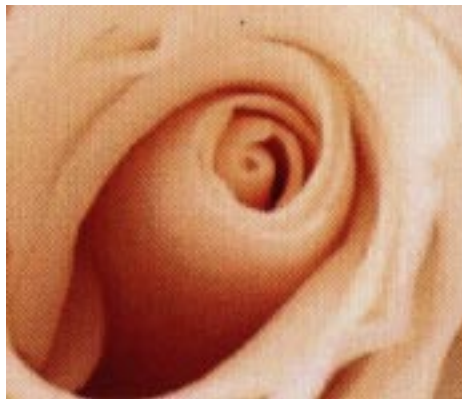
When documents containing gradation images are printed with the PCL driver, the gradation may not be smooth and patchy red or green dots may appear, depending on the colors contained in the image and density of the gradation.

“Patchy” dots

In toner reduction mode, a dither pattern control error occurs when the total index value of CMYK colors exceeds the following value.

Either 170% with 2 colors or 250% in total.

Use the PS driver instead of the PCL driver

If this is not accepted by the customer, update the controller firmware to the following version or later.

System code : Aug 6 1999

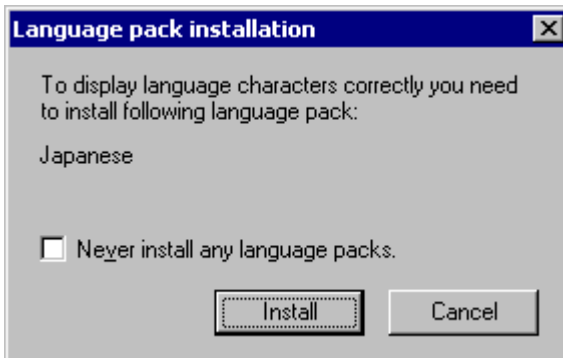
When you browse the Pomelo and FresaWIN printers with Microsoft Internet Explorer 5.x (IE 5.x), IE 5.x requires installing a Japanese font even if the HTML does not have a Japanese font.
 i.e., if browsing http://Printer IP Address/en/cgi-bin/sts_index.cgi, the following message appears:

Maybe the message is different because of a minor variation in the IE version or Windows OS. The above message appears when using IE 5.00.2920.0000 with Windows 2000. In this case, IE requires a Japanese font every time.

Note: The NIB works properly by canceling messages stating that a Japanese font is required.

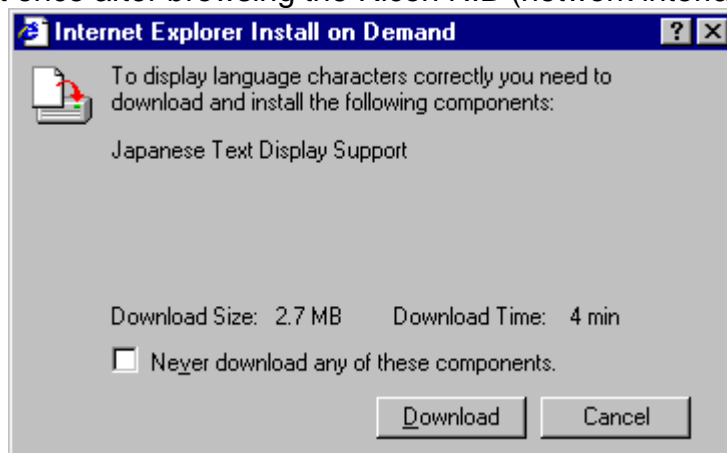
IE 5.00.2314.10003 with Windows NT 4.0 is shown below. In this case, IE requires a Japanese font once after browsing the Ricoh NIB (network interface board).

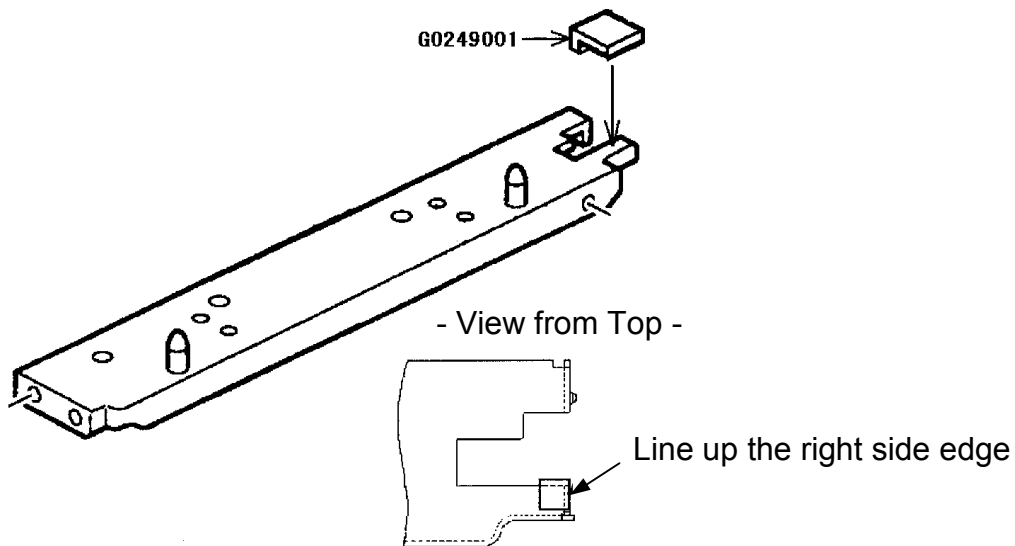
- 1) Acoustic noise from the upper cover around the fusing unit
- 2) Tightner Gear Ass'y (G0241808) damaged. (No fusing unit drive)

For the machines produced before January '00,
Put Spacer – Fusing Stay (G0249001) on the Fusing Unit Stay as shown in the illustration below.

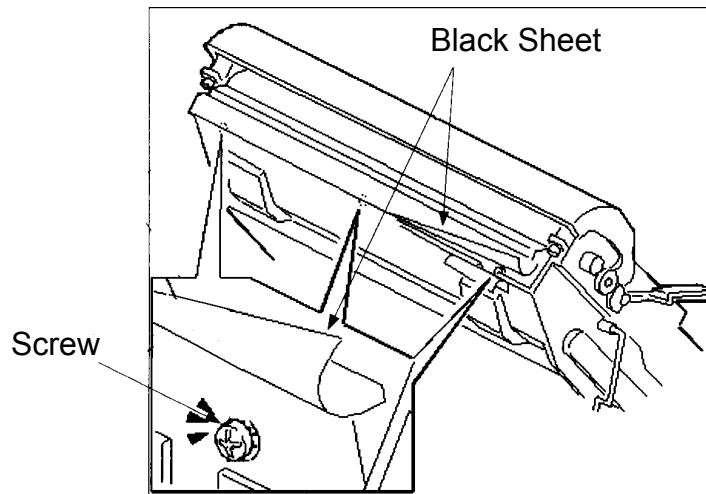
The heat cycle in the machine causes expansion and contraction of the paper transfer cleaning cover. This in turn causes the screws holding the cover to the PCU frame to become loose or fall out. Fallen screws interfere with the rotation of the screening auger.

Secure the cover with the following screws:
