Model: Russian-P2		Date: 30-Jan-01	No.: RG062001
Subject: Engine Firmware History		Prepared by: S. Tomoe	
From: Technical Services Dept., GTS Division			
Classification:	<input type="checkbox"/> Troubleshooting	<input type="checkbox"/> Part information	<input type="checkbox"/> Action required
	<input type="checkbox"/> Mechanical	<input type="checkbox"/> Electrical	<input type="checkbox"/> Service manual revision
	<input type="checkbox"/> Paper path	<input type="checkbox"/> Transmit/receive	<input type="checkbox"/> Retrofit information
	<input checked="" type="checkbox"/> Other ()

Engine firmware history for the Russian-P2.

Model: Russian-P2		Date: 1-Jun-04	No.: RG062007
Subject: Non-paper feed jam (Bad friction pad)		Prepared by: S.Tomoe	
From: 1st Tech. Support Sec. Service Support Dept.			
Classification:	<input checked="" type="checkbox"/> Troubleshooting	<input type="checkbox"/> Part information	<input type="checkbox"/> Action required
	<input type="checkbox"/> Mechanical	<input type="checkbox"/> Electrical	<input type="checkbox"/> Service manual revision
	<input type="checkbox"/> Paper path	<input type="checkbox"/> Transmit/receive	<input type="checkbox"/> Retrofit informati

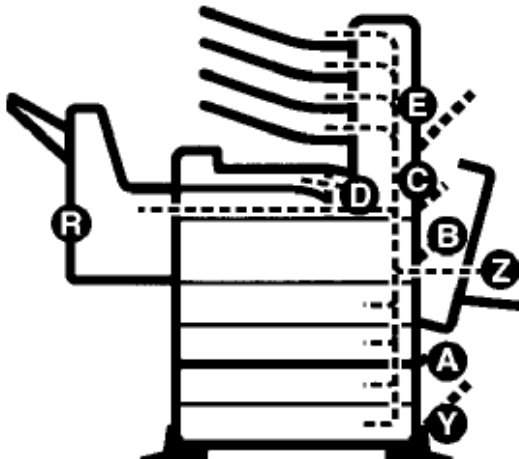
Jam Locations:

ERROR CODES	JAM LOCATION	DESCRIPTIONS
0001h	A (Standard Tray)	Paper does not reach the upper (1st) relay sensor.
0002h	B	Paper does not reach the registration sensor.
0004h	C	Paper does not reach or release from the paper exit sensor.
0040h	D	Paper does not reach or release from the bridge relay sensor.
0008h	Y (Optional Tray)	Paper does not reach the lower (2nd) relay sensor or optional relay sensor.
0010h	E (Mailbox)	Paper does not reach or release from the mailbox vertical transport sensor.
0020h	R (Finisher)	Paper does not reach or release from the finisher entrance sensor, or does not reach or release from the finisher exit sensor.
0100h	Z (Duplex)	Paper does not reach or release from the duplex entrance sensor, or does not reach or release from the duplex exit sensor.

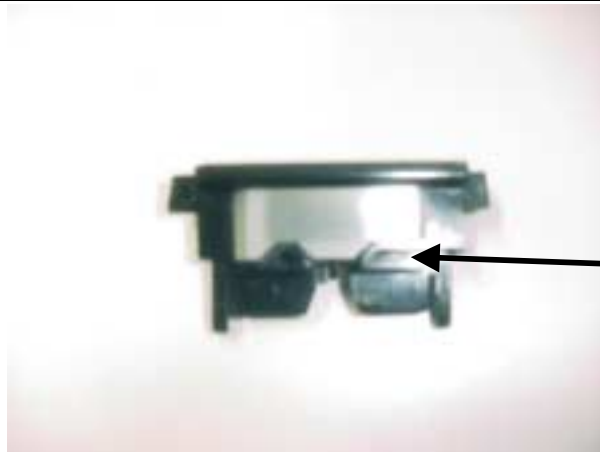
A defect in one of the molds that the manufacturer uses to produce the friction pad left a burr on the pad surface, catching the paper and preventing it from being fed.

Note: Only one of the two molds used to form the friction pad was defective (Cav 2).

As mentioned above, all defective friction pads were made from Cav 2.

Cav number (1 or 2) is visible here.
 Cav 1: Normal
Cav 2: May be defective

- (1) Replace the friction pad
