Model: K-P1, A-C2, J-P1		Date: 03-Jul-01	No.: RB003008
Subject: Slow Printing from Macintosh		Prepared by: K. Misugi	
From: Technical Services Dept., GTS Division			
Classification:	<input checked="" type="checkbox"/> Troubleshooting	<input type="checkbox"/> Part information	<input type="checkbox"/> Action required
	<input type="checkbox"/> Mechanical	<input type="checkbox"/> Electrical	<input type="checkbox"/> Service manual revision
	<input type="checkbox"/> Paper path	<input type="checkbox"/> Transmit/receive	<input type="checkbox"/> Retrofit information
	<input type="checkbox"/> Other ()

Model: General (GW Models)		Date: 20-Dec-01	No.: RGene010
Subject: Series Print Mode		Prepared by: K. Misugi	
From: Technical Services Dept., GTS Division			
Classification:	<input checked="" type="checkbox"/> Troubleshooting	<input type="checkbox"/> Part information	<input type="checkbox"/> Action required
	<input type="checkbox"/> Mechanical	<input type="checkbox"/> Electrical	<input type="checkbox"/> Service manual revision
	<input type="checkbox"/> Paper path	<input type="checkbox"/> Transmit/receive	<input type="checkbox"/> Retrofit information
	<input type="checkbox"/> Other ()

Model: M

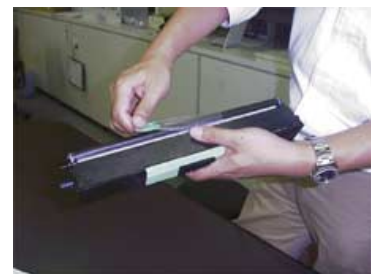
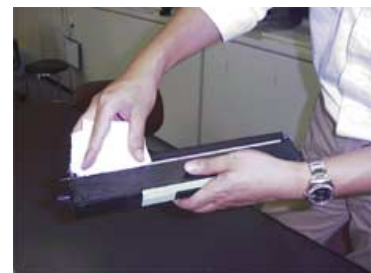
5. If it is difficult to judge whether the condition on the oil supply felt is OK or NG, clean the oil supply felt with a clean cloth to remove any oil on the felt as shown.

6. Make sure that shield tape (with the green ① tab) has been removed, and then install the oil supply unit onto the fusing unit.
7. Make sure that the oil supply unit is properly set and the release (green) lever is moving freely. (If the release lever stops and does not return to the original position after pressing and releasing it, check the cause of it.)

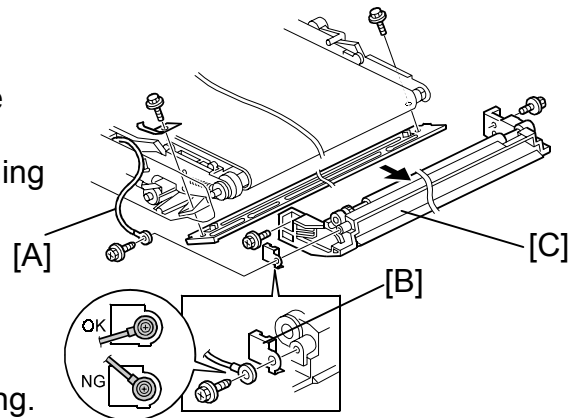
NOTE: If the paper transfer unit is placed on a dirty surface, foreign particles may get onto the transfer belt and cause damage to the OPC drums.

- High voltage wire [A]
NOTE: When re-securing the wire, make sure to angle it down as shown in the illustration. This will prevent it from touching the PCUs.
- Wire contact [B]
- Transfer entrance guide [C]
- Tension springs [D]
NOTE: Be careful so that the springs do not jump out when removing or reinstalling.

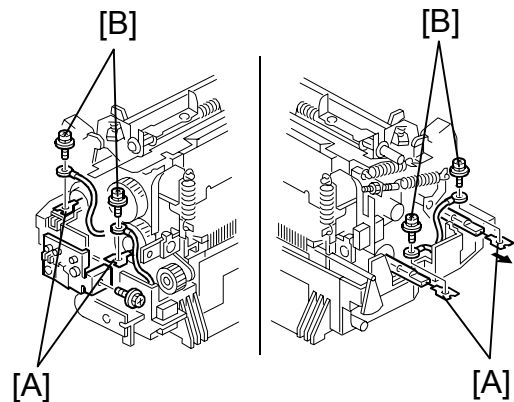
If they are not, there will be too much space between the screw and lamp terminal, causing a short. This can lead to SC543 or SC553, or in the worst case burn marks on the terminal area.

SC543: Heating roller fusing lamp overheat
 SC553: Pressure roller fusing lamp overheat

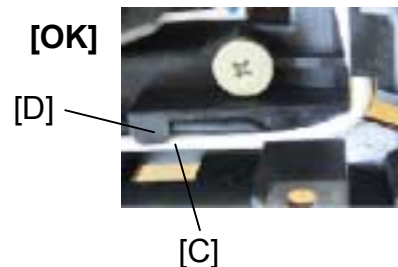
2. Wiring the cable of the heating roller fusing lamp

1. This positioning is essential. If the cable is above the projection, the C-ring of the heating roller may contact the cable and damage the protective sleeve. In the worst case, this could lead to an electrical short circuit.
2. If the white cable has been properly led, you will be able to see both it [C] and the gray cable [F] through the window [E] in the fusing unit cover.

When securing the white cable [C] of the heating roller fusing lamp (front side), make sure to lead it underneath the projection [D] as shown.

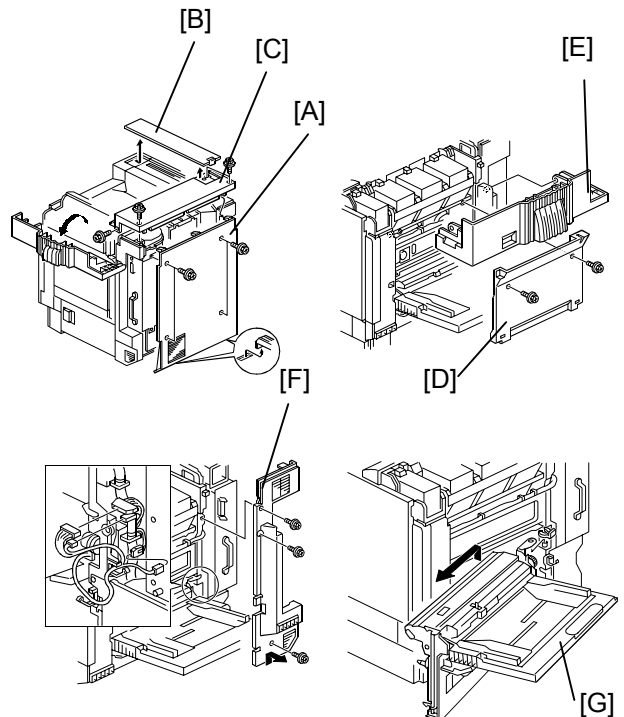
The electrical resistance of the Sheet (#G0602632) attached to the Guide Plate – Middle Registration is out of specification in some machines from July to September '01 production. This may cause the static electricity generated during a multi-print run to charge the Sheet, leading to a jam at the registration area (occasionally a Z-jam).

Replace the Guide Plate with the newly registered “Guide Plate – Middle Registration” assembly (#G0602613):

1. Make sure that the main switch is turned off and the power cord is unplugged.
2. Remove the following parts:
 - Rear Cover [A] (4 screws)
 - Upper Exit Cover [B]
 - Note:** Also remove the Mailbox if installed.
 - Upper Rear Cover [C] (4 screws)
 - Right Cover [D] (2 screws)
 - Upper Right Cover [E]
 - Right Rear Cover [F] (3 screws)
3. Open the Right Door Unit [G] and remove it (3 connectors, 1 snap-ring).

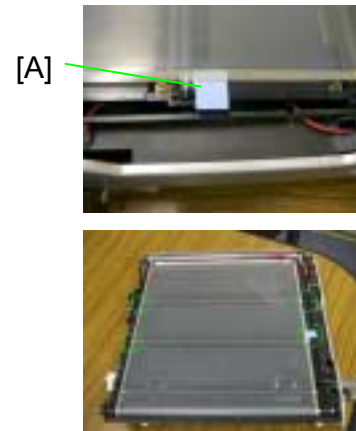
NOTE: If the 4 temporary stoppers [A] for the back-up rollers are present in the circled areas, be sure to remove them before installing the unit. Installing the transfer unit with these stoppers may cause noise or image problems.

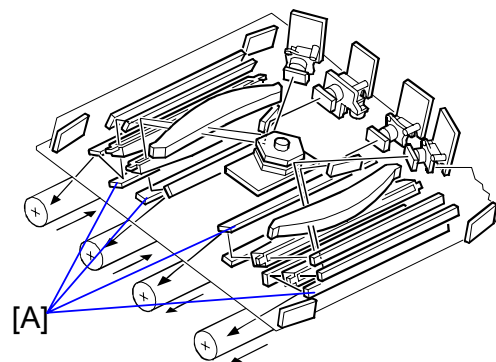
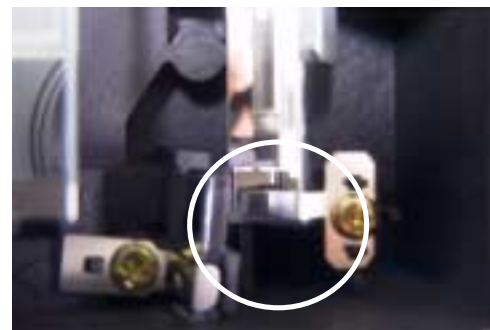
As shown in the pictures, the spring plate [B] positions the mirror. The mirror may become the out of position, changing the angle with the OPC drum.

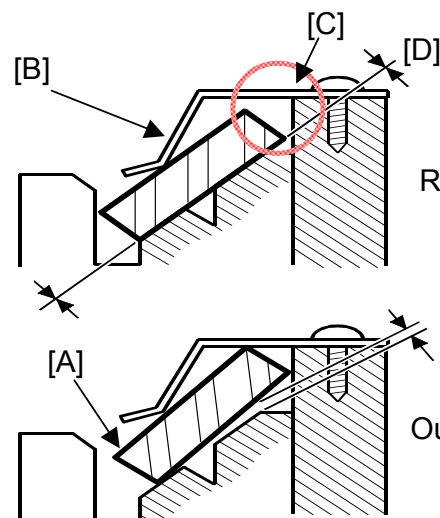
Right position

Out of position

If color(s) is (are) missing on the output, remove the laser optics housing unit and lower cover (10 screws), and reposition the mirror(s) for the missing color(s) once the spring plate is removed.
