Model: Model-J P1c	Date: 4-Jun-02	No.: RG082001a
--------------------	----------------	----------------

RTB Correction

Subject: Machine Installation & Short Haul Transportation		Prepared by: H. Someya	
From: Technical Services sec. Service Planning Dept.			
Classification:	<input type="checkbox"/> Troubleshooting	<input type="checkbox"/> Part information	<input checked="" type="checkbox"/> Action required
	<input type="checkbox"/> Mechanical	<input type="checkbox"/> Electrical	<input type="checkbox"/> Service manual revision
	<input type="checkbox"/> Paper path	<input type="checkbox"/> Transmit/receive	<input type="checkbox"/> Retrofit information
	<input type="checkbox"/> Other ()

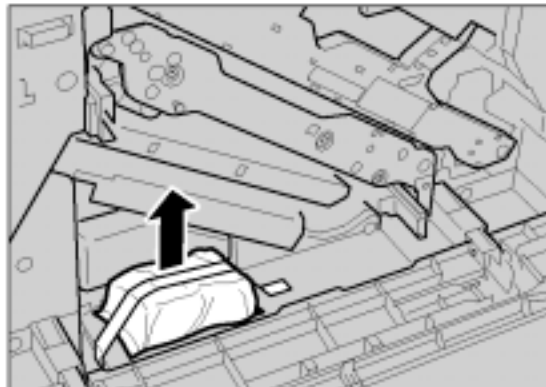
At machine installation, the following types of white lines appear in black halftone areas at the same interval as the drum circumference:

Vibrations during transport cause scratches on the black OPC drum, as the image transfer belt is always contacting the black PCU during this time.

The transfer belt unit lever has been detached and placed inside the machine as shown in the illustration. This lever must then be reattached at installation by the customer or service technician.

Until the permanent solution can be applied, P1c machines are shipped with the transfer belt unit separated from the black PCU. Specifically, the transfer belt unit lever has been detached before shipping to allow the front cover to be closed.

The attachment procedure for this lever has been packaged together with the machine.

1. Open the front cover.
2. Turn the transfer belt unit release lever counterclockwise to lower the transfer belt unit.
3. Remove the lever (1 screw).
4. Reinstall the lever when the machine arrives at the installation site.
