| Model: Model C-P1 | | Date: 17-Sep-03 | No.: RG094001 |

| Subject: Engine Board | | Prepared by: A. Ishiyama | |

Important Note Regarding the G0965116 Engine Board

| Model: General RTB | Date: 15-Nov-04 | No.: RGene019a |

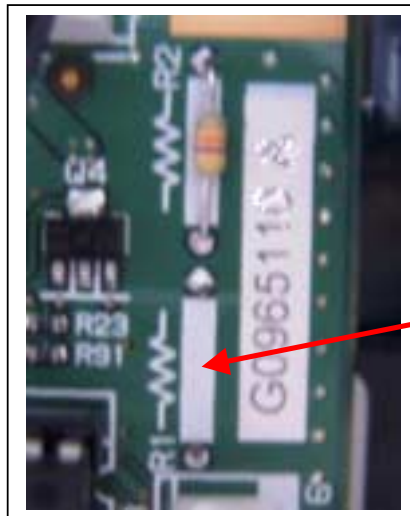
The old engine board (G0965116) contains two resistors, R1 and R2, but the new board for NA (G0985102) contains only R2 and the new board for EU/Asia (G0985104) contains only R1.

2. **For NA version**
 Remove R1 as shown below using a pair of wire cutters (nippers).

Remove R1 using a pair of wire cutters
