Subject: Controller Firmware Release History (System)		Prepared by: A. Ishiyama	
From: 1st Tech. Support Sec. Service Support Dept.			
Classification:	<input type="checkbox"/> Troubleshooting	<input type="checkbox"/> Part information	<input type="checkbox"/> Action required
	<input type="checkbox"/> Mechanical	<input type="checkbox"/> Electrical	<input type="checkbox"/> Service manual revision
	<input type="checkbox"/> Paper path	<input type="checkbox"/> Transmit/receive	<input type="checkbox"/> Retrofit information
	<input checked="" type="checkbox"/> Other ()

This RTB has been issued to announce the firmware history for the System of the Model C-P2c (G113 model).

Model: Model C-P2		Date: 25-Mar-05	No.: RG112009
Subject: Bypass Tray Paper Pick-up Mechanism		Prepared by: A. Ishiyama	
From: 1st Tech. Support Sec. Service Support Dept.			
Classification:	<input type="checkbox"/> Troubleshooting	<input type="checkbox"/> Part information	<input type="checkbox"/> Action required
	<input checked="" type="checkbox"/> Mechanical	<input type="checkbox"/> Electrical	<input type="checkbox"/> Service manual revision
	<input type="checkbox"/> Paper path	<input type="checkbox"/> Transmit/recei

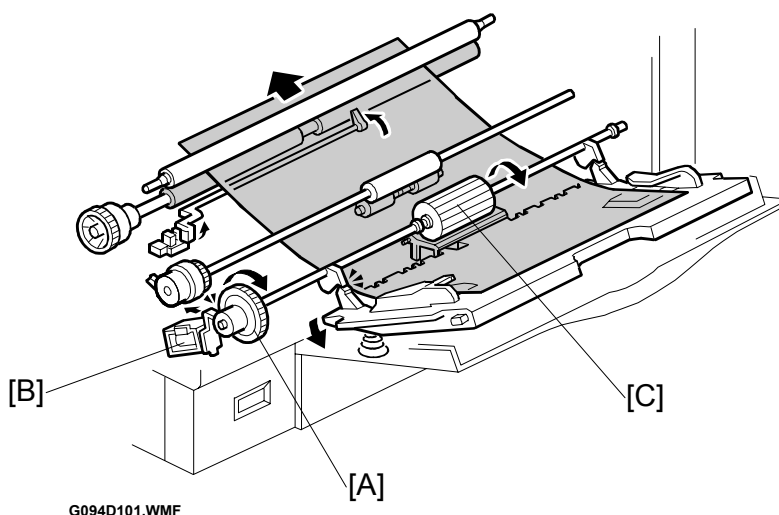
Solenoid System: Same as the C-P1/K-P3 system

The paper feed mechanism for the bypass tray will be **temporarily** changed from a clutch system to a **solenoid** system. The system will be changed back to the clutch system from around August 2005 production (cut-in S/N TBA).

[A] Bypass feed gear

[B] Solenoid

[C] Bypass feed roller

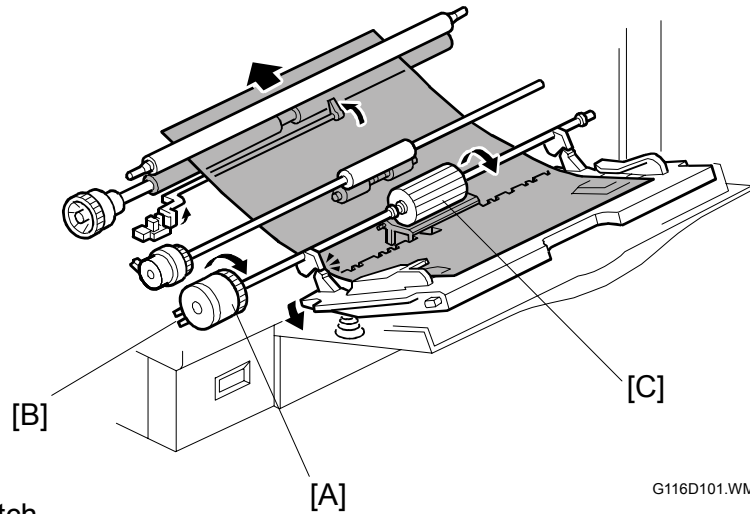
Clutch System: Originally designed for the C-P2/K-P4

[A] Bypass feed clutch

[B] Stopper

[C] Bypass feed roller
