Model: Adonis-P		Date: 31-Oct-99	No.: RG035001
Subject: Service Manual Corrections		Prepared by: K. Takagi	
From: Technical Service Dept., GTS Division			
Classification:	<input type="checkbox"/> Troubleshooting	<input type="checkbox"/> Part information	<input type="checkbox"/> Action required
	<input type="checkbox"/> Mechanical	<input type="checkbox"/> Electrical	<input checked="" type="checkbox"/> Service manual revision
	<input type="checkbox"/> Paper path	<input type="checkbox"/> Transmit/receive	<input type="checkbox"/> Retrofit information
	<input type="checkbox"/> Other ( )

Please make the following corrections in your Adonis-P service manual.

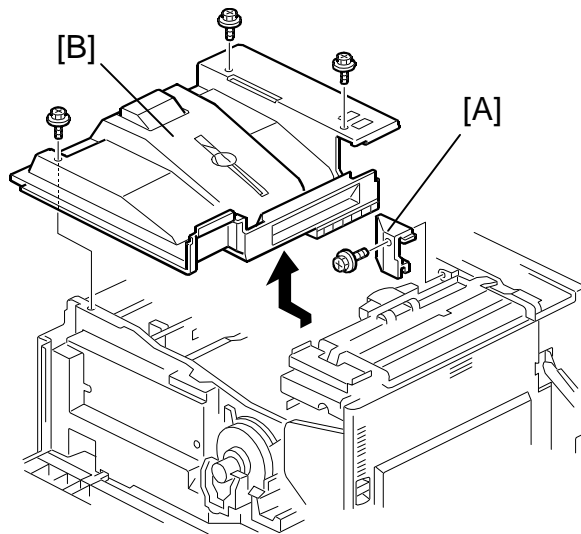
**4. REPLACEMENT AND ADJUSTMENT****• Upper Cover (Page 6-48)**

The wrong illustration is attached for the upper cover removal.

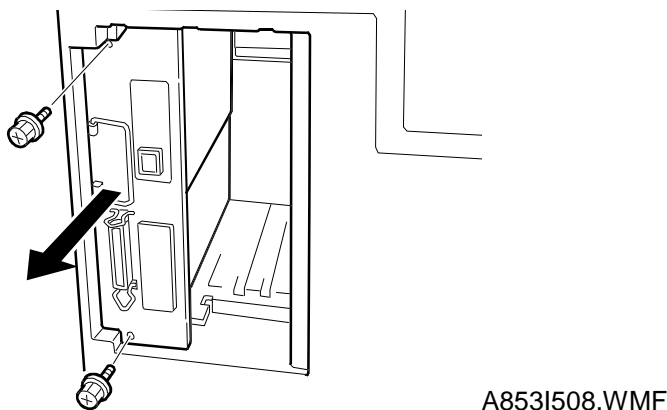
- **Printer Control Board and NIB (Page 6-50)**

The wrong illustration was attached.

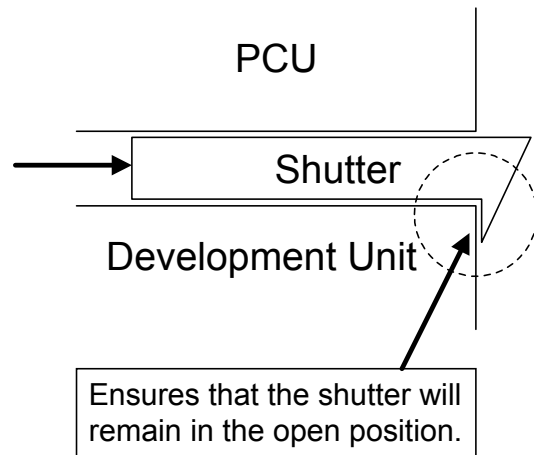
- Light print problem is not fixed after developer is replaced.
- The Toner End message does not disappear after the toner bottle is replaced.

The toner supply shutter (parts catalog pg.27, index #28) returns to the closed position when the PCU unit (PCU and development unit) is put in the machine.

Normally, the shutter is not in the closed position when the machine is shipped out. However, if the technician removes the PCU unit from the machine and attempts to separate the PCU from the development unit, the shutter may return to the closed position.

The following modification to the toner supply shutter was applied to the production line from October 1999:

1. The length of the pawl edge of the shutter was increased by 2.5 mm to prevent the shutter from returning to the closed position.
2. The tension spring (parts catalog pg.27, #27) included in the user maintenance kit was deleted.

If you should experience any future occurrences, remove the PCU unit from the machine, check the position of the shutter and return it to the open position if necessary (see the illustration below). After this, carefully place the unit back in the machine.
