Model: Model A-P3		Date: 27-Nov-01	No.: RG065001
Subject: Service Manual Correction		Prepared by: E. Fukuyama	
From: Technical Services Dept., GTS Division			
Classification:	<input type="checkbox"/> Troubleshooting	<input type="checkbox"/> Part information	<input type="checkbox"/> Action required
	<input type="checkbox"/> Mechanical	<input type="checkbox"/> Electrical	<input checked="" type="checkbox"/> Service manual revision
	<input type="checkbox"/> Paper path	<input type="checkbox"/> Transmit/receive	<input type="checkbox"/> Retrofit information
	<input type="checkbox"/> Other (        )

Model: General (GW Models)		Date: 20-Dec-01	No.: RGene010
Subject: Series Print Mode		Prepared by: K. Misugi	
From: Technical Services Dept., GTS Division			
Classification:	<input checked="" type="checkbox"/> Troubleshooting	<input type="checkbox"/> Part information	<input type="checkbox"/> Action required
	<input type="checkbox"/> Mechanical	<input type="checkbox"/> Electrical	<input type="checkbox"/> Service manual revision
	<input type="checkbox"/> Paper path	<input type="checkbox"/> Transmit/receive	<input type="checkbox"/> Retrofit information
	<input type="checkbox"/> Other ( )

Model:

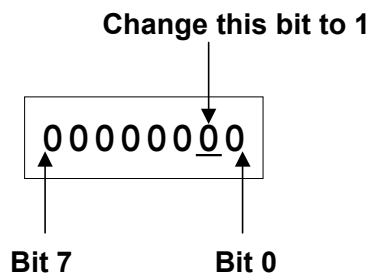
In response to complaints from customers that the intervals between jobs are too long when sent in series, a new service switch has been added to improve performance.

Controller SP mode bit switch 2, bit 1  
 Series print mode On/Off  
**0:** Off (default setting)  
**1:** On

Enter the printer controller service mode, access the bit switch settings display, then change bit 1 of bit switch 2 to "1."

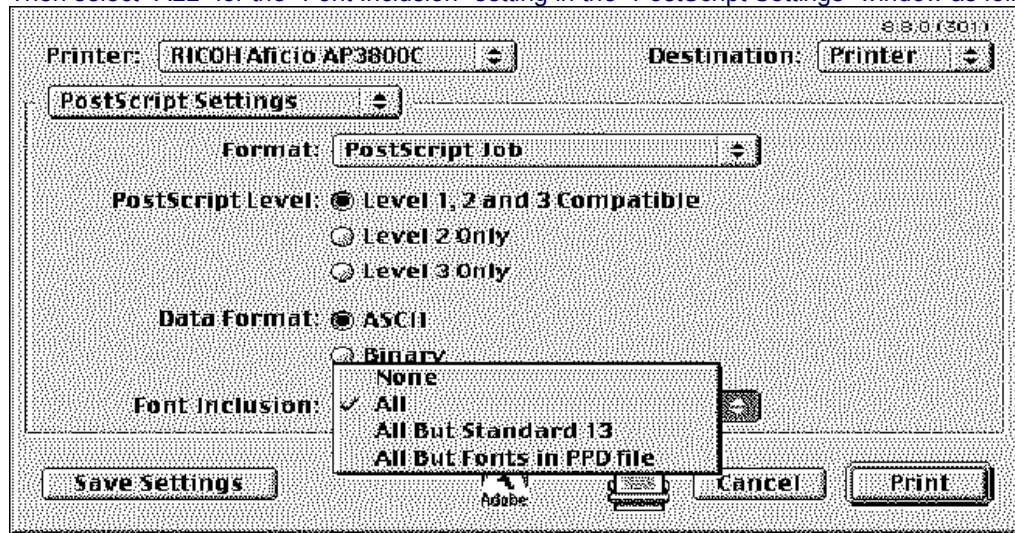
MacOS 9.x / 8.x

Euro Fonts printing problem

Use the AdobePS 8.8 printer driver.

Then select "ALL" for the "Font Inclusion" setting in the "PostScript Settings" window as follows.
