Technical Bulletin

Model: Model K-	P3		Dat	e: 14-Nov-03	No.: RG091001
Subject: Service Manual Correction				Prepared by: A.	Ishiyama
From: 1st Techni	cal Support sec. Service Supp	ort Dept.			
Classification:	Troubleshooting	Part info	ormat	tion 🗌 Actio	on required
	Mechanical	Electric	al	🖂 Serv	ice manual revision
	Paper path	🗌 Transm	it/rec	eive 🗌 Retr	ofit information
	Other ()

Model: Model K-	P3		Dat	e: 26-Apr-04	No.: RG091003
Subject: Engine Board				Prepared by: A	. Ishiyama
From: 1st Technical Support Sec. Service Support Dept.					
Classification:	Troubleshooting	Part info	ormat	tion 🛛 🖂 Act	ion required
	Mechanical	Electric	al	🗌 Ser	vice manual revision
	Paper path	🗌 Transm	it/rec	eive 🗌 Ret	rofit information
	Other ()

Important Note Regarding the G0885123 Engine Board

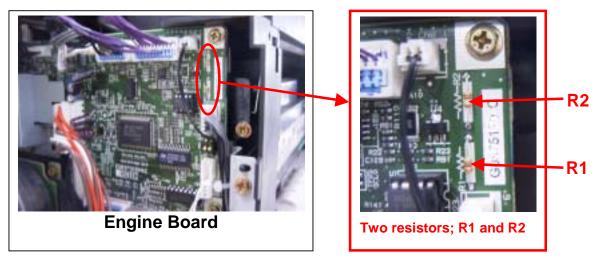
Minor Modification of old G0885123 Engine Board to its New Version

The old engine board (G0885123) contains two resistors, R1 and R2, but the new board for NA (G0885121) contains only R2 and the new board for EU/Asia (G0885122) contains only R1.

- 1. If the old engine board is already installed in the machine:
 - i) Open the front door.
 - ii) Remove the operation panel (2 hooks, 1 harness).
 - iii) Remove the rear cover and option top cover.
 - iv) Remove the top cover (4 screws).
 - v) Remove the left cover (2 screws).
