Model: Model PL-P1	Date: 25-Jun-04	No.: RG108001c
--------------------	-----------------	----------------

Subject: Firmware Release History (printer)		Prepared by: H. Taguchi	
From: 1st Tech. Support Sec. Service Support Dept.			
Classification:	<input type="checkbox"/> Troubleshooting	<input type="checkbox"/> Part information	<input type="checkbox"/> Action required
	<input type="checkbox"/> Mechanical	<input type="checkbox"/> Electrical	<input type="checkbox"/> Service manual revision
	<input type="checkbox"/> Paper path	<input type="checkbox"/> Transmit/receive	<input type="checkbox"/> Retrofit information
	<input checked="" type="checkbox"/> Other ()

Model: Model PL-P1		Date: 15-Sep-04	No.: RG108007
Subject: Dust cover		Prepared by: H.Taguchi	
From: 1st Tech. Support Sec. Service Support Dept.			
Classification:	<input checked="" type="checkbox"/> Troubleshooting	<input type="checkbox"/> Part information	<input type="checkbox"/> Action required
	<input type="checkbox"/> Mechanical	<input type="checkbox"/> Electrical	<input type="checkbox"/> Service manual revision
	<input type="checkbox"/> Paper path	<input type="checkbox"/> Transmit/receive	<input type="checkbox"/> Retrofit

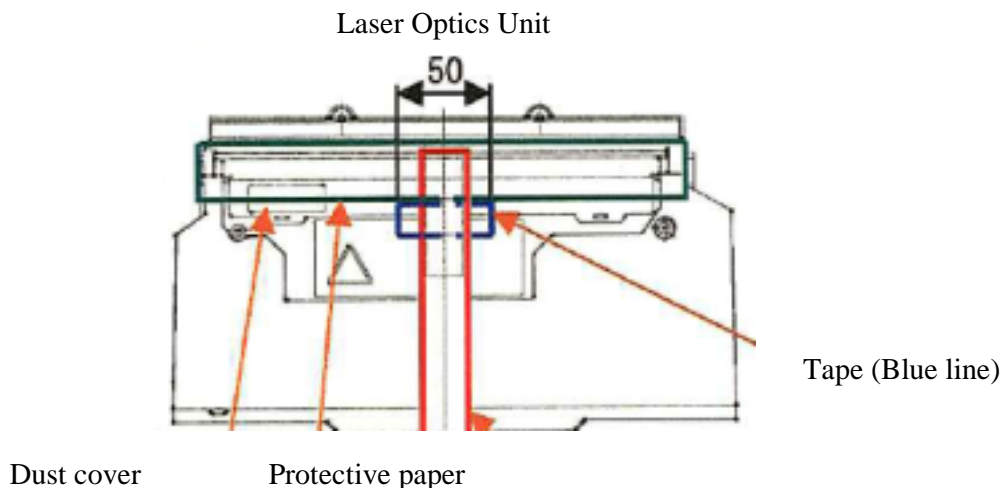
No image is printed at installation.

The dust cover for the optics unit comes loose and blocks the laser.

Sometimes, customers reach through the top cover and remove the protective sheet for the optics unit. In some cases, the dust cover opens and then comes loose when the toner cartridge is pushed in.

If the symptom is reported, close the dust cover or replace it if it is broken.

A strip of tape was added to the dust cover to keep it closed.

Important: You do not need this tape after installation. Remove the tape if you need to open the cover to do regular maintenance (for example, to clean the dust glass).
