Model: General (GW Models)		Date: 20-Dec-01	No.: RGene010
Subject: Series Print Mode		Prepared by: K. Misugi	
From: Technical Services Dept., GTS Division			
Classification:	<input checked="" type="checkbox"/> Troubleshooting	<input type="checkbox"/> Part information	<input type="checkbox"/> Action required
	<input type="checkbox"/> Mechanical	<input type="checkbox"/> Electrical	<input type="checkbox"/> Service manual revision
	<input type="checkbox"/> Paper path	<input type="checkbox"/> Transmit/receive	<input type="checkbox"/> Retrofit information
	<input type="checkbox"/> Other (      )

Model: Model U-P1		Date: 20-Dec-02	No.: RG071001
Subject: Image Skew		Prepared by: H.K.	
From: Technical Services sec. Service Planning Dept.			
Classification:	<input checked="" type="checkbox"/> Troubleshooting	<input type="checkbox"/> Part information	<input type="checkbox"/> Action required
	<input type="checkbox"/> Mechanical	<input type="checkbox"/> Electrical	<input type="checkbox"/> Service manual revision
	<input type="checkbox"/> Paper path	<input type="checkbox"/> Transmit/receive	<input type="checkbox"/> Retrofit information
	<input type="checkbox"/> Other (      )

Model: Model U-P1

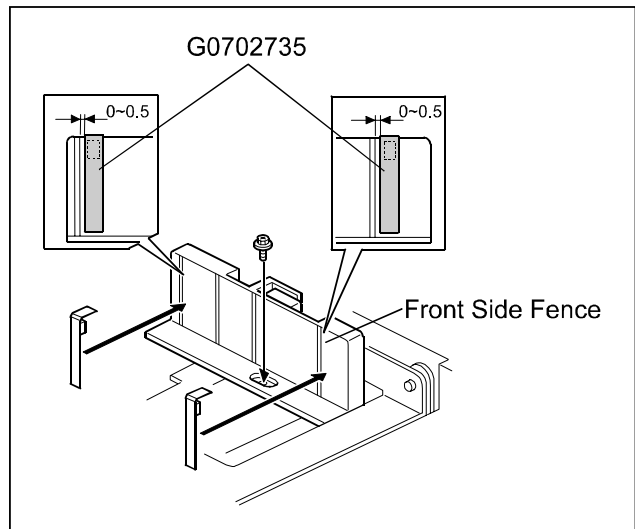
**Cause**

As a supplement, the level of skew can be further minimized by increasing the paper buckle with SP1-003. Try adjusting this value several times while checking the level of skew on the printouts, keeping in mind that a higher value tends to cause Z-folds and a lower value tends to cause paper jams.

1. Clean the attachment surface on the Front Side Fence (AF016097) with alcohol.
2. Attach the Mylar (G0702735) to the Front Side Fence as shown in the illustration.

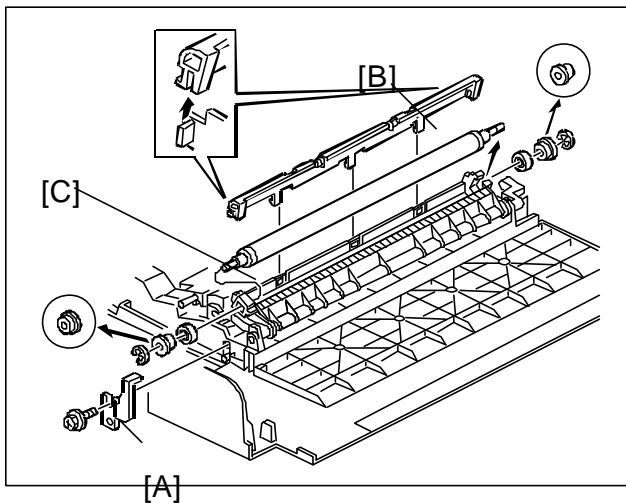
The orientation of both bearings in the illustration below should be reversed.

**Note:** This is an illustration correction only. The procedure itself is unchanged.

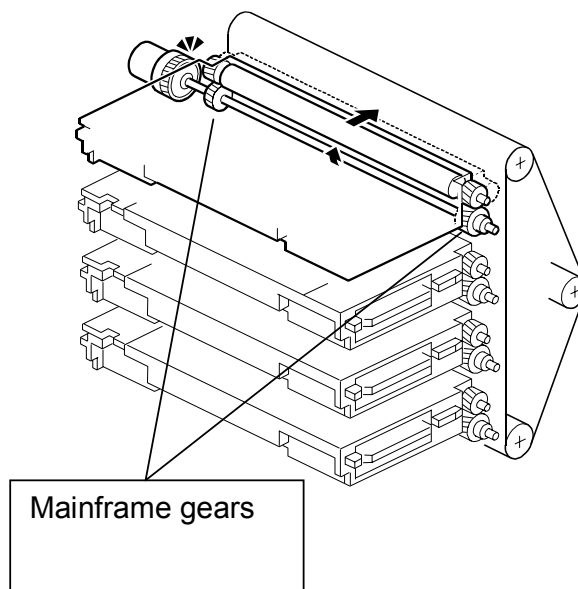
A blank area may appear on one side of the image (development unit front or rear).

The development unit front gears engage their mainframe counterparts slightly differently than the rear gears.

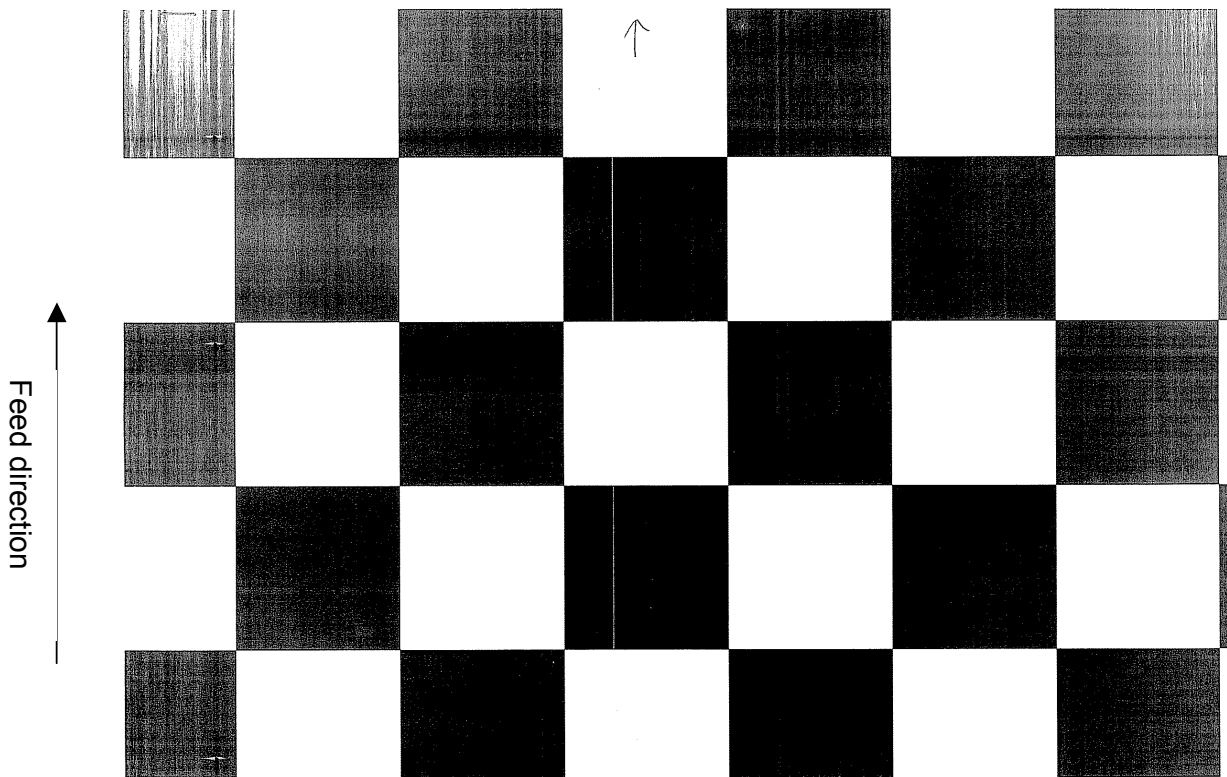
Sample:

- 1) B/W image areas
- 2) Originals with low image coverage ratios and
- 3) Jobs with a low quantity of sets (e.g. 1 or 2P/J)

Please perform the following update and replacements, which will minimize the chances of symptom occurrence. The modified firmware reduces the amount of lubrication used on the OPC, which in effect minimizes the amount of lubrication that can get inside the development unit and toner cartridge.

2) Replace the black development unit.

3) Replace the black toner cartridge.

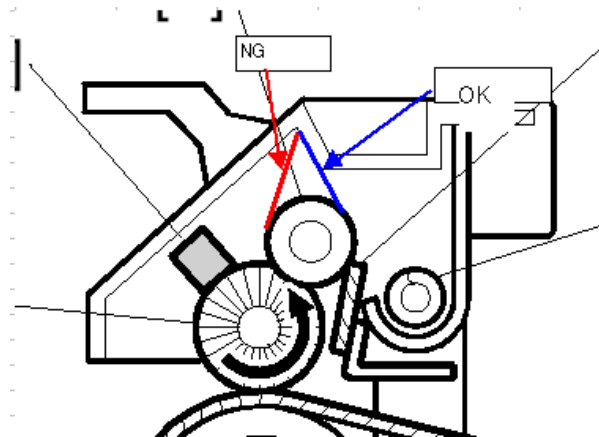
The Mylar next to the cleaning roller in the image transfer belt cleaning unit was placed in the opposite position. Refer to the following illustration. (Incorrect position: red, correct position: blue)

These machines were picked up for the QA sample check after they were produced in the production line. After the QA check, the cleaning unit was cleaned in the line. It is likely that the mylars were moved to the opposite position during cleaning the ITB cleaning unit. If the cleaning roller is rotated by turning the gear incorrectly during the cleaning stage, the mylar is then in the opposite position.

Replace the image transfer belt cleaning unit (G0706300: Belt Cleaning Assembly).

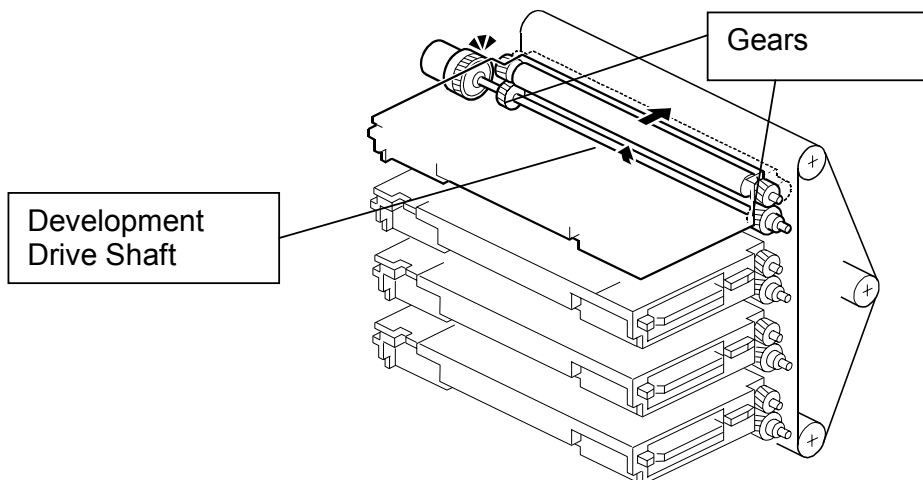
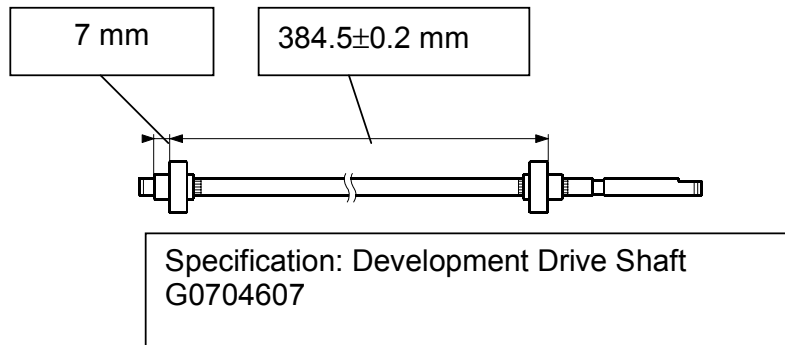
The gear on the development shaft shifts when the development drive is supplied.

The manufacturer reported that they normally perform surface grinding if dirt or other materials or scratches are detected on the shaft. This can cause the diameter to be reduced to below spec minimum.

Replace the development shaft with the spare part (G0704607: Development Shaft - FC).

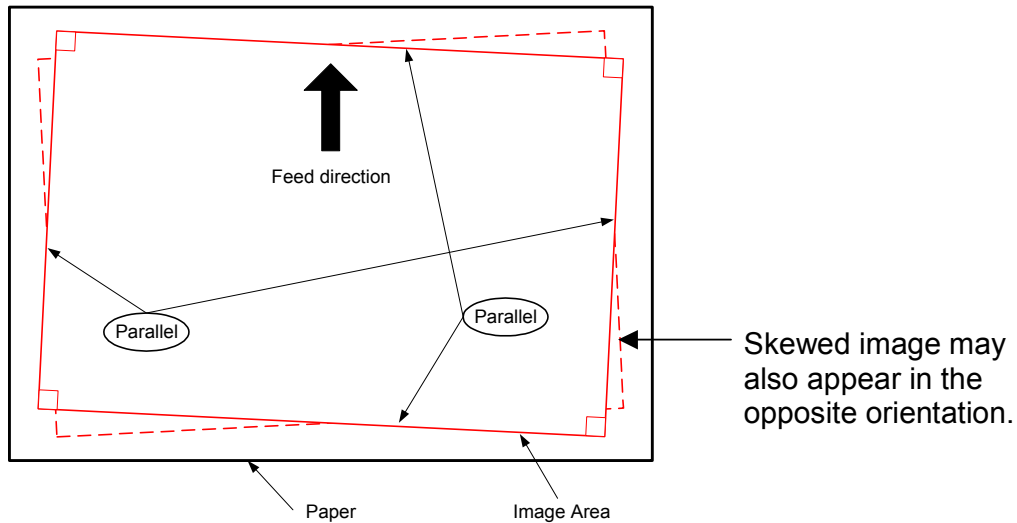
## 1.1 SKEWED IMAGES

- The image's leading and trailing edges are parallel to one another.
- The image's left and right edges are also parallel.
- However, **all four sides** are slanted with respect to the paper's edge.

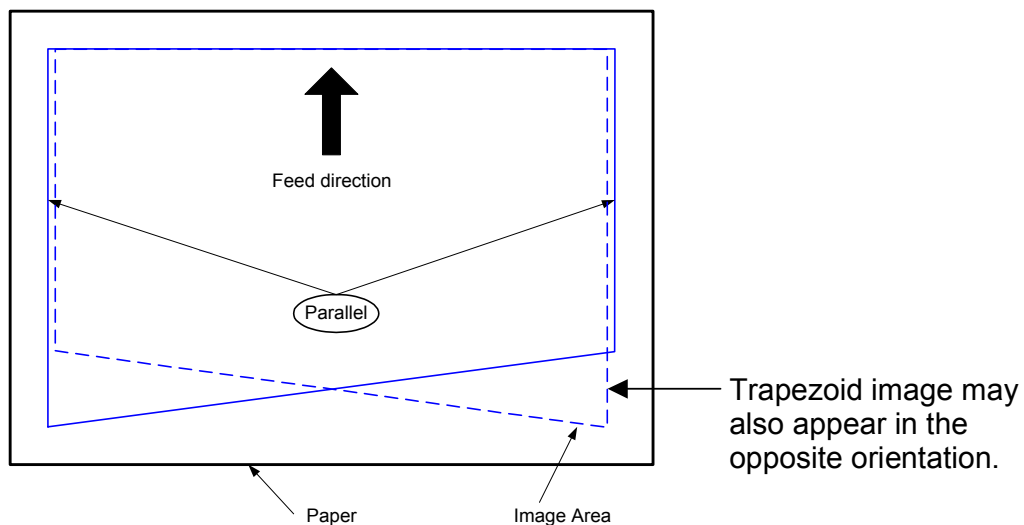
## 1.2 TRAPEZOID IMAGES

- Only the image's **trailing edge** is slanted with respect to the paper. The remaining 3 sides are parallel to the paper's edges.

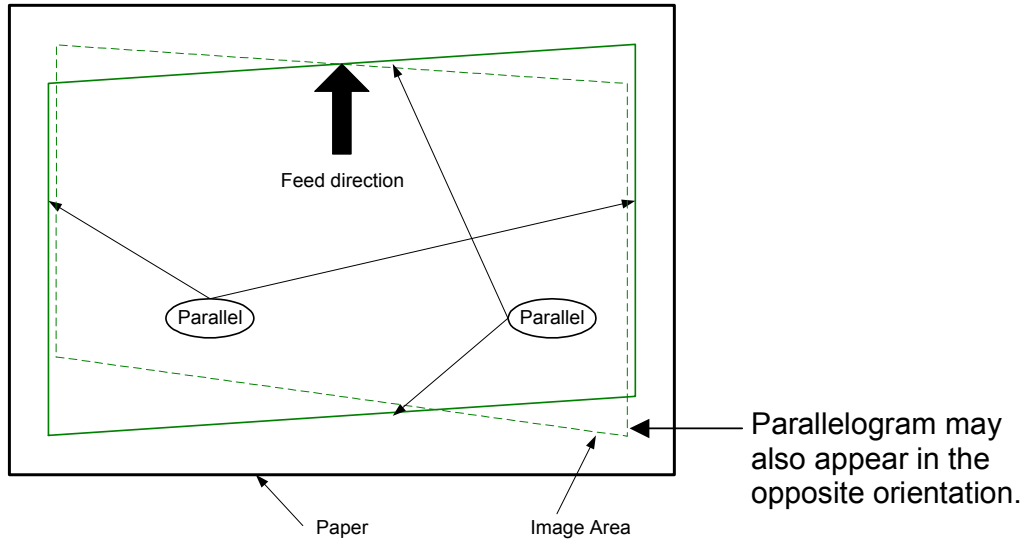
### 1.3 PARALLELOGRAM IMAGES

- Like skewed images, the leading/trailing edges and left/right edges are parallel to each other, but here, the **leading and trailing edges** are both slanted with respect to the paper's edge.

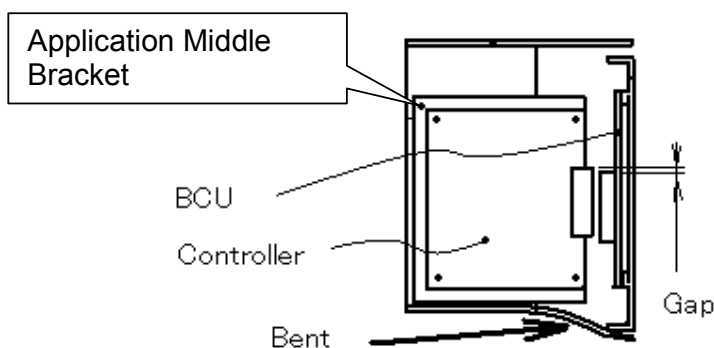
The height of the application middle bracket has been reduced by 0.6 mm to ensure the controller is always attached in the optimal position.

P/N change for this part: G0705523 → G0705520

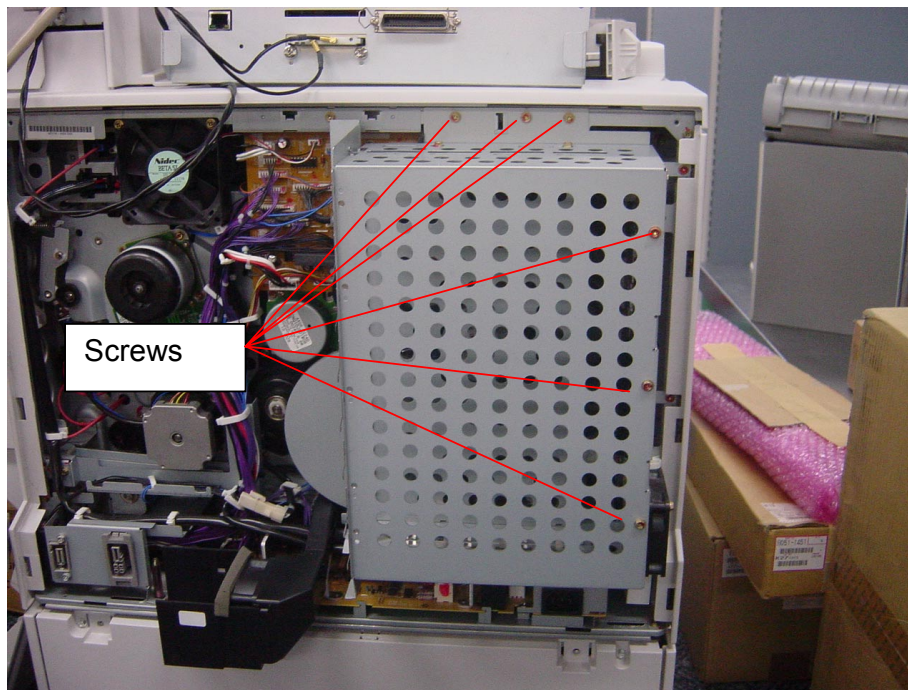
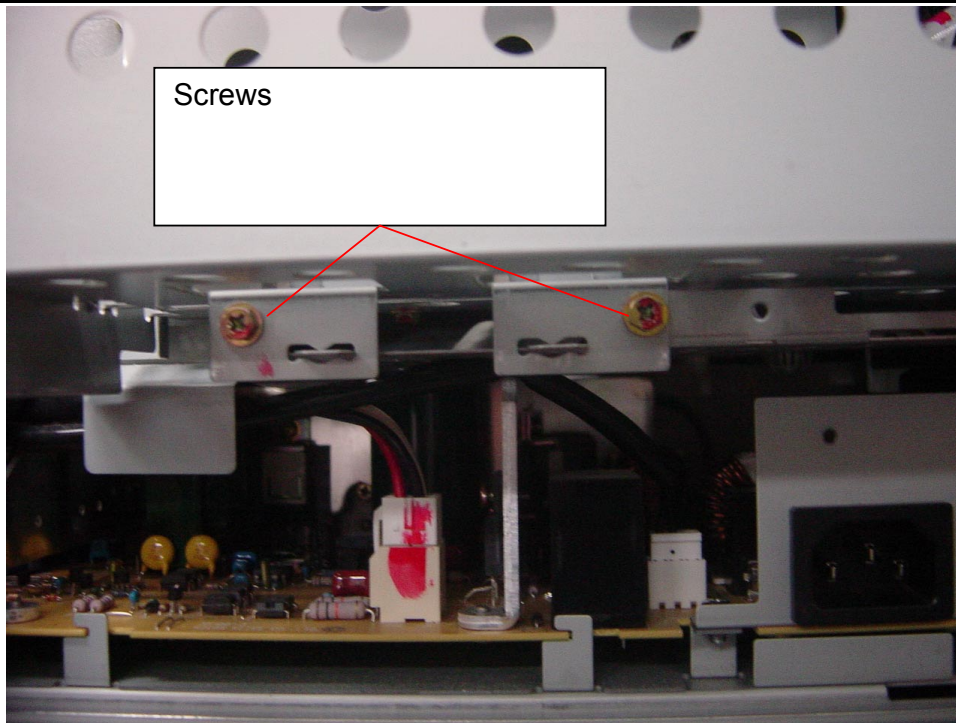
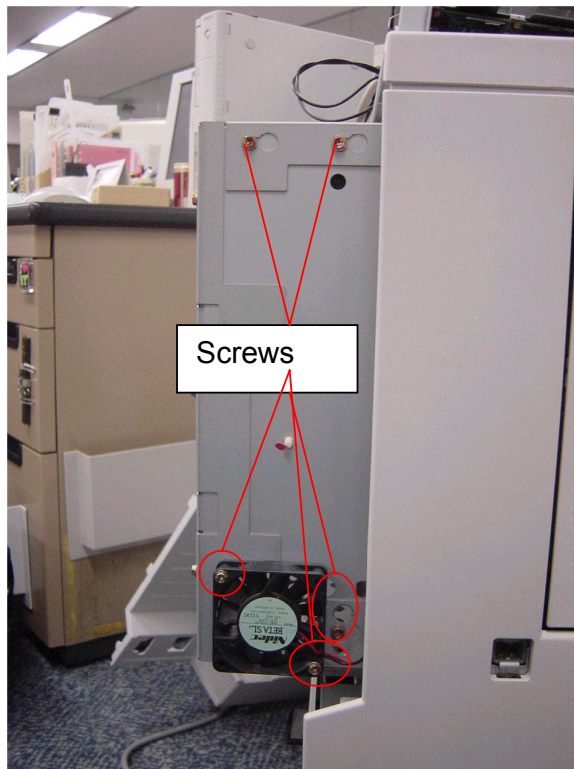
**Point:** The controller box is attached in this lower position to prevent poor connection between the BCU and controller. If the controller box is assembled in the upper position, a poor connection may occur.

If the above symptom occurs, reattach the controller box as shown below to ensure a proper connection between the controller box and BCU board.

1. Turn off the main switch and remove the duct cover, ozone filter, printer controller, and rear cover.
2. Loosen the 13 screws that secure the controller box and cooling fan.

3. While holding the controller box in its lower position, secure the 13 screws.

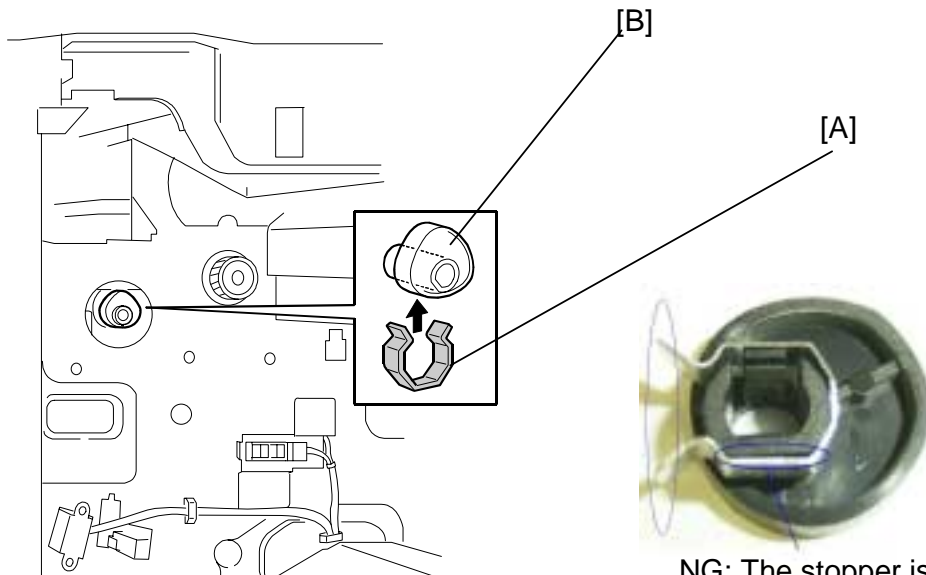
NG: The stopper is sticking out from the cam.

1. Turn off the main switch.
2. Open the front cover.
3. Remove the old PCU.
4. Install the cam stopper [A] on the cam [B] so that the stopper does not stick out from the cam.  
**Note:** The straight edges of the cam stopper and cam are aligned with each other. The cam stopper will snap into position.
5. Install the new PCU.
