Model: General RTB	Date: 4-Feb-03	No.: RGene013b
--------------------	----------------	----------------

Subject: Service remarks at installation		Prepared by: T. Itoh	
From: Technical Service Sec. Service Planning Dept.			
Classification:	<input type="checkbox"/> Troubleshooting	<input type="checkbox"/> Part information	<input type="checkbox"/> Action required
	<input type="checkbox"/> Mechanical	<input type="checkbox"/> Electrical	<input type="checkbox"/> Service manual revision
	<input type="checkbox"/> Paper path	<input type="checkbox"/> Transmit/receive	<input type="checkbox"/> Retrofit information
	<input checked="" type="checkbox"/> Other (Specification change)

Model: Model J-P2		Date: 2-Apr-03	No.: RG080001
Subject: Service Manual Revision		Prepared by: H.Taguchi	
From: 1st Tech. Support Sec. Service Support Dept.			
Classification:	<input type="checkbox"/> Troubleshooting	<input type="checkbox"/> Part information	<input type="checkbox"/> Action required
	<input type="checkbox"/> Mechanical	<input type="checkbox"/> Electrical	<input checked="" type="checkbox"/> Service manual revision
	<input type="checkbox"/> Paper path	<input type="checkbox"/> Transmit/receive	<input typ

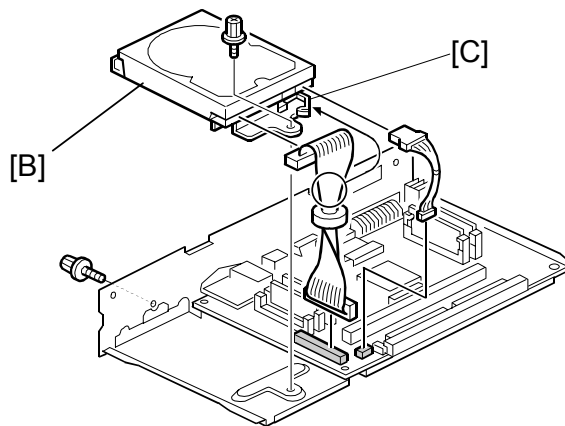
**Page 1-32**

A harness clamp [C] and harness core have been added, and the harness attachment has been revised as follows.

2. Mount the 40GB HDD [B] on the controller (Harness x 2, Screw x 2, **Clamp[C] x 1**)

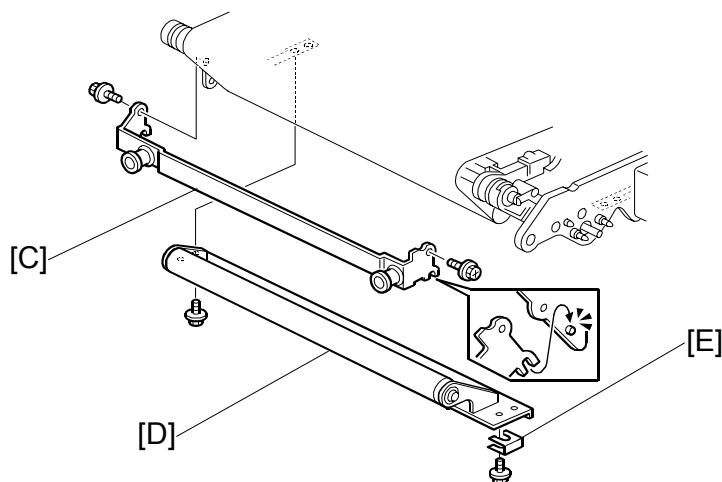
Page 3-25

- A spacer [E] has been added.

6. Tension roller [D] (**Spacer [E] x 1**, Screw x 2)

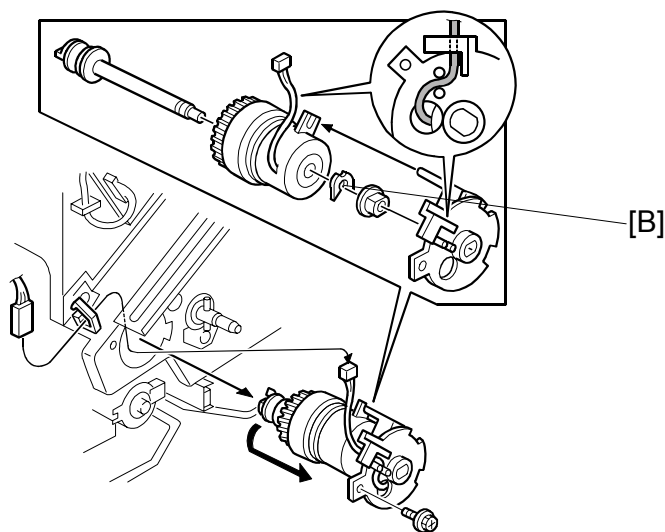
## Page 3-50

- A retaining ring [B] has been inserted between the magnetic clutch and the bushing, as follows.

3. Development clutch [A] (Connector x 1, Screw x 1, **Retaining ring [B] x 1**)

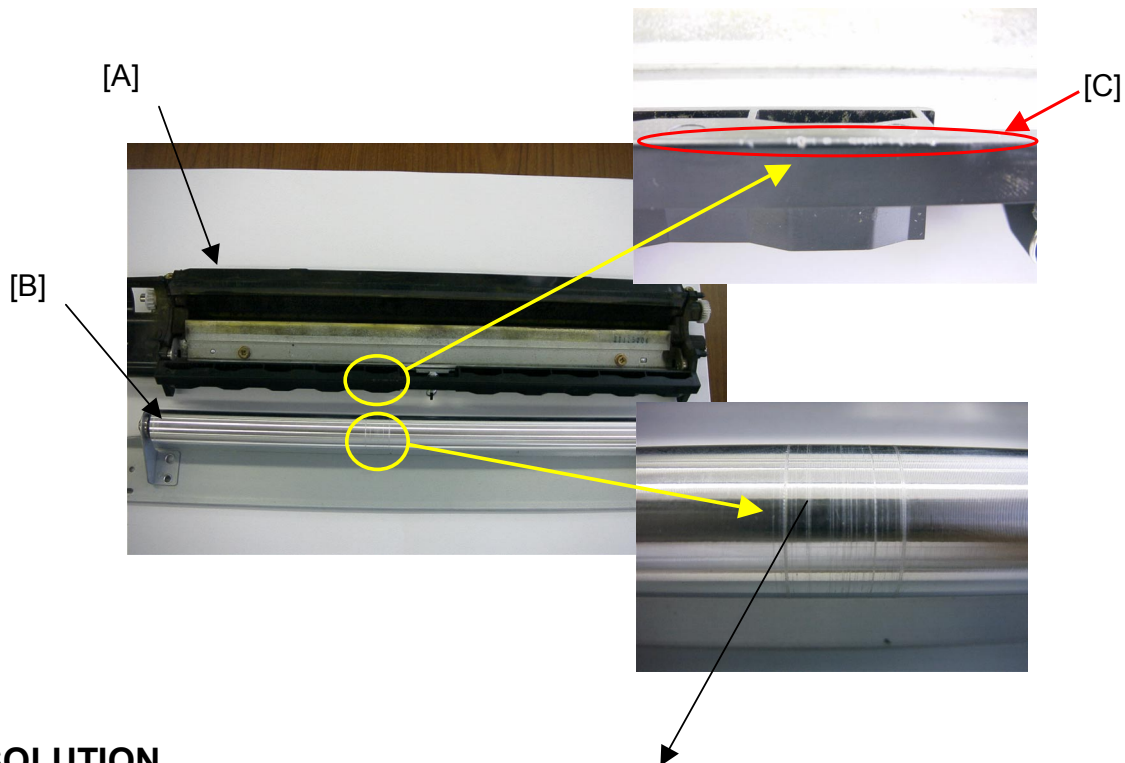
The edge of the cleaning unit [C] bends slightly during operation, causing the gap between it and the left lower driver roller [B] (#G0803945, P/C 41-7) to narrow and the unit to contact the roller.

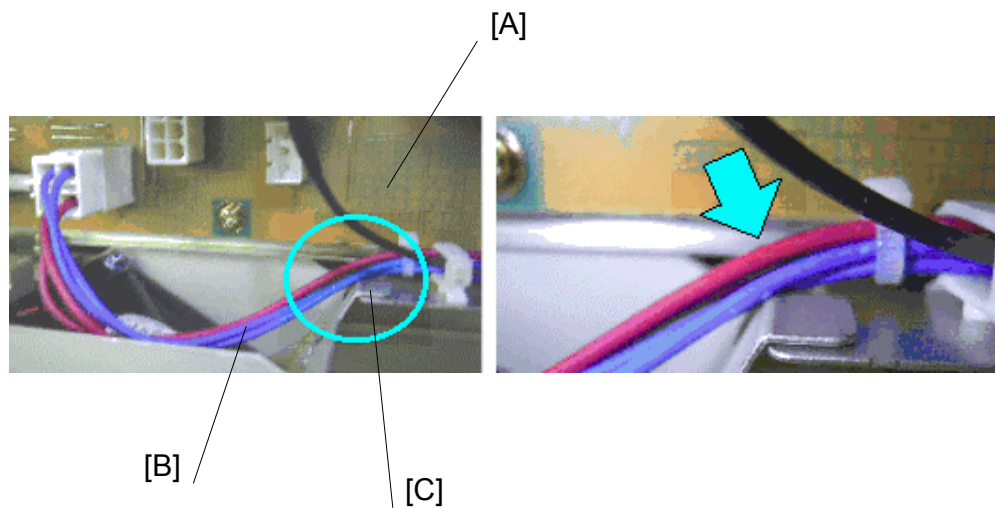
When replacing the above mentioned parts, the harness may be damaged when it comes in contact with the edge of the bracket or PSU bracket.

When replacing the PSU, Harness or Bracket, wrap the area of the harness shown by the arrow in electrical tape to protect it from the bracket edges.

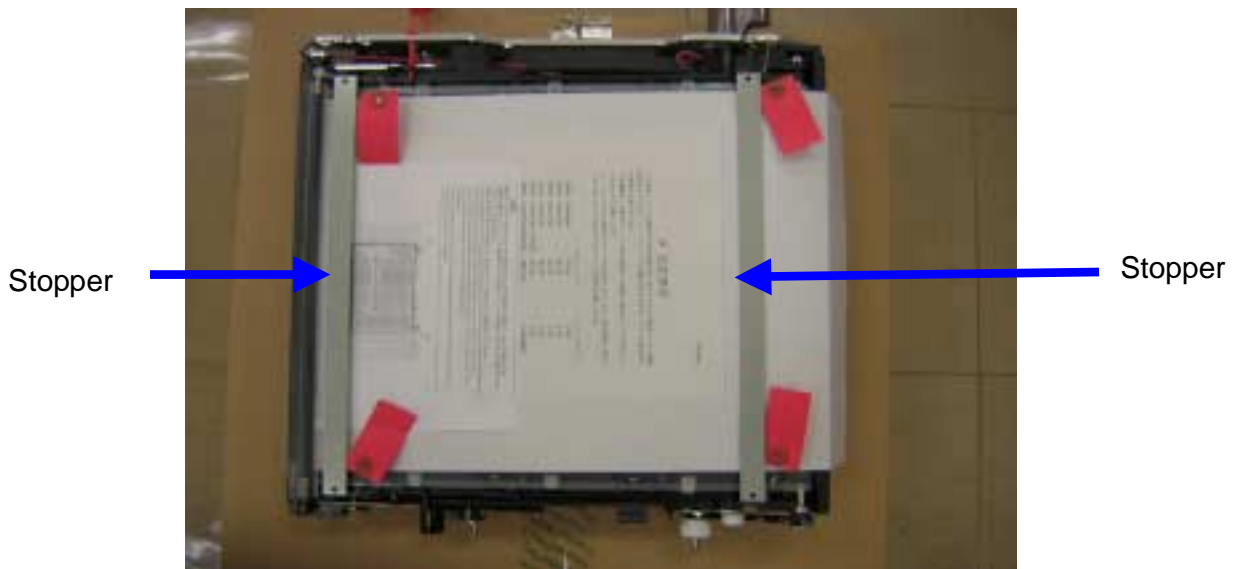
The springs for the transfer unit rollers come loose during transport.

Vibration during transport makes the springs come loose.

When you install the new units (=units with stoppers):

- Remove the two stoppers before you install the new transfer unit.
  - Remove the wires at the four ends of the stoppers
  - Remove the four red tags

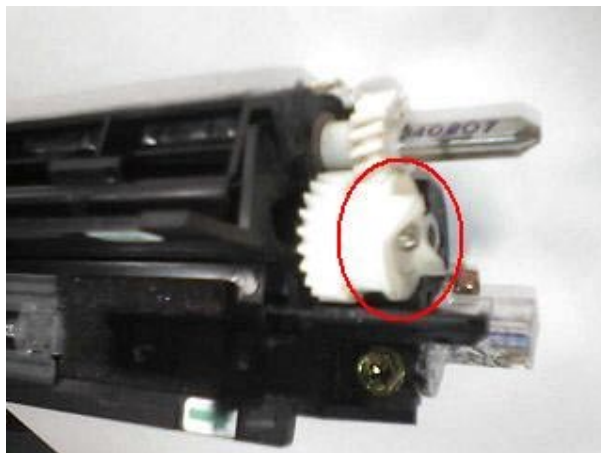
- White spots
- SC386, SC387, SC388, SC389
- Toner leaks from the toner supply window

- 1) When you install the development unit:  
Make sure to push it all the way inside the machine so that the **mainframe gear engages with the development unit gear**.
- 2) If the symptom is reported:  
Replace the Gear:Joint:Drive:Z18 with **AB014277**.
