Model: Model J-P3		Date: 14-May-04	No.: RG106001
Subject: The menu key cannot be used		Prepared by: H.Taguchi	
From: 1st Tech. Support Sec. Service Support Dept.			
Classification:	<input checked="" type="checkbox"/> Troubleshooting	<input type="checkbox"/> Part information	<input type="checkbox"/> Action required
	<input type="checkbox"/> Mechanical	<input type="checkbox"/> Electrical	<input type="checkbox"/> Service manual revision
	<input type="checkbox"/> Paper path	<input type="checkbox"/> Transmit/receive	<input type="checkbox"/> Retrofit information
	<input type="checkbox"/> Other ()

Model: Model J-P3		Date: 20-May-04	No.: RG106003
Subject: Vertical black lines		Prepared by: H.Taguchi	
From: 1st Tech. Support Sec. Service Support Dept.			
Classification:	<input checked="" type="checkbox"/> Troubleshooting	<input type="checkbox"/> Part information	<input type="checkbox"/> Action required
	<input type="checkbox"/> Mechanical	<input type="checkbox"/> Electrical	<input type="checkbox"/> Service manual revision
	<input type="checkbox"/> Paper path	<input type="checkbox"/> Transmit/receive	<input type="checkbox"/> Retrofit information
	<input type="checkbox"/> Other ()

Model: Mo

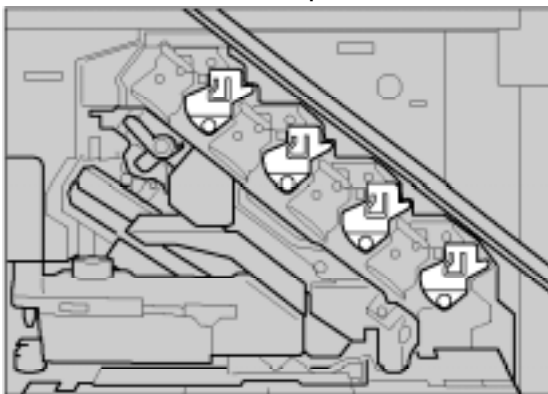
SC386, SC387, SC388 or SC389 may occur when you install the machine or replace the development unit.

The drum plate bends slightly and the development unit gear cannot join with the mainframe gear.

4. Push in the four development units all the way to the rear.

Important: Make sure to push the unit all the way to the rear.

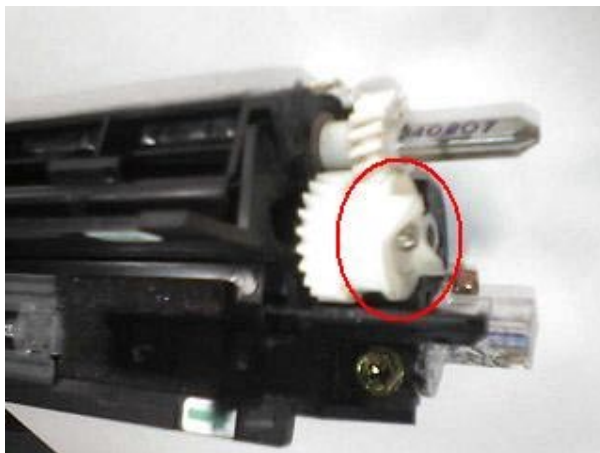
- White spots
- SC386, SC387, SC388, SC389
- Toner leaks from the toner supply window

- 1) When you install the development unit:
Make sure to push it all the way inside the machine so that the **mainframe gear engages with the development unit gear.**
- 2) If the symptom is reported:
Replace the Gear:Joint:Drive:Z18 with **AB014277.**
