Model: GF10		Date: 15-Dec-98	No: 1
Subject: Part number for the main motor		Prepared by: K.Takagi	
From: GTSS Field Information Dept.			
Classification:	<input type="checkbox"/> Troubleshooting	<input type="checkbox"/> Part information	<input type="checkbox"/> Action required
	<input type="checkbox"/> Mechanical	<input type="checkbox"/> Electrical	<input type="checkbox"/> Service manual revision
	<input type="checkbox"/> Paper path	<input type="checkbox"/> Transmit/receive	<input type="checkbox"/> Retrofit information
	<input type="checkbox"/> Other ()

Model: G Series, Schmidt Series		Date: 30-Jun-99	No.: RFMLU009
Subject: Vertical gray band		Prepared by: Y. Okunishi	
From: Technical Service Dept., GTS Division			
Classification:	<input checked="" type="checkbox"/> Troubleshooting	<input type="checkbox"/> Part information	<input type="checkbox"/> Action required
	<input type="checkbox"/> Mechanical	<input type="checkbox"/> Electrical	<input type="checkbox"/> Service manual revision
	<input type="checkbox"/> Paper path	<input type="checkbox"/> Transmit/receive	<input type="checkbox"/> Retrofit information
	<input type="checkbox"/> Other ()

Model: GF-10		Date: 15-Jul-99	No.: RG0250

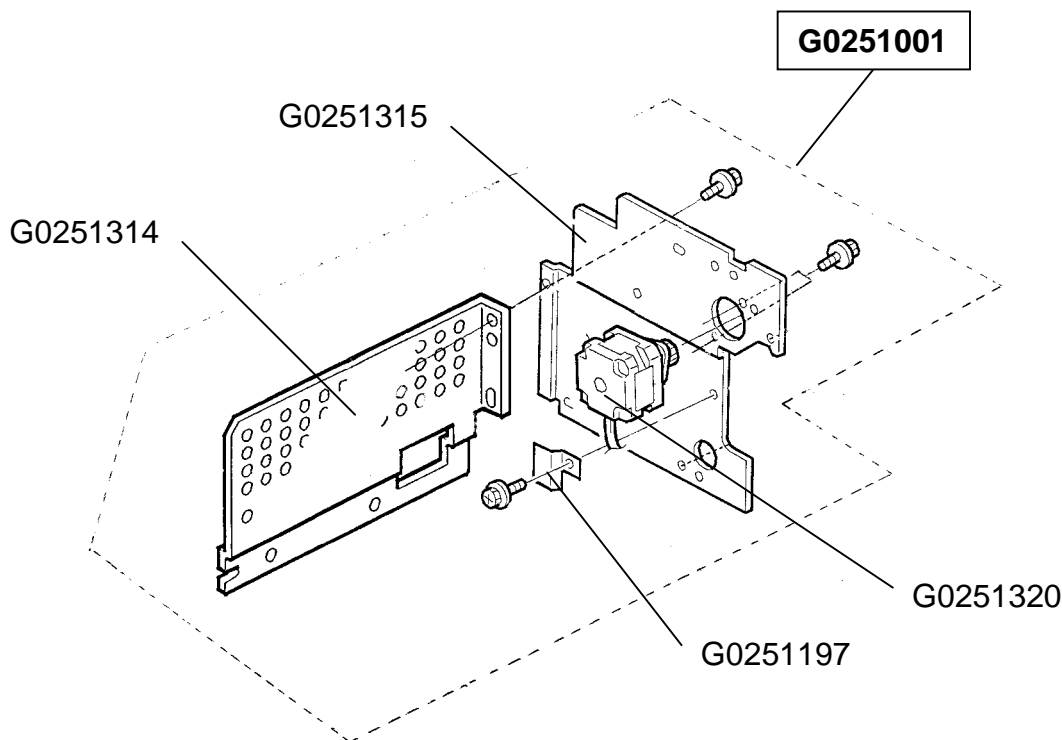
Part composition for G0251001

The service parts composition for the main motor has been changed as follows, because the manufacturer cannot supply the motor unit separately.

SPC can take orders only for part number **G0251001**, so the part number of **G0251320** will not be used for orders.

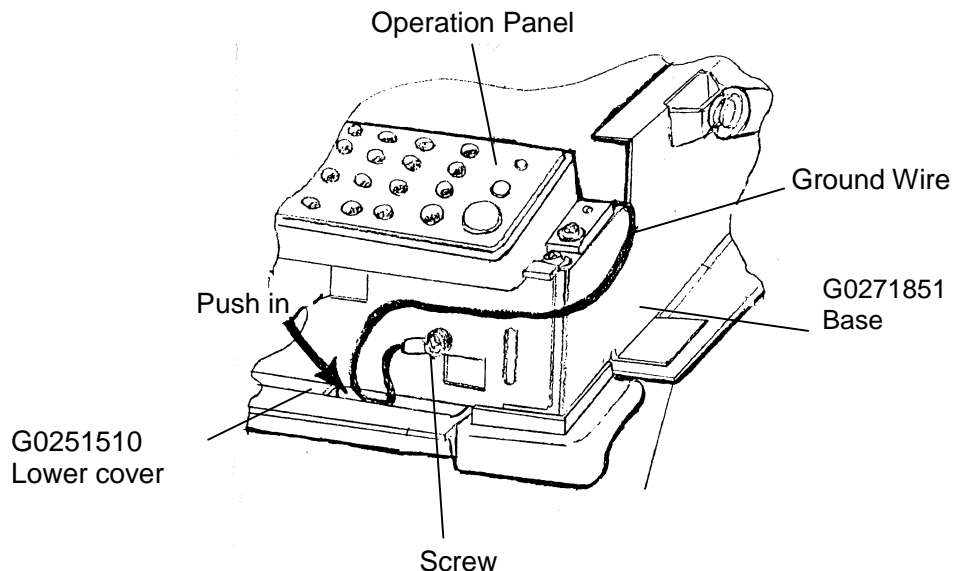
The ground wire of the operation panel has been extended so that it can be wrapped around the noise filter. This RTB shows how to attach the new operation panel.

The noise filter does not need to be attached to GF10-1/2 models. Due to the ground wire being relatively long, please follow the procedure described below to prevent the ground wire from getting caught between covers.

1. Attach the ground wire of the operation panel to the base of the scanner unit with one screw.
2. Push the loose wire into the gap between the base and lower cover (of the scanner unit).

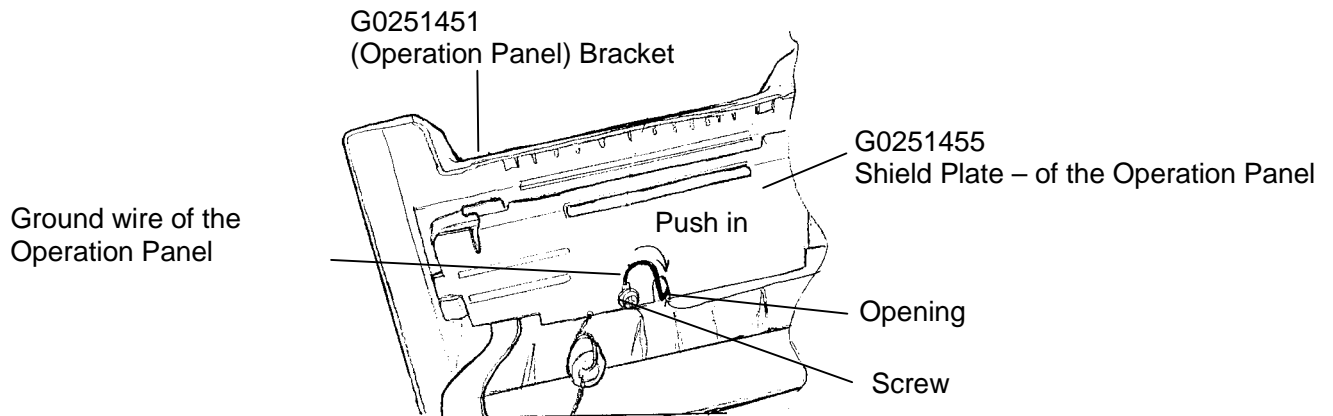
The noise filter does not need to be attached to GS10 models. Due to the ground wire being relatively long, please follow the procedure described below to prevent the ground wire from touching the ADF unit.

1. Attach the ground wire of the operation panel to the operation panel bracket.
2. Push the loose wire into the opening in the bracket.

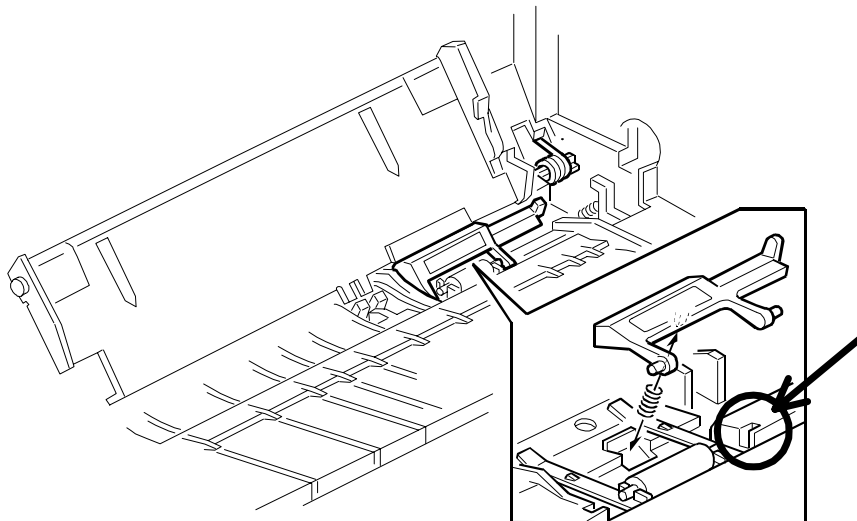
Please use the following solutions when a machine is returned to the repair center following frequent non-feed jams:

Solution 1: Apply grease to the 2 areas shown below.

Note: Be sure to use GREASE 501 (52039502).

A. The axis holder of the paper separation pad on the base frame unit:
