<b>Model:</b> PRIPORT PEARL		<b>Date:</b> 31-Dec-98	<b>No:</b> 01
<b>Subject:</b> Pressure Cylinder Maintenance Cycle		<b>Prepared by:</b> H. Kokubo,

<b>Model:</b> PRIPORT PEARL		<b>Date:</b> 31-Dec-98	<b>No:</b> 02
<b>Subject:</b> Master Feed Jams or Cutter Errors		<b>Prepared by:</b> H. Kokubo, Priport Service Planning Section	
<b>Classification:</b>	<input checked="" type="checkbox"/> Troubleshooting	<input checked="" type="checkbox"/> Part information	<input type="checkbox"/> Action required
	<input type="checkbox"/> Mechanical	<input type="checkbox"/> Electrical	<input type="checkbox"/> Service manual revision
	<input type="checkbox"/> Paper path	<input type="checkbox"/> Transmit/receive	<input type="checkbox"/> Retrofit information
	<input type="checkbox"/> Other (      )		
<b>Model Name:</b> PEARL: Ricoh JP5000, Gestetner 5450, RexRotary 1560, nashuatec CP450, SVN 3350DNP

<b>Model:</b> PRIPORT PEARL		<b>Date:</b> 15-Sep-99	<b>No:</b> R-C229-4
<b>Subject:</b> Auxiliary Firmware Update Method - Flash memory card for updating firmware -		<b>Prepared by:</b> H. Kokubo, Priport Service Planning Section	
<b>Classification:</b>	<input type="checkbox"/> Troubleshooting	<input chec

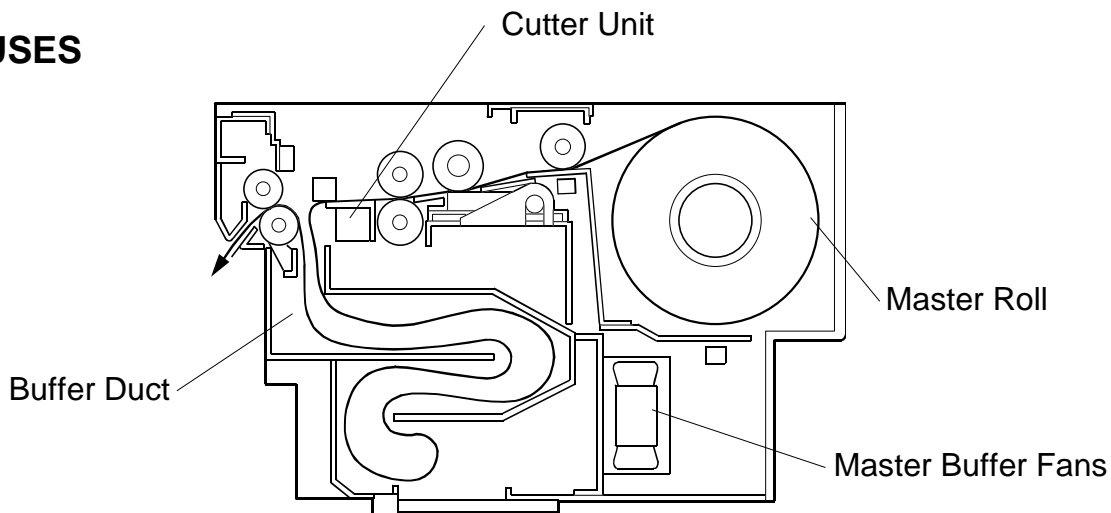
Small pieces of torn master are sucked into the master buffer duct, and the suction (generated by the three buffer fans) weakens. As a result, the master is not guided properly into the buffer duct. This can occur even if a tiny piece of master gets caught in the buffer fans.

A tiny piece of master can cause the problem. Remove the three fans by loosening the screws, and check if there are anypieces of master.

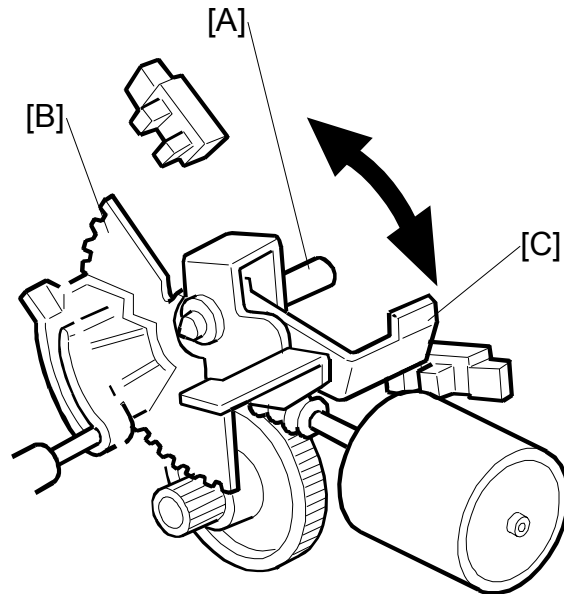
Master clamber drive unit

At the factory it was found that the grease applied to the sector gear shaft (in the master clamber drive unit) was insufficient. After investigating the production units, we found that this problem occurred from the December 1999 production of these machines.

If the sector gear shaft [A] wasn't greased or was insufficiently greased, the surface of the shaft [A] will gradually wear down, as the sector gear plate [B] and sensor actuator bracket [C] rotate along the shaft each time a new master is made.

If the shaft wears down (frictional wear), the sector gear plate [B] and/or sensor actuator bracket [C] will not work smoothly. This will cause the master clamber motor to lock or cause master clamping errors.

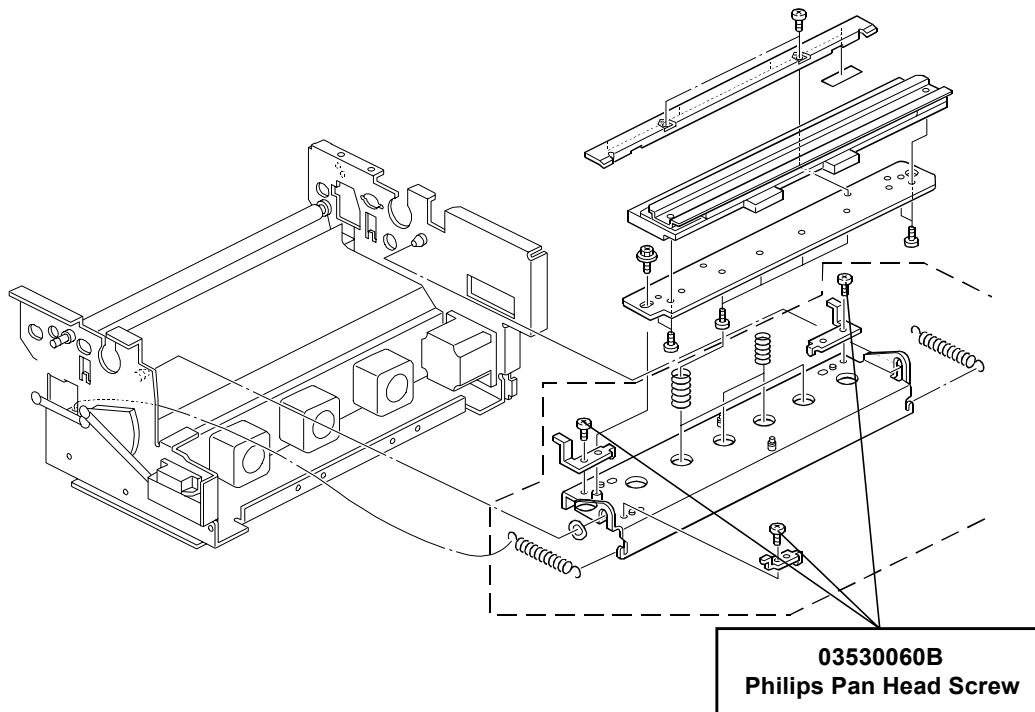
In some machines, the shape of the 3 screws under the thermal head is different from the standard ones used in the Plotter Unit, causing solid image areas to appear light.

The three screw heads were too thick, which caused them to push the thermal head slightly upward and release the pressure between the platen roller and thermal head.

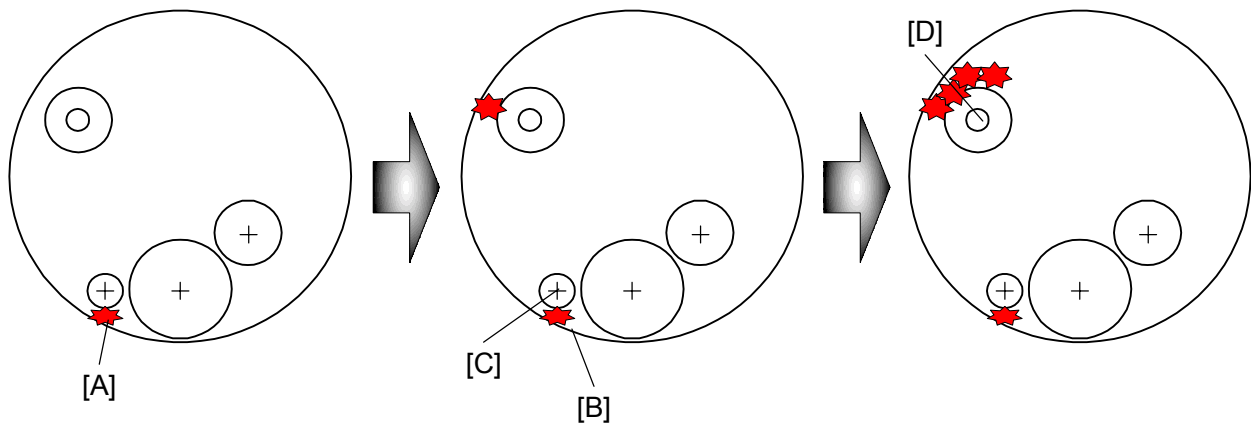
SC05-22 (No drum shift sensor pulse), SC05-32 (Ink pump sensor remains on or off), and/or an ink leak/overflow at power-up or during operation.

Producing over 2,000 prints with the same master causes an ink buildup to occur [A] between the inner surface of the drum metal screen [B] and the drum idling roller [C], after which the buildup is transferred to the area of the ink pump motor [D].

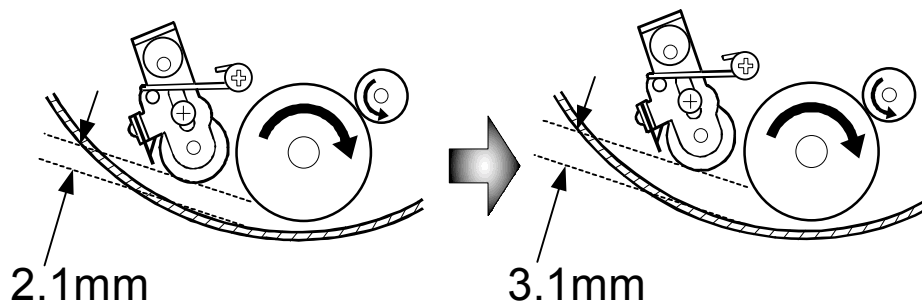
The shape of the bearing holder has been changed to ensure that ink is evenly applied to the drum screen and that ink leaks do not occur.

The home position of the drum idling roller has been increased to 3.1 mm from the drum screen, so that ink on the inner surface of the screen is applied evenly and ink leaks do not occur.

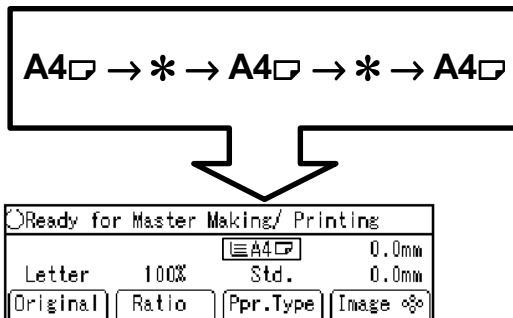
The paper size indicator on the operation panel lights on and off during operation.

The light from the fluorescent lamp causes a paper length sensor misdetection.

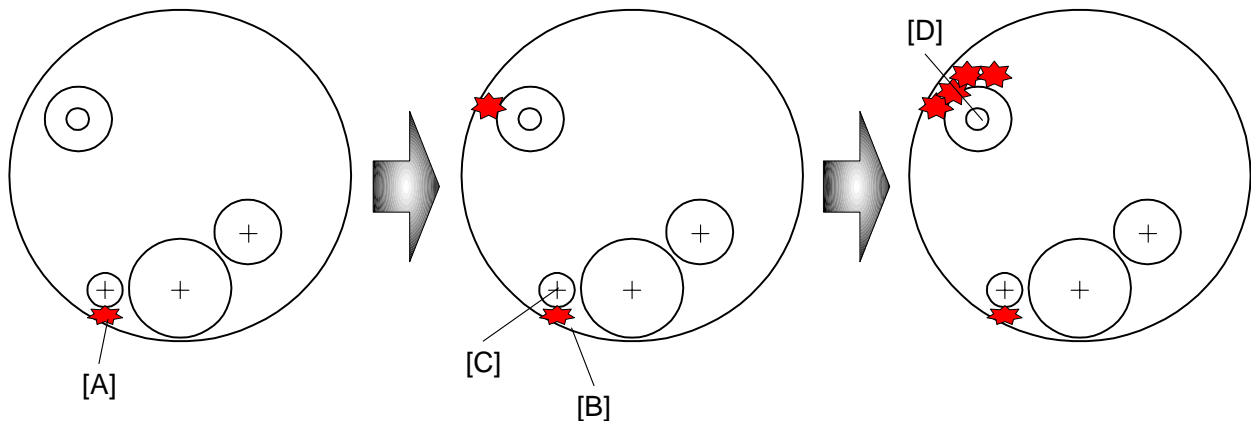
Producing over 2,000 prints with the same master causes an ink buildup [A] to occur between the inner surface of the drum metal screen [B] and the drum idling roller [C], after which the buildup is transferred to the area of the ink pump motor [D].

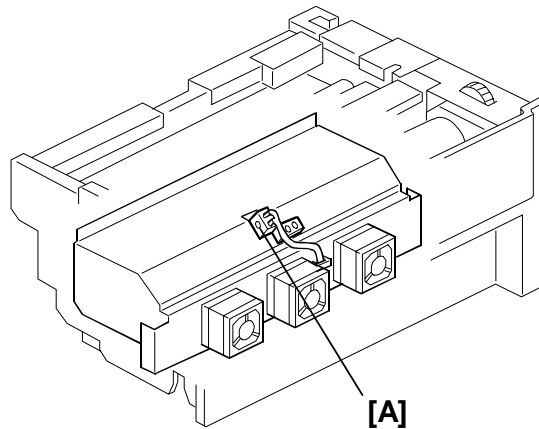
The master duct sensor [A] is too sensitive.

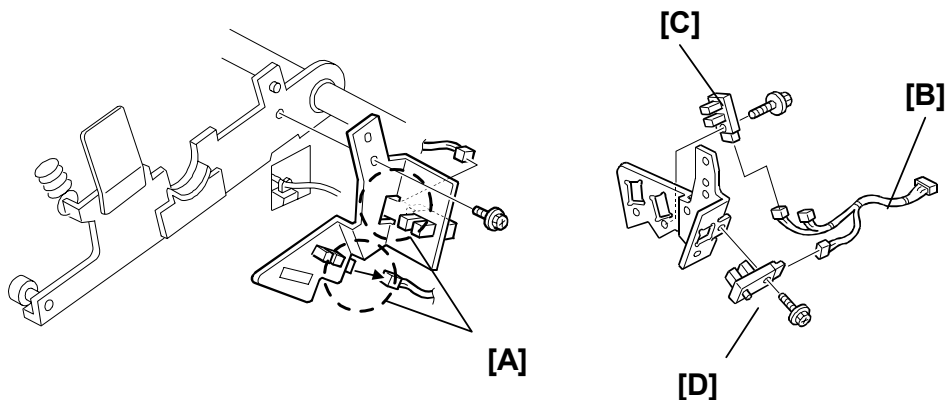
- 1) SC07-20 or sensor misdetection: Light from the fluorescent lamp.
- 2) SC07-20 or SC07-21: Poor connection [A] between the feed encoder cable and the feed start sensor [C] or feed encoder sensor [D].
