Model: PRIPORT LCS	Date: 7-Jan-04	No: R-C625-001c
Subject: Firmware Modification History	Prepared by: K. Yamamoto, Priport Service Planning Section	
Classification: <input type="checkbox"/> Troubleshooting <input type="checkbox"/> Part information <input type="checkbox"/> Action required <input type="checkbox"/> Mechanical <input type="checkbox"/> Electrical <input type="checkbox"/> Service manual revision <input type="checkbox"/> Paper path <input type="checkbox"/> Transmit/receive <input type="checkbox"/> Retrofit information <input checked="" type="checkbox"/> Other (Firmware release)		
Model Name: Large Capacity System LS3000

Model: PRIPORT LCS		Date: 4-Mar-04	No: R-C625-002
Subject: Undefined paper non-feed		Prepared by: K. Yamamoto, Priport Service Planning Section	
Classification:	<input type="checkbox"/> Troubleshooting	<input type="checkbox"/> Part information	<input checked="" type="checkbox"/> Action required
	<input type="checkbox"/> Mechanical	<input checked="" type="checkbox"/> Electrical	<input type="checkbox"/> Service manual revision
	<input type="checkbox"/> Paper path	<input type="checkbox"/> Transmit/receive	<input type="checkbox"/> Retrofit information
	<input

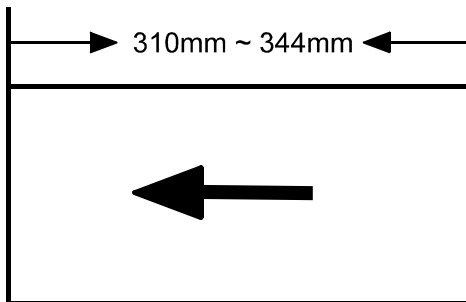
Paper 310mm to 344mm in length (not a machine-defined size) cannot be fed, resulting in an A-jam.

NOTE: 1) This symptom applies to this particular paper size only.
2) The length (310 to 344mm) is the only factor, i.e. width does not affect this symptom at all.

Firmware bug.

The LCIT firmware has been modified to ensure that the above size can be fed correctly.

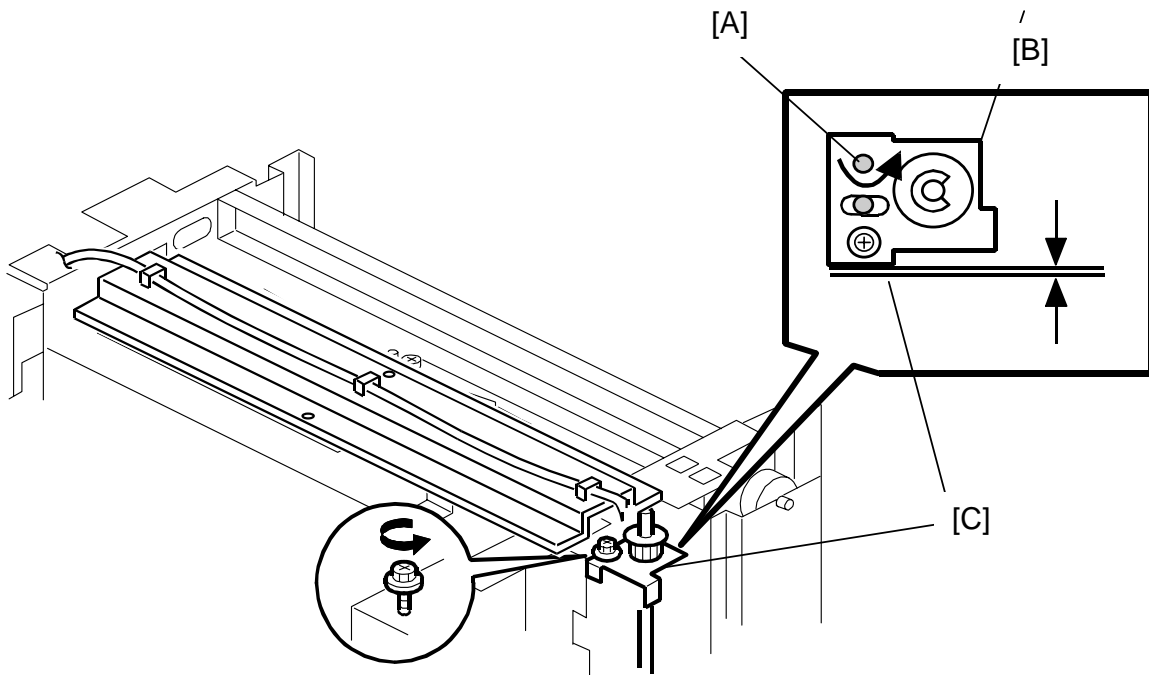
Note: The top opening [A] in the bracket [B] is used as a pivot point to rotate the bracket and adjust the tension of the side fence belt. The bracket should be aligned parallel with the side fence [C], which will ensure the proper belt tension.

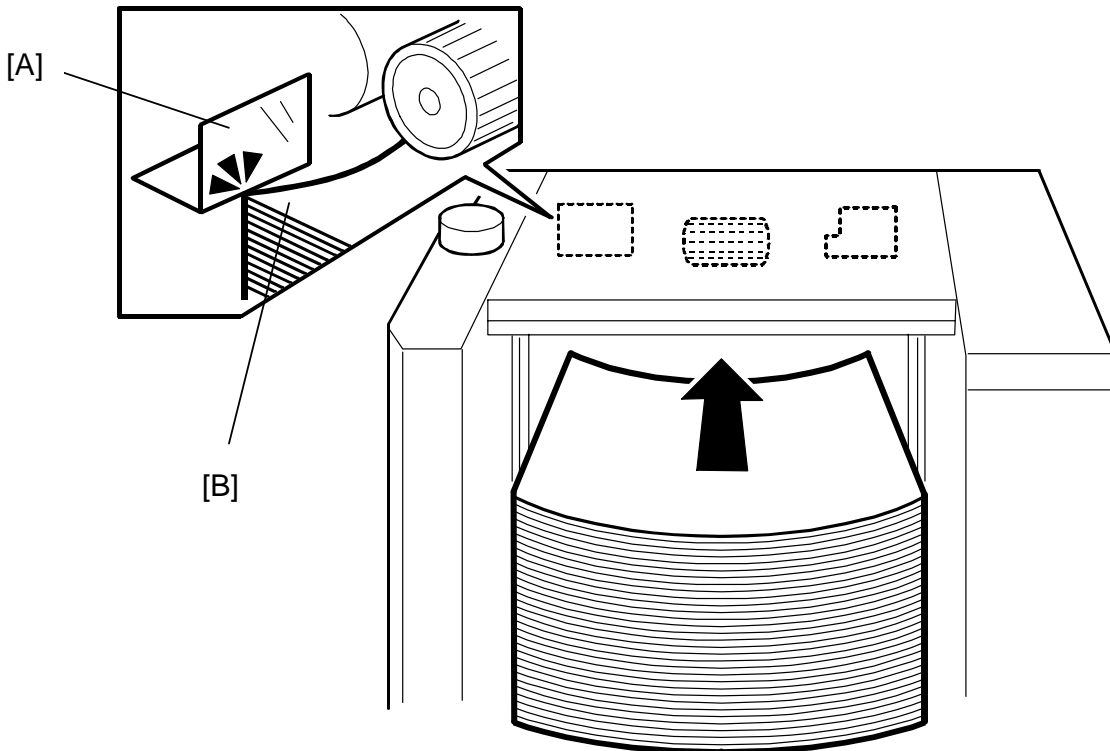
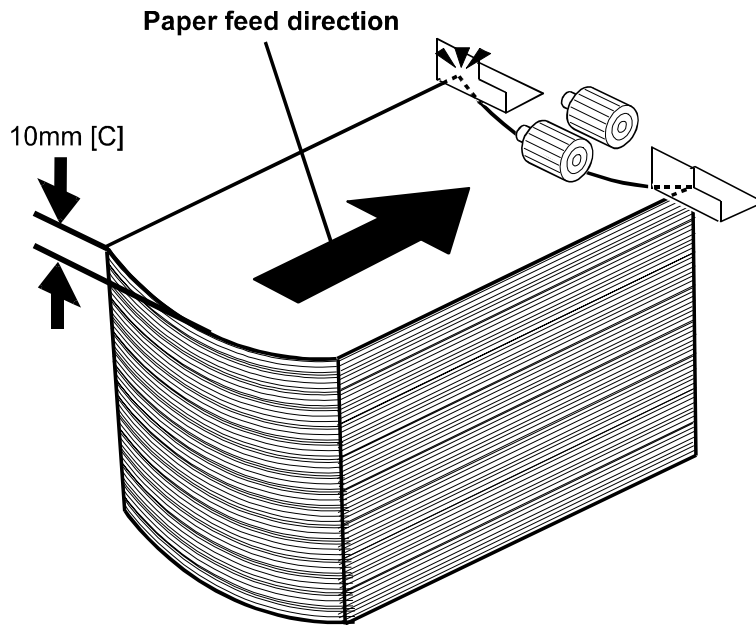
An A-jam occurs at the paper feed section if the paper is stacked near capacity (approximately 3,000 sheets) and the sheets are curled.

The paper [B] contacts the guide board sheet [A] due to the height of the stack and the curl in the paper, and the paper is fed skewed. (This curl is exaggerated with increased paper stack height).

Paper stack condition leading to skewed feed:

- The curl in each individual sheet is amplified as the height of the stack increases.
- With close to 3,000 sheets, a sheet gap of about 10 mm [C] can result, which tends to trigger the skewed feed and paper jam.

Please advise customers to use paper that is not curled, as described in the Operator's Instructions. To offset the effect from curling, it is often effective to load the paper upside down in the tray and/or fan the paper before loading.

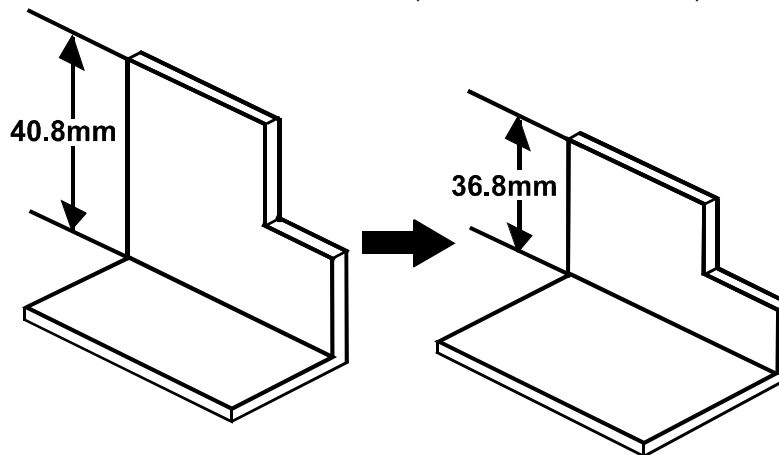
The shape of the guide board sheet has been changed to improve paper feed even when the sheets are already curled and are stacked near paper feed table capacity.

- This modification ensures proper paper feed even when the sheet gap [C] is higher than 10mm (i.e. up to approximately 15mm).
- New guide board sheet P/N: C6252921 (see MB #MC625006).

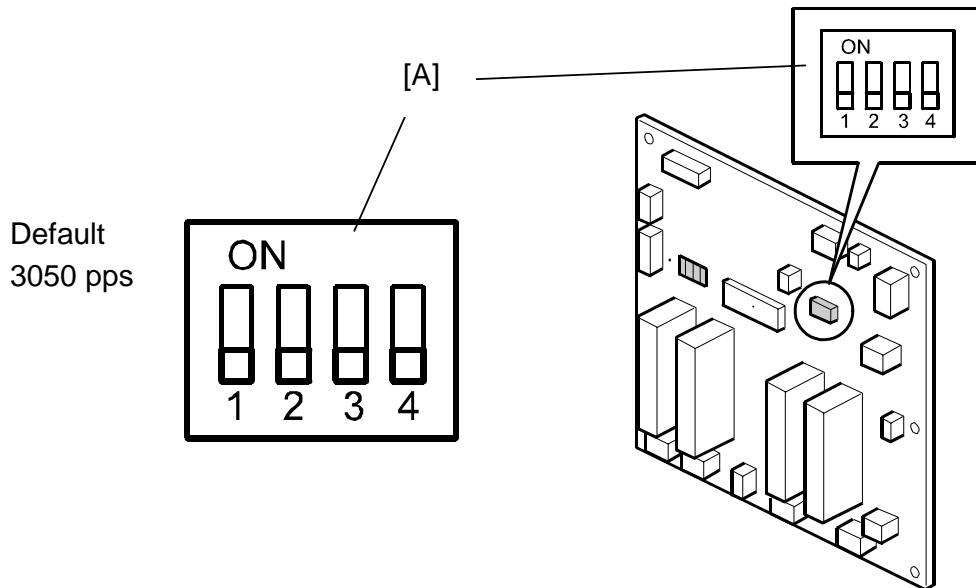
If A-jams are reported from the field, increase the paper pickup speed with the dip switch on the MPU board.

1. Turn off the main switch, and then disconnect the power plug.
2. Remove the rear cover.
3. Set the dip switch [A] on the LCIT MPU as follows.

Speed (pps)	Dip Switch			
	1	2	3	4
2550	OFF	ON	ON	OFF
2750	ON	ON	ON	OFF
3050 (default)	OFF	OFF	OFF	OFF
3200	ON	ON	OFF	OFF
3300	OFF	OFF	ON	OFF
3400	ON	OFF	ON	OFF
3500	OFF	ON	OFF	OFF

NOTE: If A-jams still occur after you increase the speed to 3500 pps, replace the paper feed roller for the LCIT. If this is not effective enough, replace the intermediate under feed rollers.
