Model: PRIPORT TITANIUM		Date: 7-Apr-03	No: R-C252-001
Subject: Notes the model TT installation		Prepared by: M. Ohtsubo, Priport Service Planning Section	
Classification:	<input type="checkbox"/> Troubleshooting	<input type="checkbox"/> Part information	<input type="checkbox"/> Action required
	<input type="checkbox"/> Mechanical	<input type="checkbox"/> Electrical	<input checked="" type="checkbox"/> Service manual revision
	<input type="checkbox"/> Paper path	<input type="checkbox"/> Transmit/receive	<input type="checkbox"/> Retrofit information
	<input type="checkbox"/> Other ()		
Model Name: Ricoh JP730/JP750/JP780C, Gestetner 6123lcp/5410c/6123cp, Lanier LDD 730, nashuatec 6123cp, RexRotary 6123cp

Model: PRIPORT TITANIUM	Date: 23-Oct-03	No: R-C252-003	
Subject: Notes for model TT installation - revision	Prepared by: M. Ohtsubo, Priport Service Planning Section		
Classification:	<input type="checkbox"/> Troubleshooting	<input type="checkbox"/> Part information	<input type="checkbox"/> Action required
	<input type="checkbox"/> Mechanical	<input type="checkbox"/> Electrical	<input checked="" type="checkbox"/> Service manual revision
	<input type="checkbox"/> Paper path	<input ty

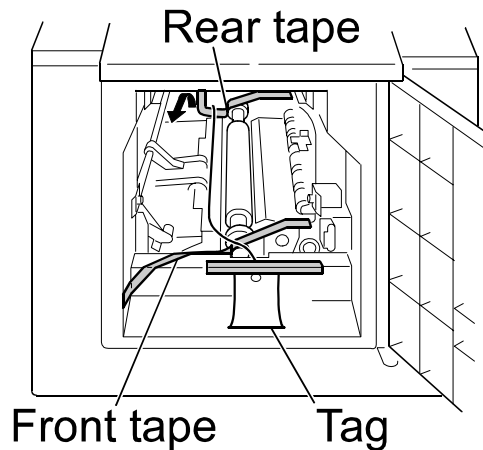
Strips of tape have been added as shown below to secure the Press Roller during transport. Please make sure to remove the tape and tag before machine operation begins. If they are not removed:

- Paper jams or blank images may occur, due to the lack of pressure on the Press Roller.
- The tape may stick to the drum screen or Press Roller.

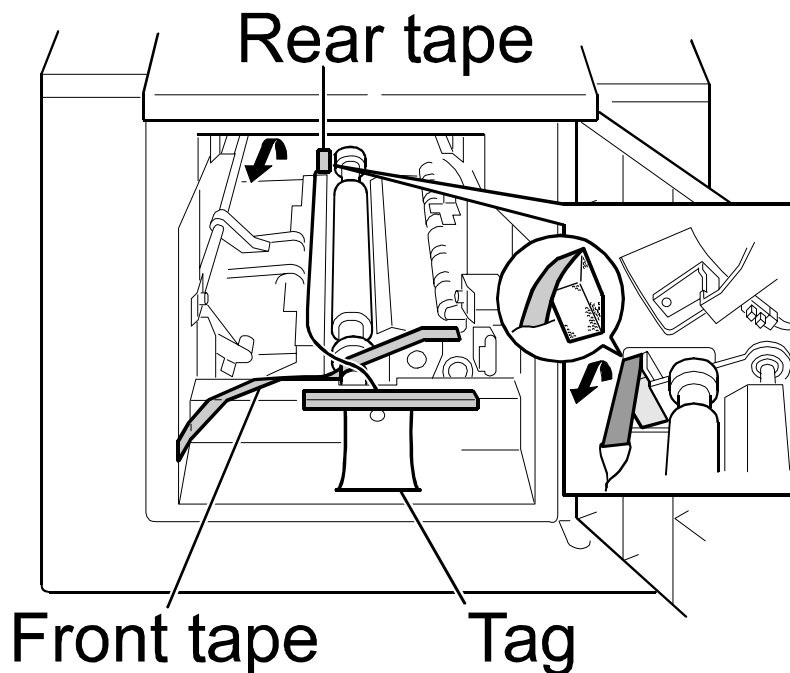
As announced in RTB #RC252-001, a Styrene foam sponge is used to ensure that the rear shipping tape stays properly fixed in place, which prevents the printing pressure release lever from unlocking. At installation, please remove the rear tape by pulling the portion shown in the photo below toward the front of the machine.

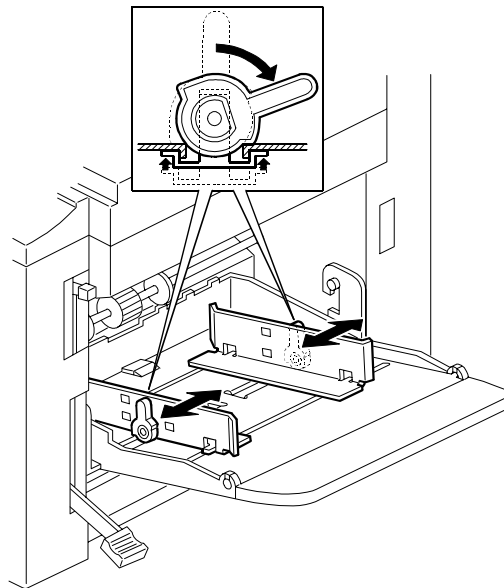
The left or/and right edges of the original can be seen on the printout as black lines.

1. The paper tray side fences are not aligned with the scanner unit side fences.

1. Measure the distance from the paper edge to the black line (X mm).
2. Move the side fences a distance of about X mm, so that the edge of the paper aligns with the edge of the original.
3. Check the print results. Repeat this until you cannot see the black line on the printout.
