SUBJECT: Paper jams caused when one-way clutch slips

FROM: Copier Technical Support Section

SS 810/830

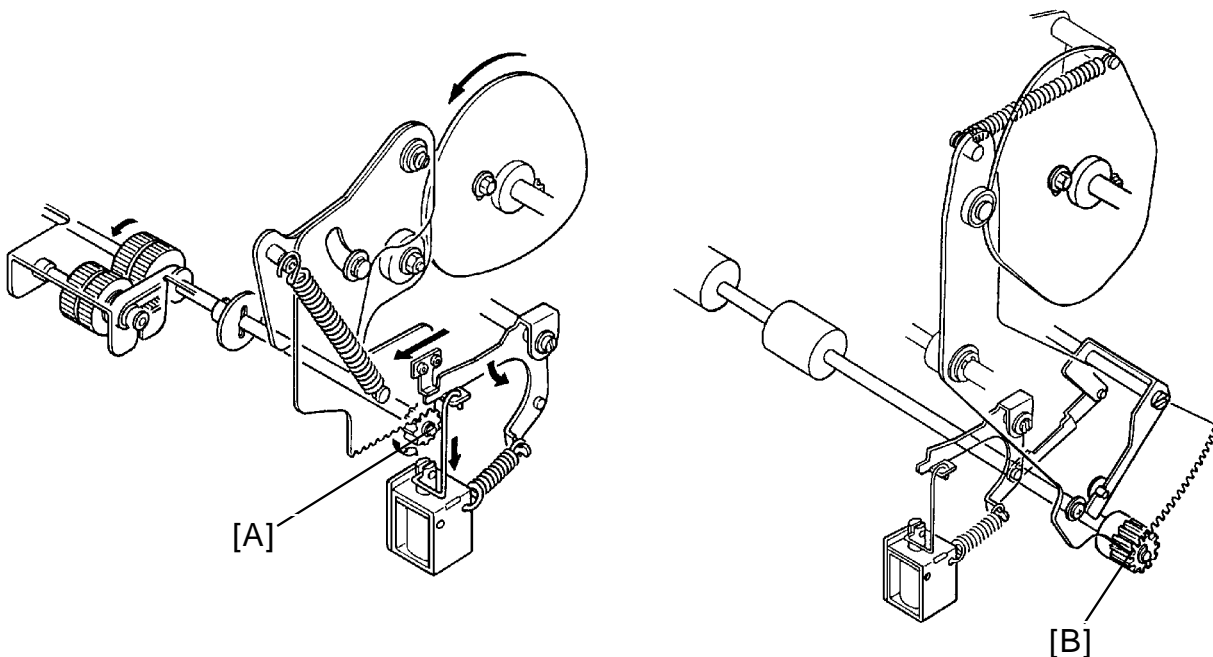
The one-way clutches inside the paper feed and second feed roller gears have worn the roller shafts smooth. The clutch slips and paper jams or is not fed. This tends to occur during high speed printing and is more likely to occur on machines that exceed the recommended monthly copy volume. When the feed mechanism is manually operated to check the paper feed, paper feeds correctly.

1. Remove the paper feed roller gear [A] and the second feed roller gear [B].
2. With fine sandpaper, lightly sand the roller shaft surface at the point where it comes into contact with the one-way clutch. This increases the coefficient of friction.
3. If paper jams continue to occur, replace the one-way clutch.
4. If paper jams continue to occur, replace the roller shaft together with the one-way clutch.

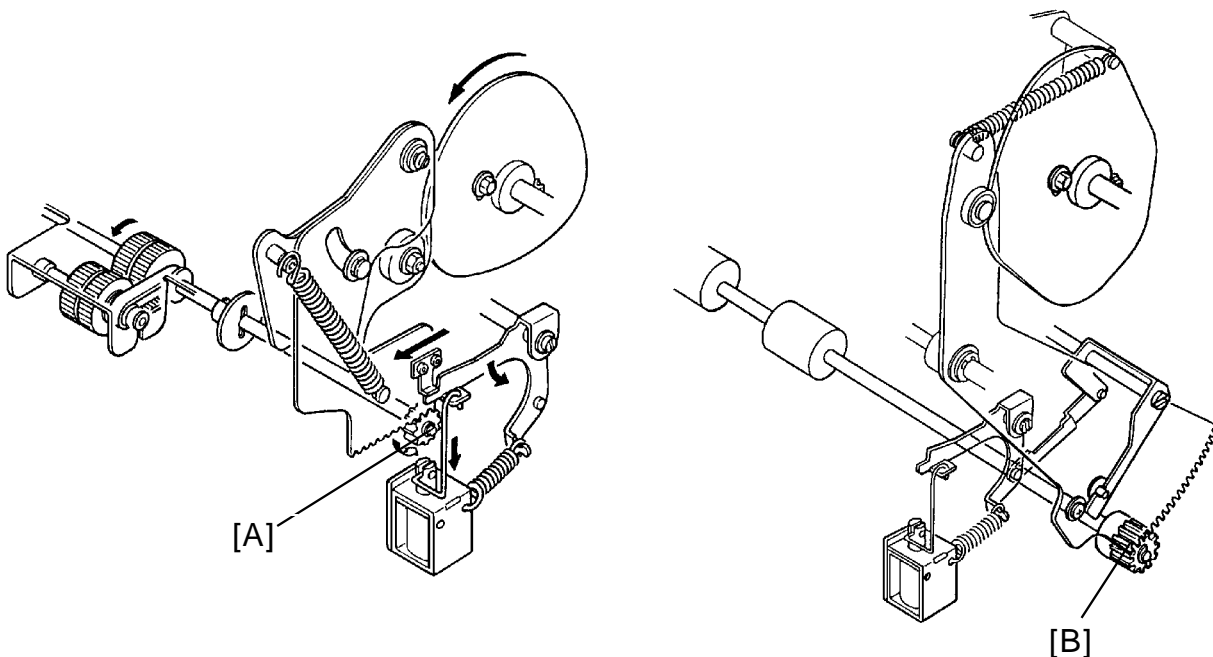
The one-way clutches inside the paper feed and second feed roller gears have worn the roller shafts smooth. The clutch slips and paper jams or is not fed. This tends to occur during high speed printing and is more likely to occur on machines that exceed the recommended monthly copy volume. When the feed mechanism is manually operated to check the paper feed, paper feeds correctly.

1. Remove the paper feed roller gear [A] and the second feed roller gear [B].
2. With fine sandpaper, lightly sand the roller shaft surface at the point where it comes into contact with the one-way clutch. This increases the coefficient of friction.
3. If paper jams continue to occur, replace the one-way clutch.
4. If paper jams continue to occur, replace the roller shaft together with the one-way clutch.
