SUBJECT: Ink Cartridge Seal

FROM: Copier Technical Support Section

SS915/930/950

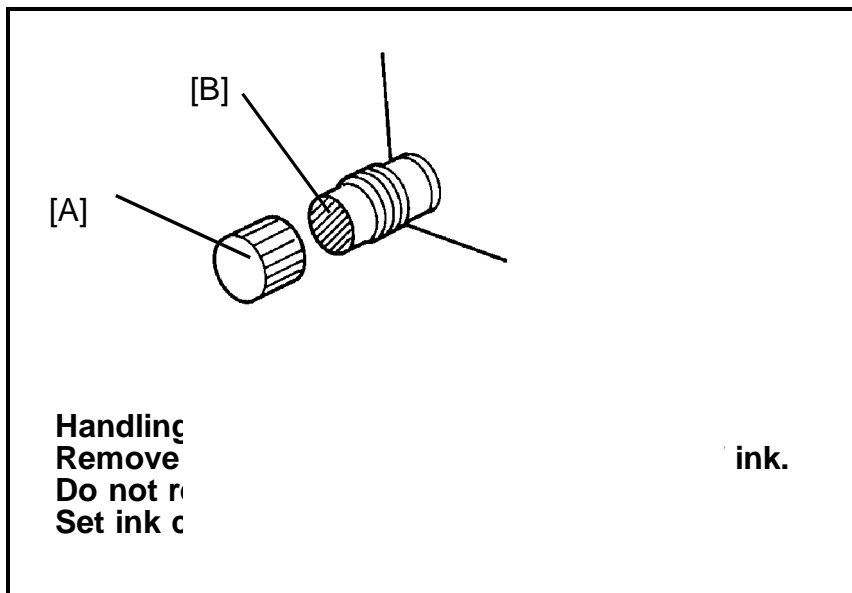
A transparent seal will be added to the exit of the ink cartridge (all colors) to prevent ink from being spilled on the floor during cartridge installation. It is not necessary to remove this seal; a projection on the ink pump inlet breaks this seal when the cartridge is set into the drum cartridge holder.

This modification will be implemented in the December production run. The following illustration and instructions will be printed on all ink cartridges early next year. This instructs the customers not to remove the seal at installation.

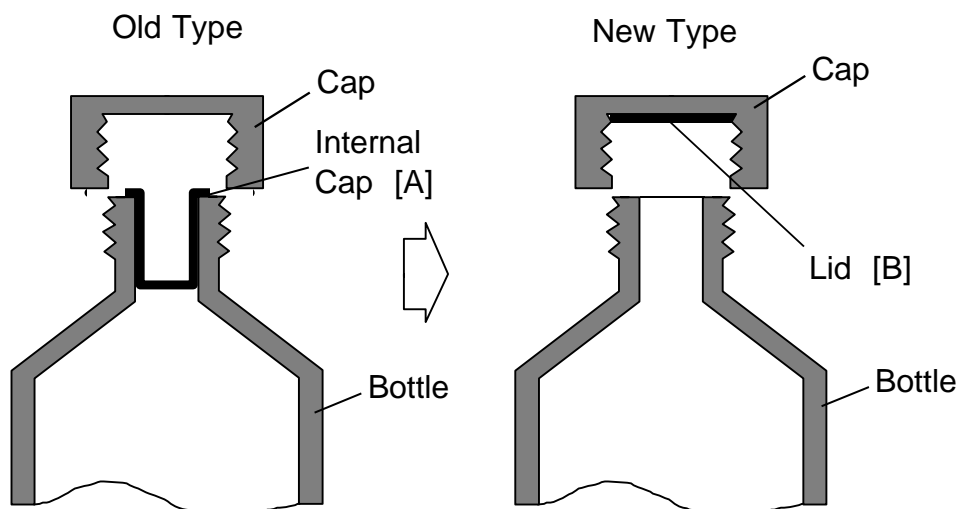
There has been a problem with the internal cap [A] getting stuck inside the thermal head cleaner bottle and it is difficult to pull it out.

The internal cap has been changed to a lid [B] as illustrated below:

This modification has been implemented since the November '90 production run. Please note that the part number of the thermal head cleaner remains the same.

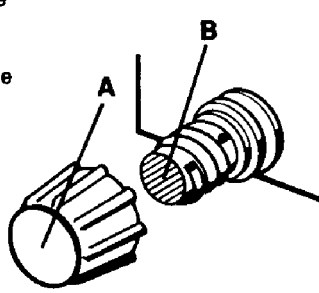
To increase ink production, the transparent seal will be removed from the exit of the black ink cartridge (500cc). For the color inks, the transparent seal remains because the color inks are more fluid than the black ink. Due to this change, the instructions printed on the black ink cartridge will be changed as shown below.
