SUBJECT: Ink Cartridge Seal

FROM: Copier Technical Support Section

MODEL:

SS935/955

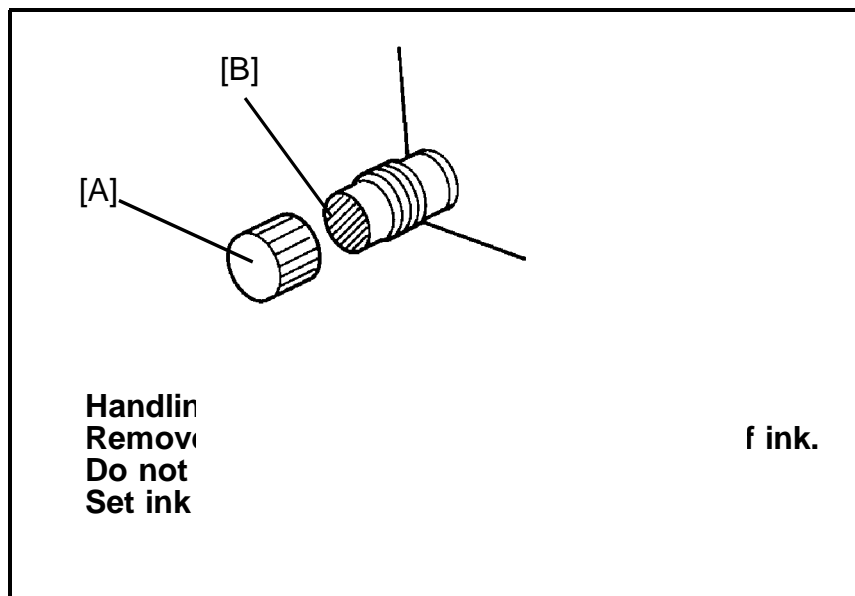
A transparent seal will be added to the exit of the ink cartridge (all colors) to prevent ink from being spilled on the floor during cartridge installation. It is not necessary to remove this seal; a projection on the ink pump inlet breaks this seal when the cartridge is set into the drum cartridge holder.

This modification will be implemented in the December production run. The following illustration and instructions will be printed on all ink cartridges early next year. This instructs the customers not to remove the seal at installation.

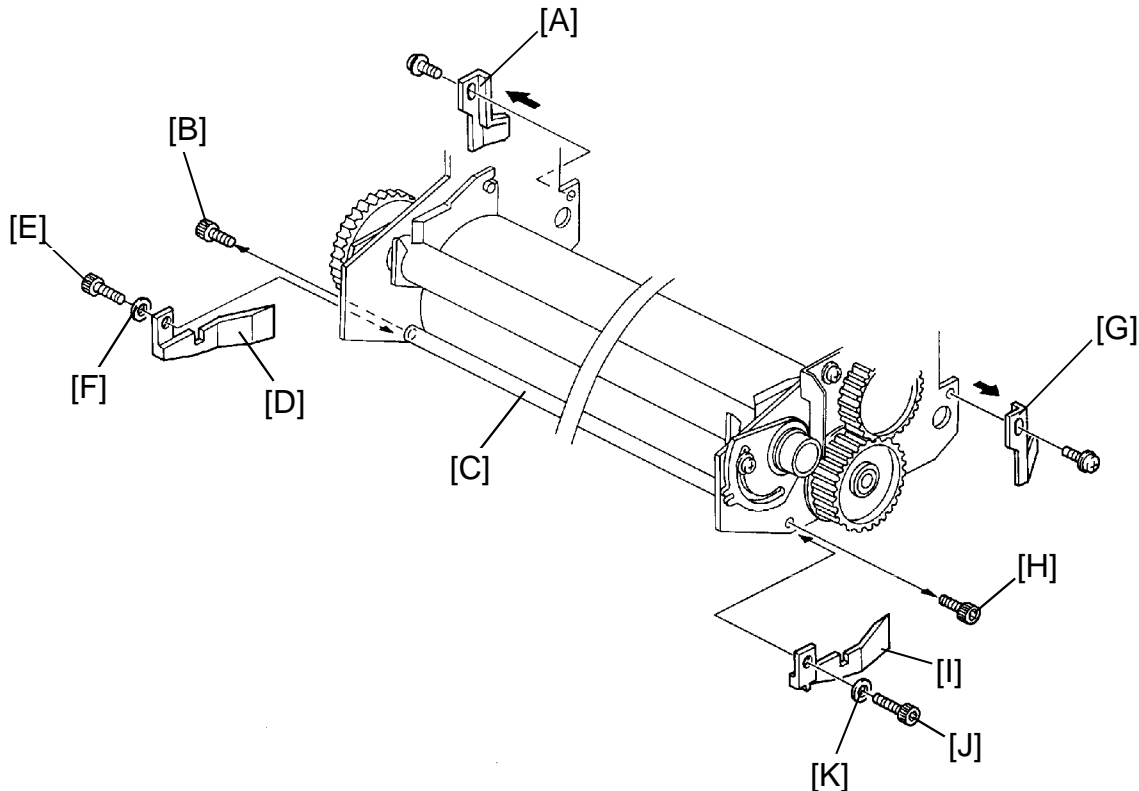
A drum blades kit has been registered as a spare part. With this retrofit kit, technicians can quickly and easily correct the drum ink leakage problem in the field.
Note that all machines produced since November 1990 have been modified at the factory to correct this problem. (See the cut-in serial numbers in M/B No. 21.)

1. Remove the drum clumper assembly.
2. Remove the tetron screens from the drum.
3. Remove the stainless steel screen from the drum.
4. Remove the old front drum blade (C2004745) [A] (1 screw).
5. Remove the internal hexagon head screw (M4 x 6) [B] securing the ink roller shaft stay [C], then install the new front drum blade (C2074745) [D] and secure it with the internal hexagon head screw (M4 x 8) [E] and the flat washer [F].
6. Remove the old rear drum blade (C2004746) [G] (1 screw).
7. Remove the internal hexagon head screw (M4 x 6) [H] securing the ink roller shaft stay [C], then install the new rear drum blade (C2074746) [I] and secure it with the internal hexagon head screw (M4 x 8) [J] and the flat washer [K].
8. Reverse the procedure to reassemble.

Note: Do not re-use the old front and rear drum blades.

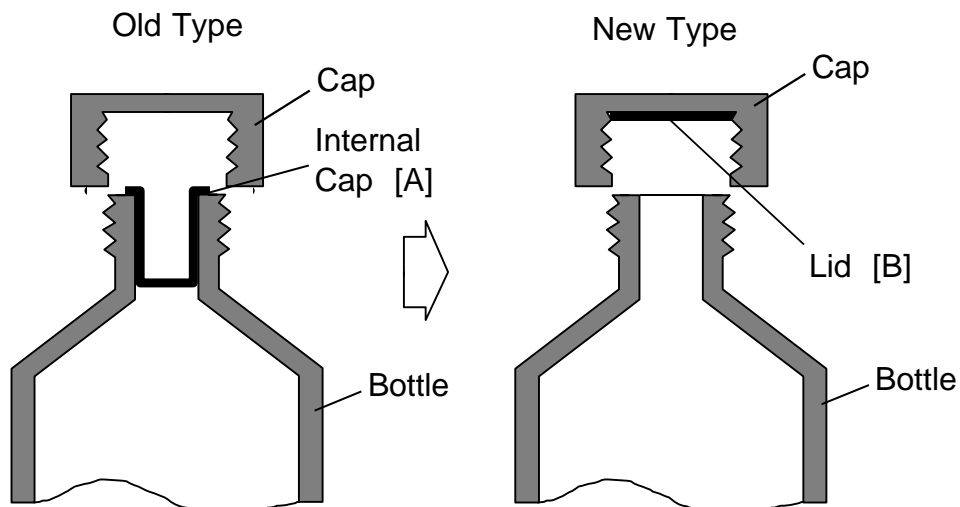
There has been a problem with the internal cap [A] getting stuck inside the thermal head cleaner bottle and it is difficult to pull it out.

The internal cap has been changed to a lid [B] as illustrated below:

This modification has been implemented since the November '90 production run. Please note that the part number of the thermal head cleaner remains the same.

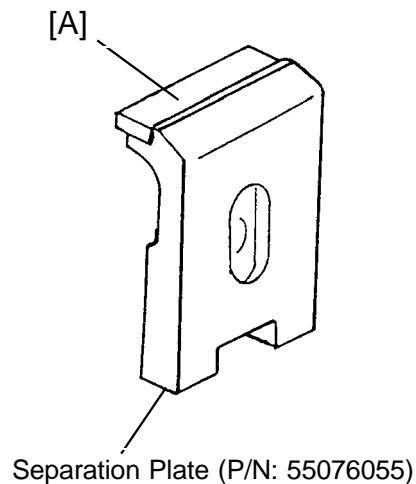
There have been reports in the field of the rubber separation pad [A] easily coming off the separation plate (P/N: 55076055) [B]. This occurred with separation plates that had been supplied as spare parts.

When installing a new separation plate, check the bond between the pad and the plate. If the bond is not sufficiently strong, apply a strong adhesive (super glue).

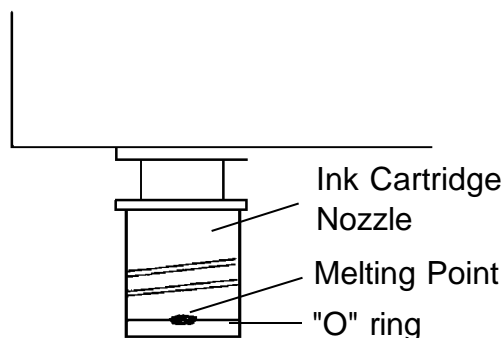
There has been a problem with the "O" ring inside the ink cartridge nozzle. The "O" ring comes off and remains on the nozzle of the ink pump when the ink cartridge is replaced, or it comes off and stays in the cartridge cap when the cap is removed. This occurs when the temperature changes radically making the "O" ring contract.

1. Make sure that the "O" ring does not stay on the nozzle of the ink pump before a new ink cartridge is installed.
If it remains on the nozzle, remove it; otherwise the new ink cartridge cannot be set properly.
2. Make sure that the "O" ring does not stay in the cartridge cap when the cap is removed from the ink cartridge nozzle.
If the "O" ring stays in the cartridge cap, remove the "O" ring from the cartridge cap and install it inside the cartridge nozzle.

Note: To prevent the "O" ring from coming off, more than 2 points between the "O" ring and the ink cartridge nozzle were soldered as shown above. This melting process has been implemented since the March '91 production run. For a mark of the melting process, a black circle has been stamped on the end of the lot number. (Example: Lot No. 1911932 ◯)

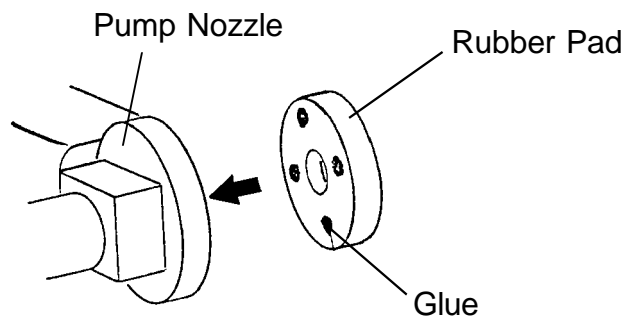
There has been a problem with the rubber pad located on the ink pump nozzle. It comes off when the ink cartridge is removed. When no rubber pad remains on the ink pump nozzle, ink inside the cartridge may not be pumped to the drum even if a new ink cartridge is installed. This problem does not happen very often.

1. Remove the rubber pad with a small screwdriver.
2. Clean the rubber pad and the ink pump nozzle (contacting place of the rubber pad) with cloth. If stains remain, clean them off with the thermal head cleaner.
3. Apply a little super glue to the 4 points on the rubber pad as shown.

Note: Do not apply too much glue. This is because the rubber pad cannot be inserted correctly if there is too much glue.

4. Insert the rubber pad into the pump nozzle.

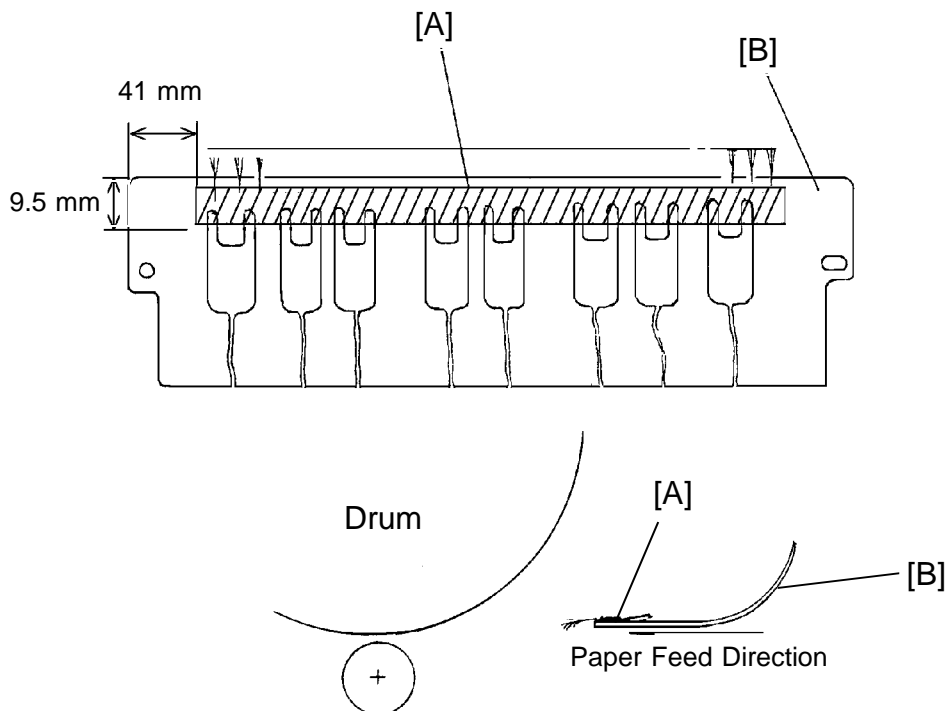
Paper jamming occurs around the drum because of static electricity when the machine is used under low humidity conditions. Heavy static charges will build up around the master during the printing run. This happens particularly when thin paper is being used at high speed rotations. This also happens if the original (and therefore the master on the drum) is changed.

Stick the antistatic brush (P/N: C2079010) [A] on the upper second feed roller guide plate [B] as illustrated below: (The antistatic brush has been registered as a spare part.)

Note: Depending on the type of paper and/or the environment, paper might still jam even though the antistatic brush was installed on the guide plate. The occurrence ratio varies according to the environment. If possible, improve the environmental conditions or move the machine to a better place.
