SUBJECT: To disable ink detection circuit

FROM: Copier Technical Support Section

Priport VT1730

SUBJECT: Master Feed Jams

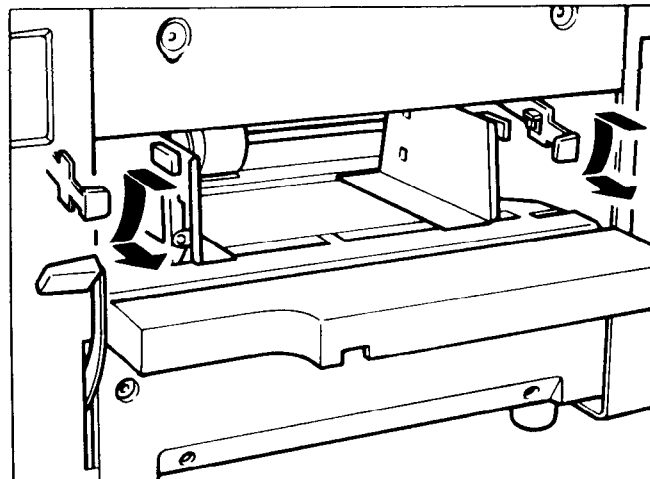
When 500 sheets of standard paper (80g/m<sup>2</sup>) is set on the paper table, paper misfeeds would occur. This is because not enough feed roller pressure is applied due to friction between the paper stack (leading edge side) and the lower paper feed guide which guides the leading edge of the paper stack.

In this case, advise your customer to change the position of the pressure adjustment levers, as shown below, to increase paper feed pressure.

We confirmed that even if the pressure adjustment levers are in the lower position, normal paper (70g/m to 200g/m) would be fed properly. So from August '93 production, the pressure adjustment levers have been set in the lower position (stronger pressure) in the factory.

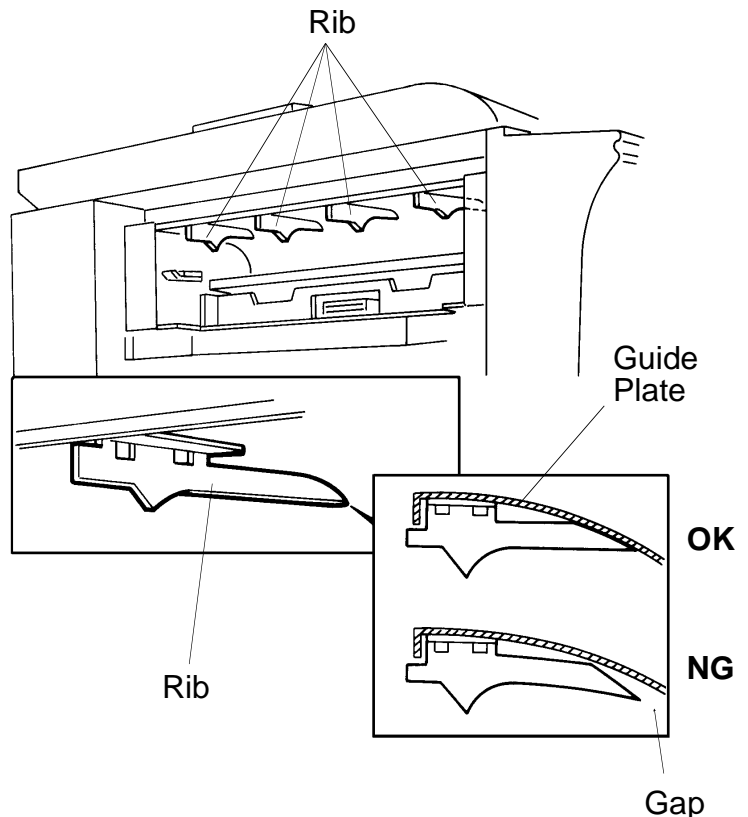
1. Frequent master eject jams at location "F".
2. The master wraps around the upper and/or lower master eject rollers.
3. "F" jam cannot be reset because the actuator (feeler) of the master eject sensor remains pushed down by the pressure plate. (The actuator comes under the pressure plate.)

There are 4 ribs to guide the ejected master in the master eject unit. There is a small gap at the leading edge of the ribs against the guide plate.

Due to a part variation, if the gap is too big, the master tends to be caught by the ribs. A jam or other problems may occur as per the following sequence:

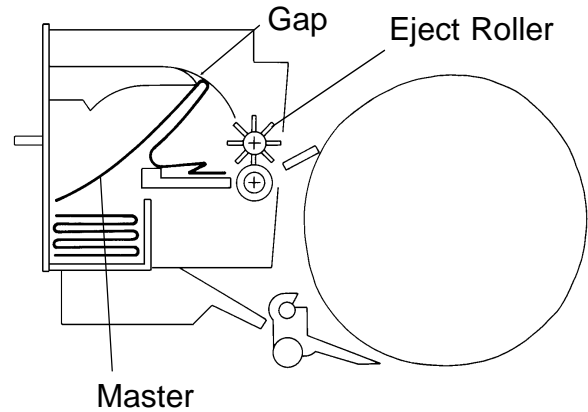
1. While the master is being removed from the drum, the leading edge of the master goes properly into the master eject unit. At this point, however, while the pressure plate moves to compress the master in the eject box, the middle part of the master tends to rub against the ribs. If there are any gaps, the master is caught by the ribs. (The master therefore remains caught by the ribs.)

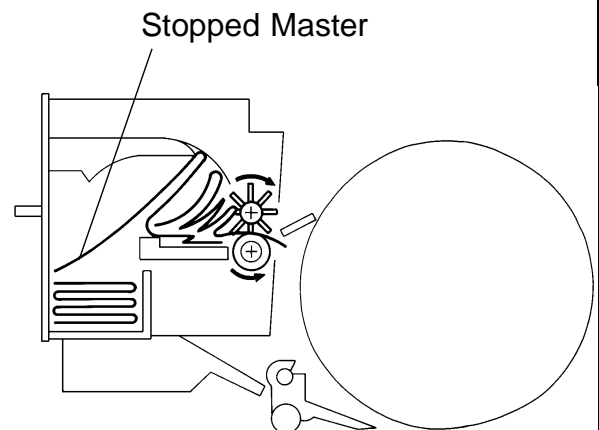
2. If no jam is detected by the machine after the above situation has occurred, the machine can carry out the next master eject. However, the next ejected master interferes with the master caught by the ribs and is stopped just behind the eject rollers.

As result, "F" jam will be indicated. Otherwise, if there is no space for the master to proceed (due to the previous master jam), the master is again caught by and wraps around the eject rollers. If the master is stopped just on the master eject sensor, the sensor feeler remains pushed down while the pressure plate is traveling. After the pressure plate returns to its home position, the sensor feeler comes under the plate. ("F" jam is then indicated and cannot be reset.)

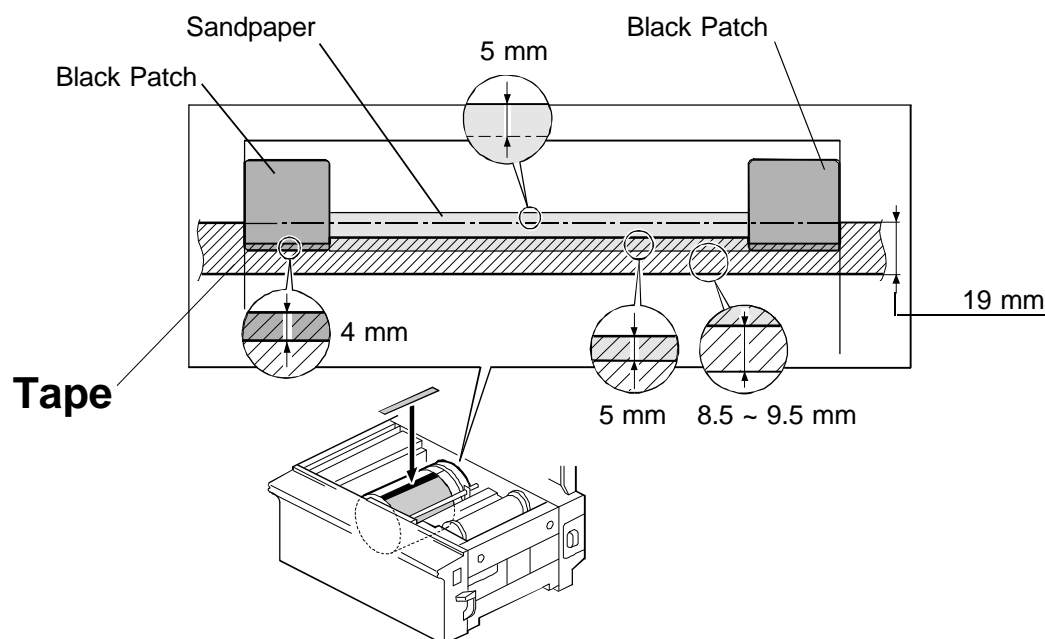
During a long printing run, unwanted ink appears at the leading edge of copies. At first, it is very hard to see, but it becomes more visible as the printing continues.

Due to rough edges of the paper, the master wrapped around the drum becomes damaged.

3. Cover the leading edge part of the cloth screen on the drum with tape, so that ink does not leak even when the master is damaged.

- Cut the tape where it covers the sandpaper as shown. (The indicated area must be left as shown to hold the tape on the screen firmly.) Be careful not to damage the cloth screen surface.
- **Also, cut the tape where it covers the black patches (for the drum master detection sensor) as shown. If they are covered, drum master detection does not work properly.**
- Cut both edges of the tape at the edge of the metal screen. Do not let the tape ride over the drum flanges.
- Even if the sandpaper is not used on the cloth screen (the old type cloth screen), install tape at the same position by measuring the distance from the edge of the black patch to the lower edge of the tape (between 8.5 and 9.5 mm).
