SUBJECT: Ink Cartridge "O" Ring and Rubber Pad

FROM: Copier Technical Support Section

VT2100/2130/2150

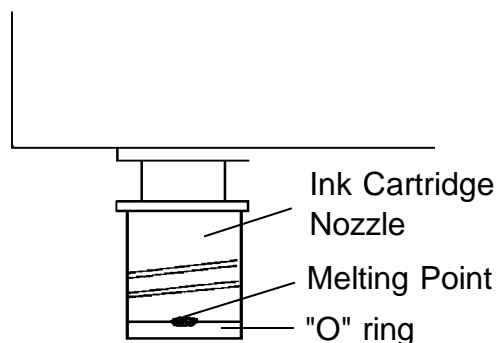
There has been a problem with the "O" ring inside the ink cartridge nozzle. The "O" ring comes off and remains on the nozzle of the ink pump when the ink cartridge is replaced, or it comes off and stays in the cartridge cap when the cap is removed. This occurs when the temperature changes radically making the "O" ring contract.

Note: To prevent the "O" ring from coming off, more than 2 points between the "O" ring and the ink cartridge nozzle were soldered as shown above. This melting process has been implemented since the March '91 production run. For a mark of the melting process, a black circle has been stamped on the end of the lot number. (Example: Lot No. 1911932 ◦)

1. Make sure that the "O" ring does not stay on the nozzle of the ink pump before a new ink cartridge is installed.
If it remains on the nozzle, remove it; otherwise the new ink cartridge cannot be set properly.
2. Make sure that the "O" ring does not stay in the cartridge cap when the cap is removed from the ink cartridge nozzle.
If the "O" ring stays in the cartridge cap, remove the "O" ring from the cartridge cap and install it inside the cartridge nozzle.

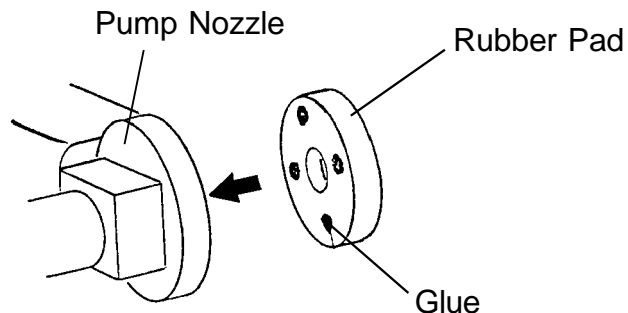
There has been a problem with the rubber pad located on the ink pump nozzle. It comes off when the ink cartridge is removed. When no rubber pad remains on the ink pump nozzle, ink inside the cartridge may not be pumped to the drum even if a new ink cartridge is installed. This problem does not happen very often.

1. Remove the rubber pad with a small screwdriver.
2. Clean the rubber pad and the ink pump nozzle (contacting place of the rubber pad) with cloth. If stains remain, clean them off with the thermal head cleaner.
3. Apply a little super glue to the 4 points on the rubber pad as shown.

4. Insert the rubber pad into the pump nozzle.

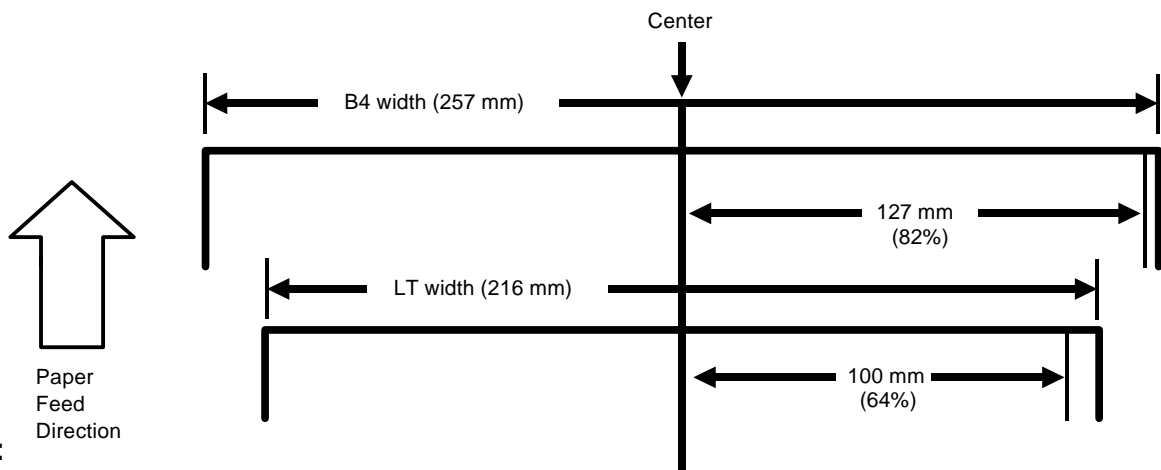
For C211 models, a one dot black line appears on the rear side of the copies when 64% (on the VT2130, LG version) or 82% (on the VT2100, B4 version) is selected. This problem does not happen very often.

- * In 82% reduction mode, the line appears 127mm from the center.
- * In 64% reduction mode, the line appears 100mm from the center.

The dummy pixel (D31) of the CCD is mixed with the effective pixels because of the timing delay of the processing circuit. This dummy data is a gray level and is output from the A/D conversion board as a black data or white data. This depends on the optics adjustment and/or the Image Density switch position.

In order to discard the dummy pixel (D31) in reduction mode, the reduction ratio of 64% and 82% was slightly changed. This will allow the D31 dummy pixel data to be discarded in reduction mode.

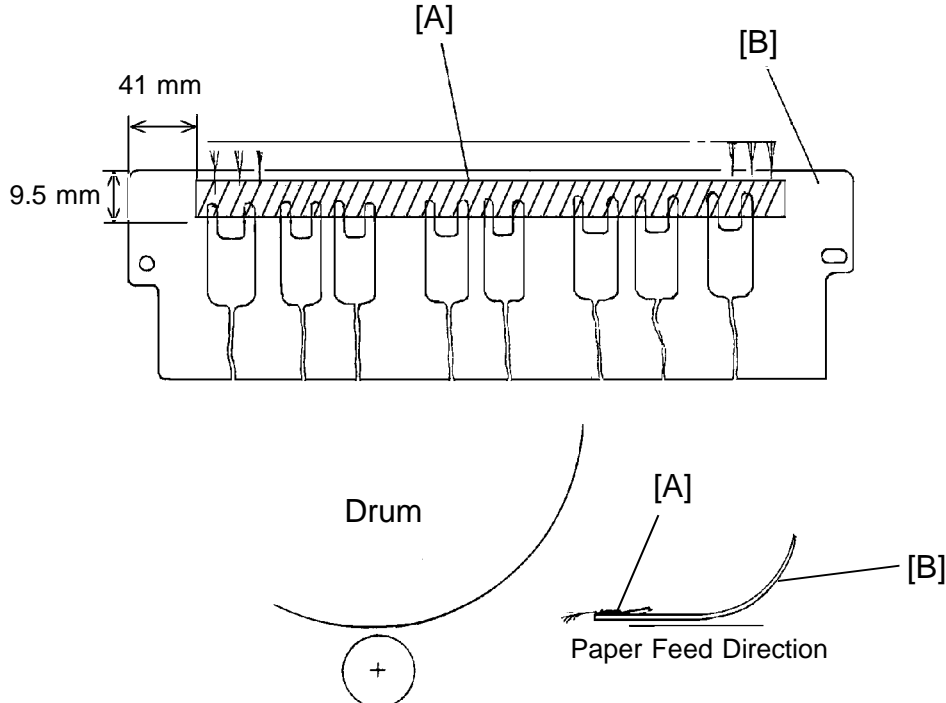
Paper jamming occurs around the drum because of static electricity when the machine is used under low humidity conditions. Heavy static charges will build up around the master during the printing run. This happens particularly when thin paper is being used at high speed rotations. This also happens if the original (and therefore the master on the drum) is changed.

Stick the antistatic brush (P/N: C2079010) [A] on the upper second feed roller guide plate [B] as illustrated below: (The antistatic brush has been registered as a spare part.)

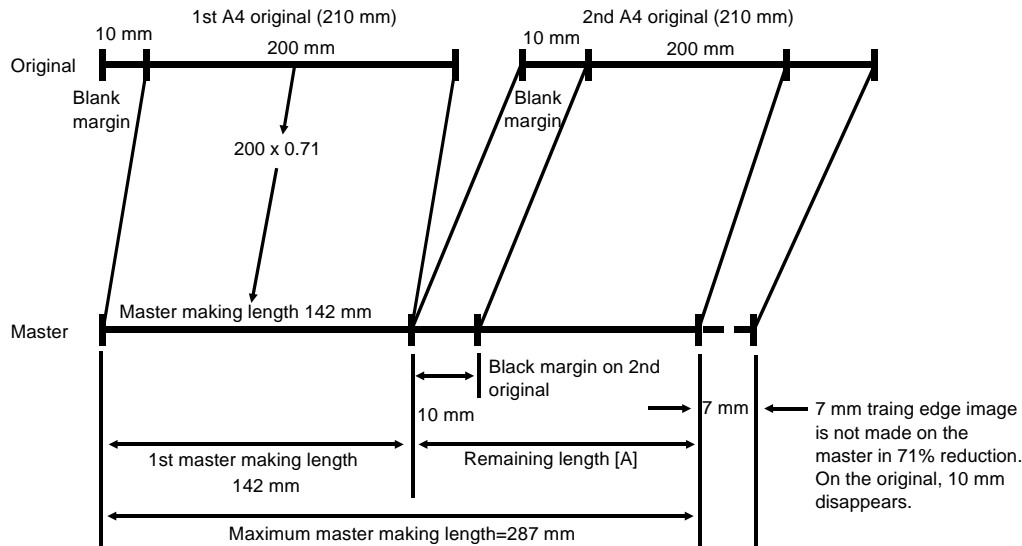
1. When the 1st original is fed out, the remaining master making length [A] for the 2nd original is 145 mm. (**287 mm - 142 mm = 145 mm**)

2. In Combine 2 Originals mode, the ROM program detects whether the remaining length [A] (145 mm) is more than half of the maximum master making length (287 mm / 2 = 143.5 mm). If the remaining length is less than 143.5 mm, the Combine 2 Originals mode is automatically canceled before the 2nd original is fed in.

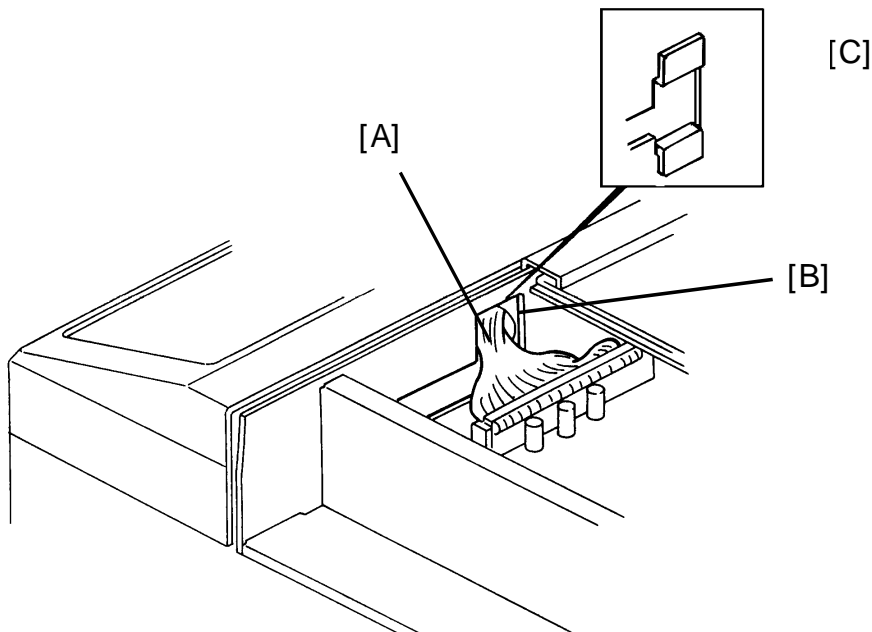
Flat Cable - A/D Conversion [A] (C2158012) is damaged by the edge of the scanner side plate cutout [B] and short circuited to the side plate.

1. File the edge of the sideplate cutout and cover it with insulating tape.
2. Bind the damaged area of the flat cable with insulating tape.

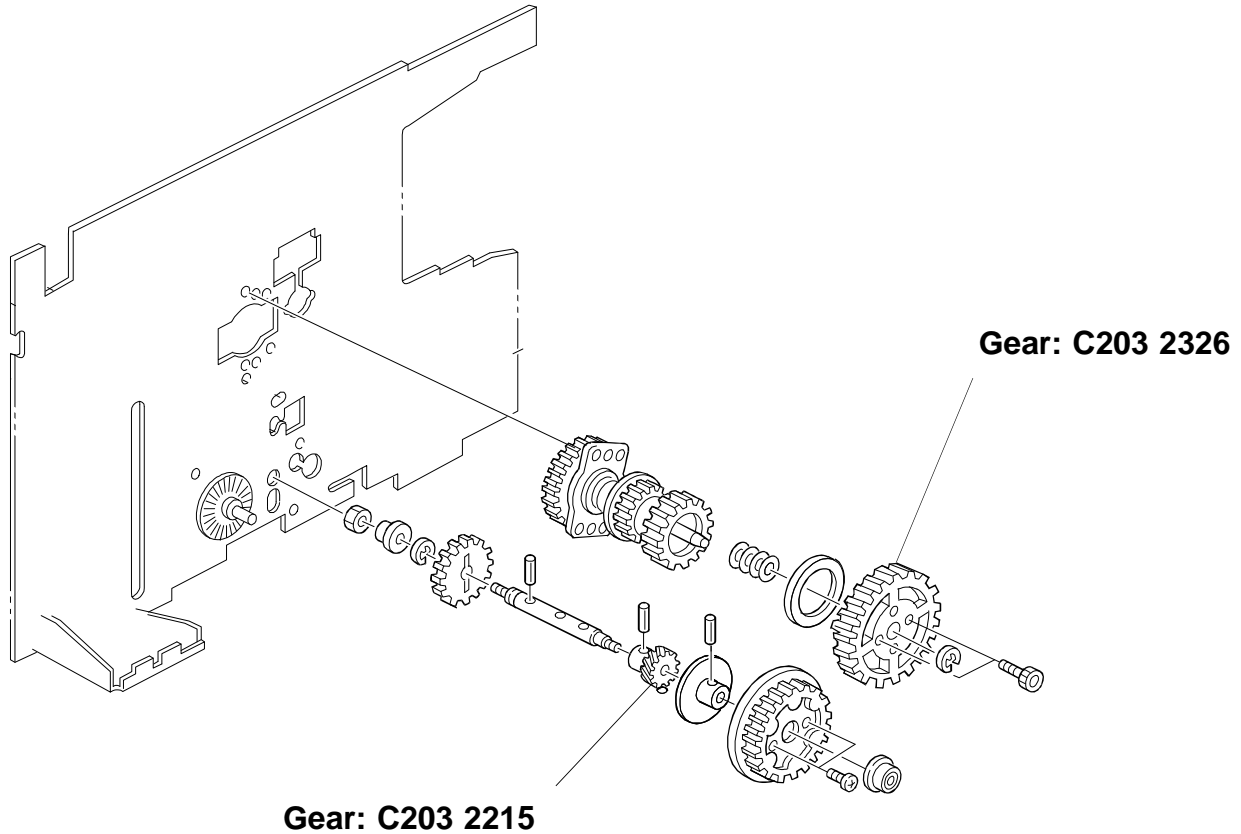
It was found that gears C2032215 and C2032326 (see the illustration on the next page) can rapidly wear out if they are not greased. In particular, gear C2032215 wears out faster (after about 30,000 to 50,000 copies).

It was also found on the production lines that some machines which were manufactured during the period from the end of 1994 to May 1995 have a lack of greasing for these gears. From April 1995, an inspection process was added to check the greasing of these gears.

Grease the gears (evenly on the surface of the gear C2032215) in the following cases:

1. For the machines detailed above (the N860 and N865 manufactured between the end of 1994 and May 1995), check if grease is properly applied and grease if necessary.
2. Grease the gears every time when they are replaced.
3. Grease at yearly PM intervals (as mentioned in the service manual).

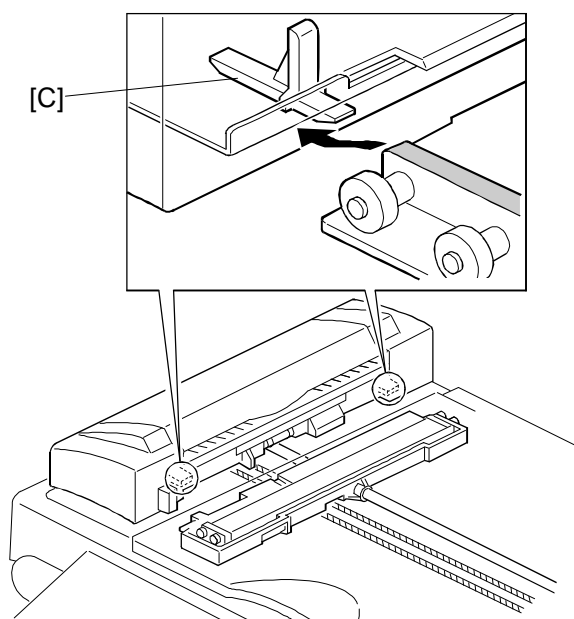
NOTE: If you do not follow the above instruction and the tab rides over the scanner unit frame, the ADF unit leans toward the right. There are guides [C], which are to guide both ends of the carriage, beneath the right end of the ADF (see the illustration above). Thus, these guides are just slightly lowered.

As a result, the carriage tends to be caught by the edge of the guides [C] while the carriage moves toward the original scanning position for the ADF mode. Even if the carriage is stopped on the way to the original scanning position, the master making process will happen as in the normal manner. However, as the original is not scanned properly, images will not be reproduced on the master, resulting in blank (or black) copies.

1. When you install the ADF unit [A] on the scanner unit, make sure to insert the tab [B] as shown above.
