SUBJECT: Black Ink Cartridge Seal

FROM: Copier Technical Support Section

VT3500  
Ges 5375/Rex 1280  
NSA CP375

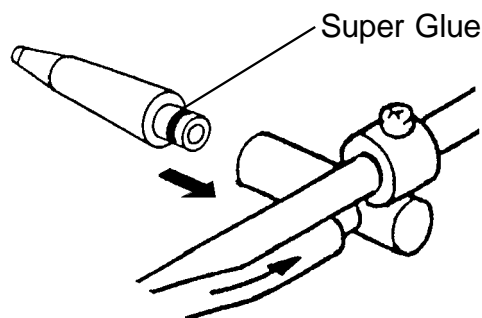
During the printing run, the paper exit pawl slightly comes off and it contacts the drum screen. This causes a black line on copies. In the worst case, the exit pawl contacts the master clamper and the clamper may be damaged.

**Note:** Before applying super glue, place a sheet of paper on the vacuum unit to prevent glue from dropping on the vacuum belt.

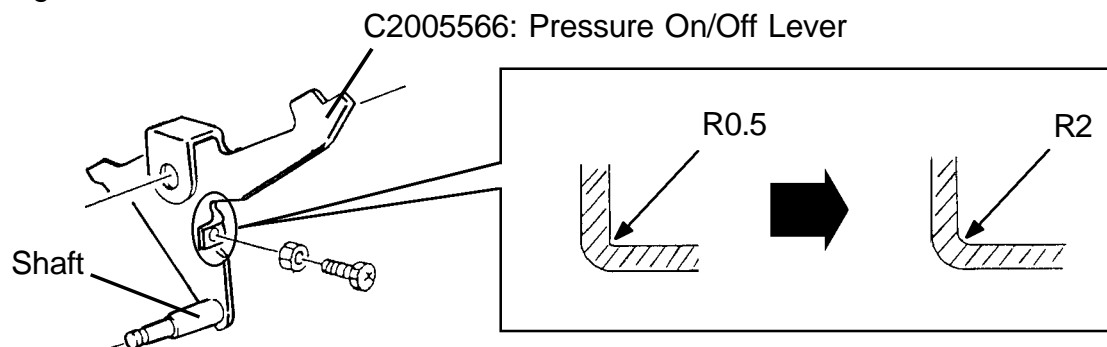
It was reported that the adjusting screw tab of the pressure on/off lever is sometimes broken.

The pressure on/off lever (part number: C200 5566) is commonly used for all the series models, but this problem is typical only on this model. This is because the pressure roller's pressure of this model is higher than that of the other models due to the A3 size printing.

To increase the durability of the lever, the angle has been rounded as shown in the illustration. This will reduce the stress on the adjusting screw tab. The new type lever has been applied since the May '92 production. The cut-in serial numbers are as follows:

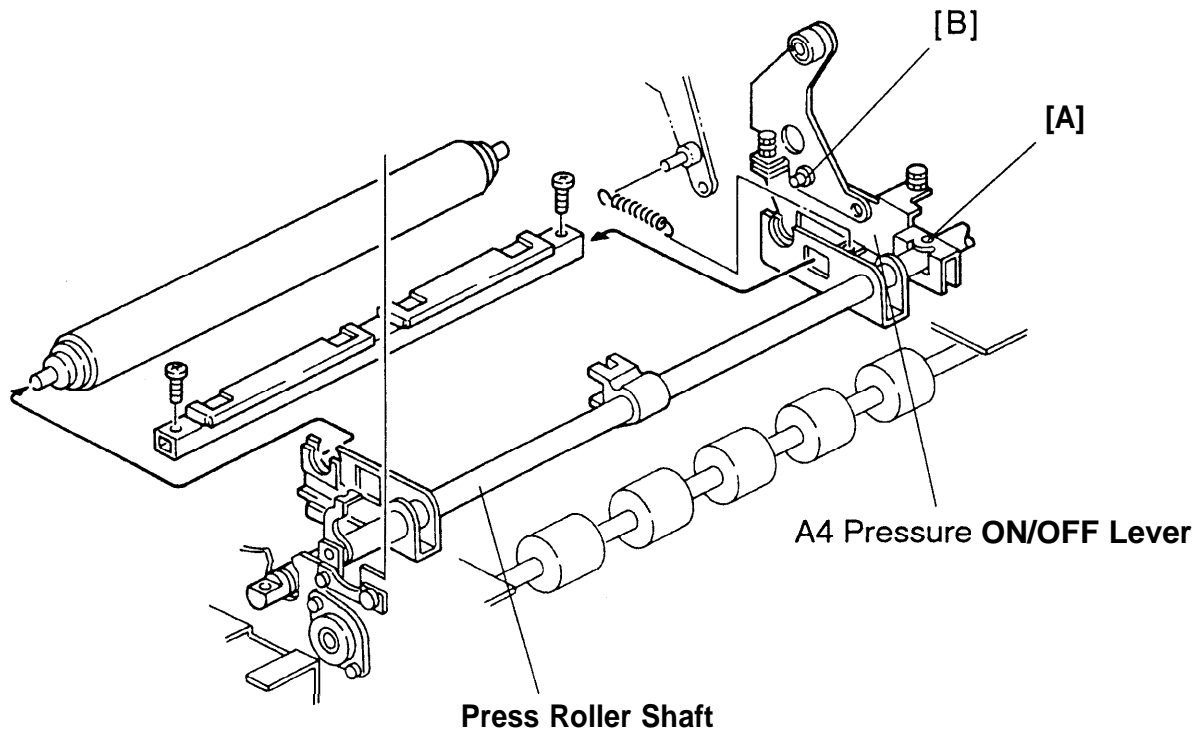
It was reported that the bolt (M5x14 hexagonal hole head bolt) that secures the A4 pressure on/off lever on the press roller shaft breaks. This will cause the exit pawl to hit the drum surface because the exit pawl drive cam is fixed with the A4 pressure on/off lever.

Since August 1992, the torque to tighten the bolt has been reduced and controlled to 40 to 50 kgfcm on the production line. In the past, it was around 100 kgfcm. It was found that there was possibility of the bolt breaking while using the optional A4 drum. The cut-in serial numbers are as follows:

1. Replace the bolt [A] with a new one (P/N: 05950140E).
2. Be sure that the bolt [B] (M4x6 hexagonal hole head bolt) is firmly tightened. If this is loose, the A4 pressure on/off lever does not operate properly.

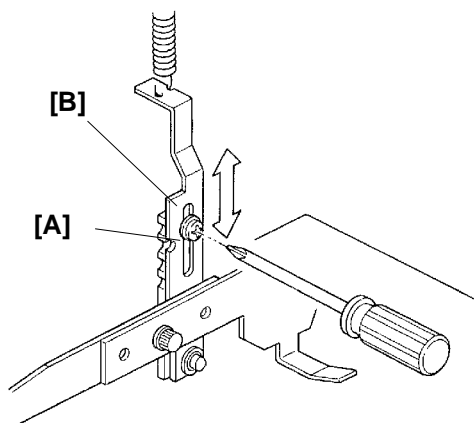
**CAUSE:**

The paper feed roller pressure is too low. It was found that on the production line the adjustment was performed improperly, for some units. Therefore, this problem can occur in the NA33 model only.

1. Check the original position first, then loosen the screw [A] while holding the lower adjustment plate [B].
2. Shift the lower adjustment plate [B] up by one notch to increase the paper feed roller pressure. Then, re-tighten the screw [A].

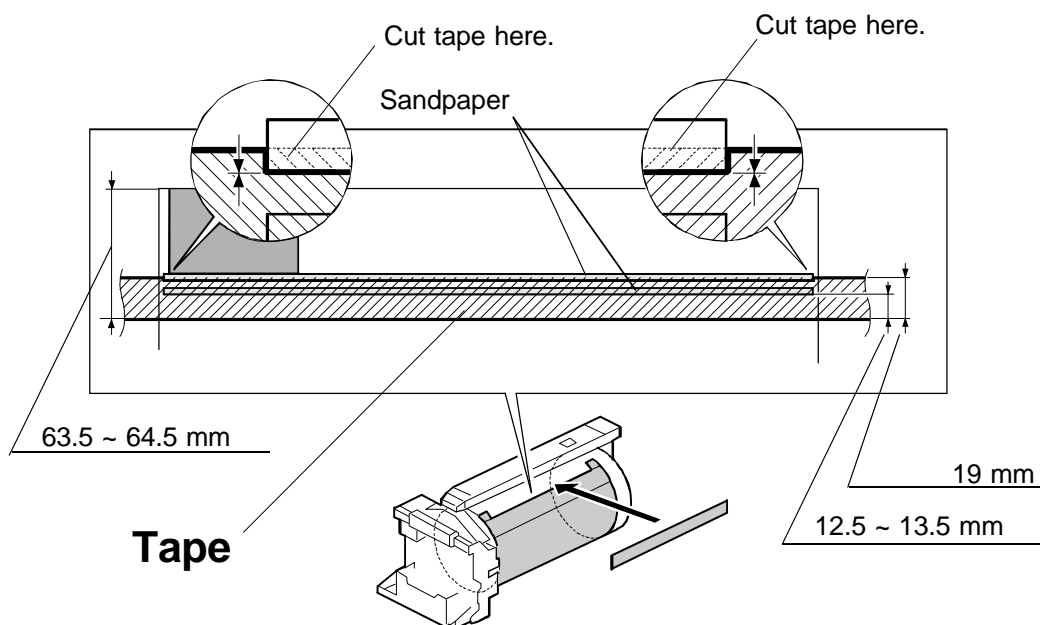
NA33: Ricoh VT3800/Gestetner 5385/RexRotary 1290/nashuatec CP385/ABDICK 6790/SVN3300DNP

**CAUSE:**

Due to rough edges of the paper, the master wrapped around the drum becomes damaged.

Normally, even if the master is damaged, there is no ink around the area beneath the master where the paper leading edge contacts it (there are no holes in the metal screen). However, after a long printing run, ink leaks onto this area and is transferred to the paper through the damaged part of the master.

3. Cover the leading edge part of the cloth screen on the drum with tape, so that ink does not leak even when the master is damaged.

- Cut the tape where it covers the upper strip of sandpaper as shown. Be careful not to damage the cloth screen surface.
- Cut both edges of the tape at the edge of the metal screen. Do not let the tape ride over the drum flanges.

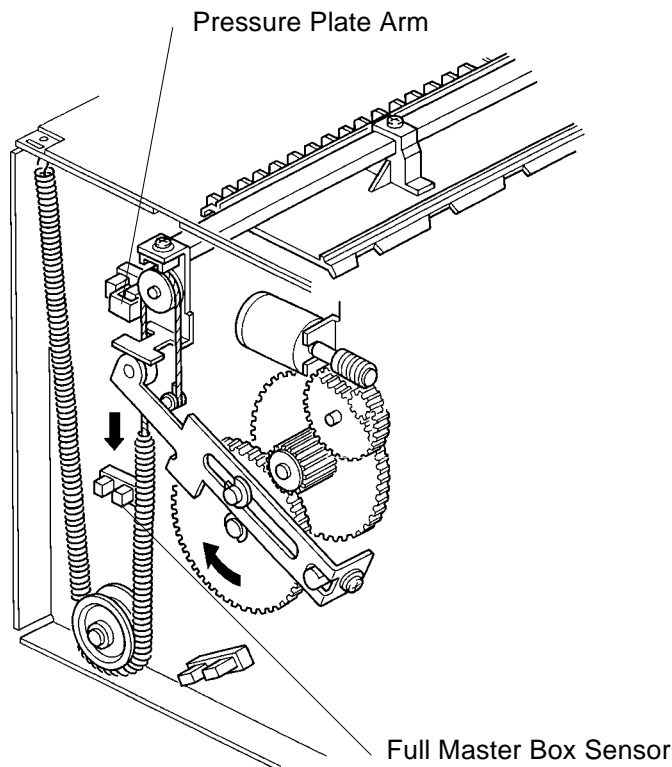
Old Pressure Plate Arm

The new part has a narrower actuation plate as shown below. This means that the full master condition will be detected earlier than before.

If **SOLUTION 1** is not good enough, install the new part on the operation side of the master eject unit (see below).

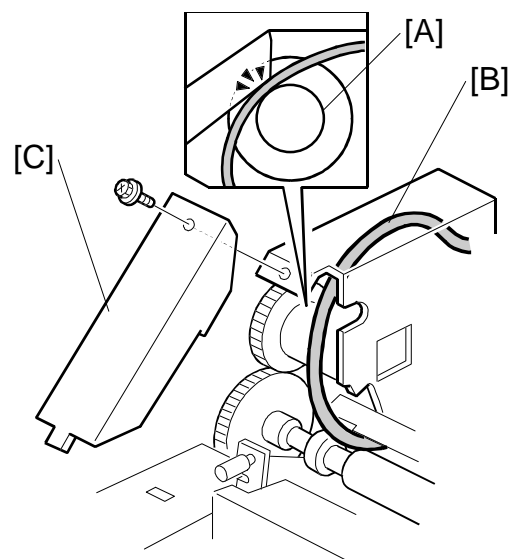
1. Master feed jam (location C jam).
2. The length of the master that wraps around the drum is shorter than normal. This causes a master eject jam during the next master making process. This is because the master eject rollers cannot catch the trailing edge of the master on the drum.

There is a torque limiter [A] built into the gear on the upper master feed roller. If the wire harness [B] from the cutter unit is run (installed) improperly when the gear cover [C] is installed, the gear cover may catch and press the wire harness against the sleeve of the torque limiter.

**NOTE:** The torque limiter is used in the NA6 only, and this problem does not occur in other PRIPORTs.

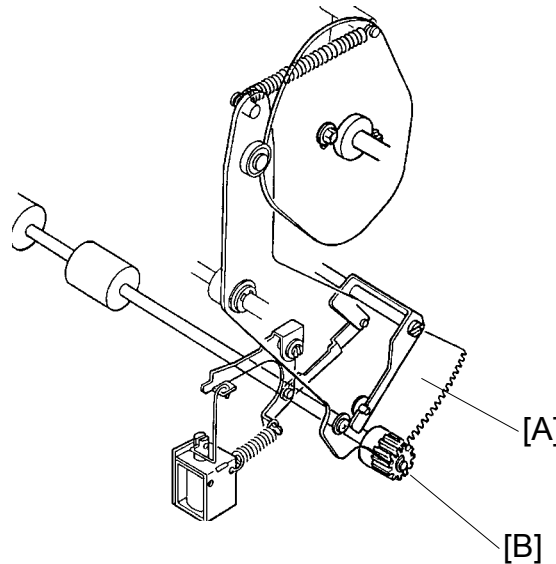
### Case 1:

A worn 2nd sector gear and/or 2nd feed roller gear causes paper feed jams.

This also causes the 2nd feed roller lifting mechanism to not work properly. In this case, printed images will be distorted. (Images are not transferred to paper properly because of the lifting mechanism failure.)

The sector gear [A] and the feed roller gear [B] ran out of lubricant. Because of this, the sector gear [A] will not be able to oscillate back and forth correctly.

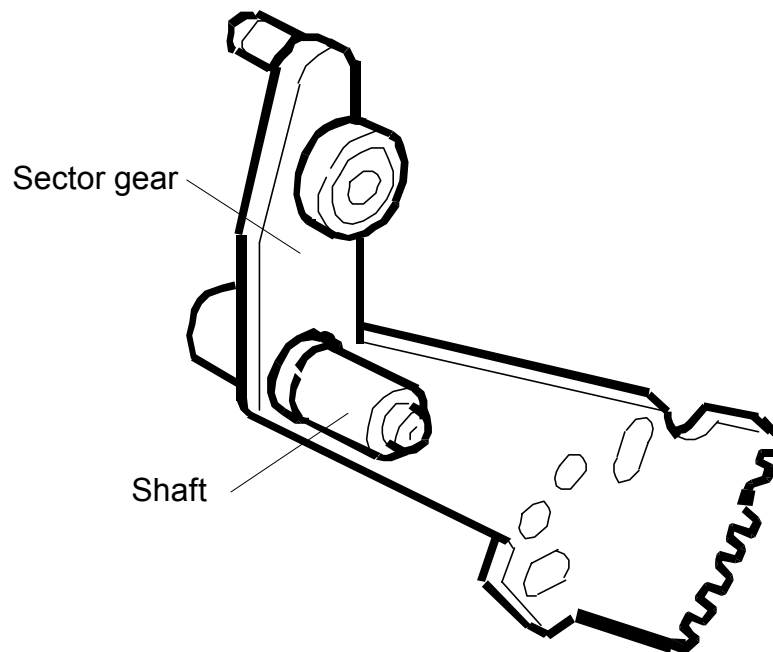
**Case 2:**

There is too much thrust play, and the sector gear is oscillating on the shaft.

Due to this, the sector gear will not be able to oscillate back and forth correctly. As a result, the sector gear does not move correctly on the 2nd feed roller gear and damages the teeth of the gear.

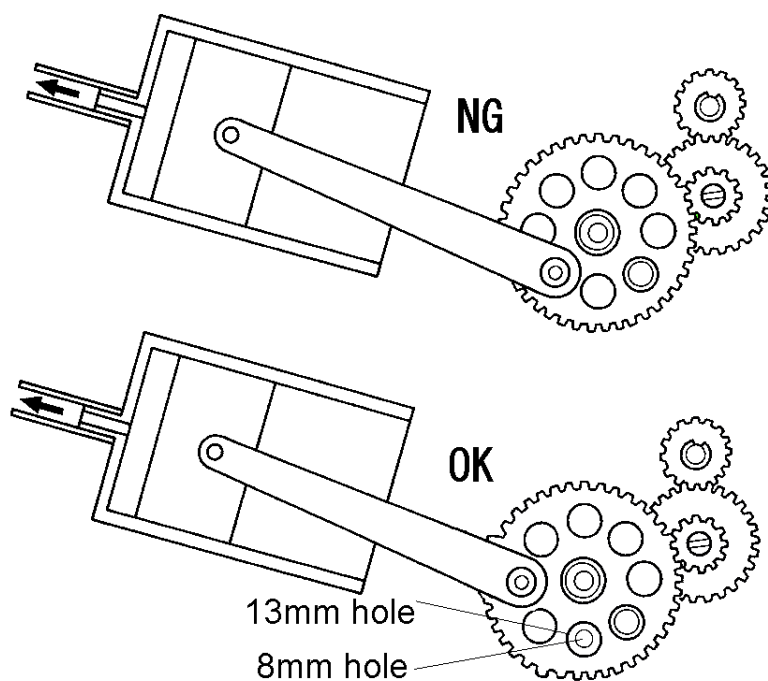
**NA33 service manual Page 5-74****● 9.5 Paper Exit Pawl Air Pump adjustment**

Please correct the procedure as follows. The 13 mm hole in the gear should be at the 6:00 position. (See below.)

1. Open the front door and remove the inner cover.
2. Press and hold down the 'Drum rotate' button until the drum reaches the home position.
3. Confirm that the 13 mm diameter hole in the gear and the 8 mm diameter hole in the side plate are lined up at the 6:00 position.
4. If the holes are not lined up, remove the E-rings and reposition the gear.
5. Rotate the drum to the home position and do step 3 again.
