SERVICE BULLETIN

Product: NF MONITOR
Model: PG17NS, PG19NS
 SyncMaster 700NF, 900NF

Bulletin No.: MON01-007 (00-C/M-E0021)
Bulletin Date: May 10, 2001
ECN Date: May 10, 2001

SUBJECT: Display Shift or Size Change

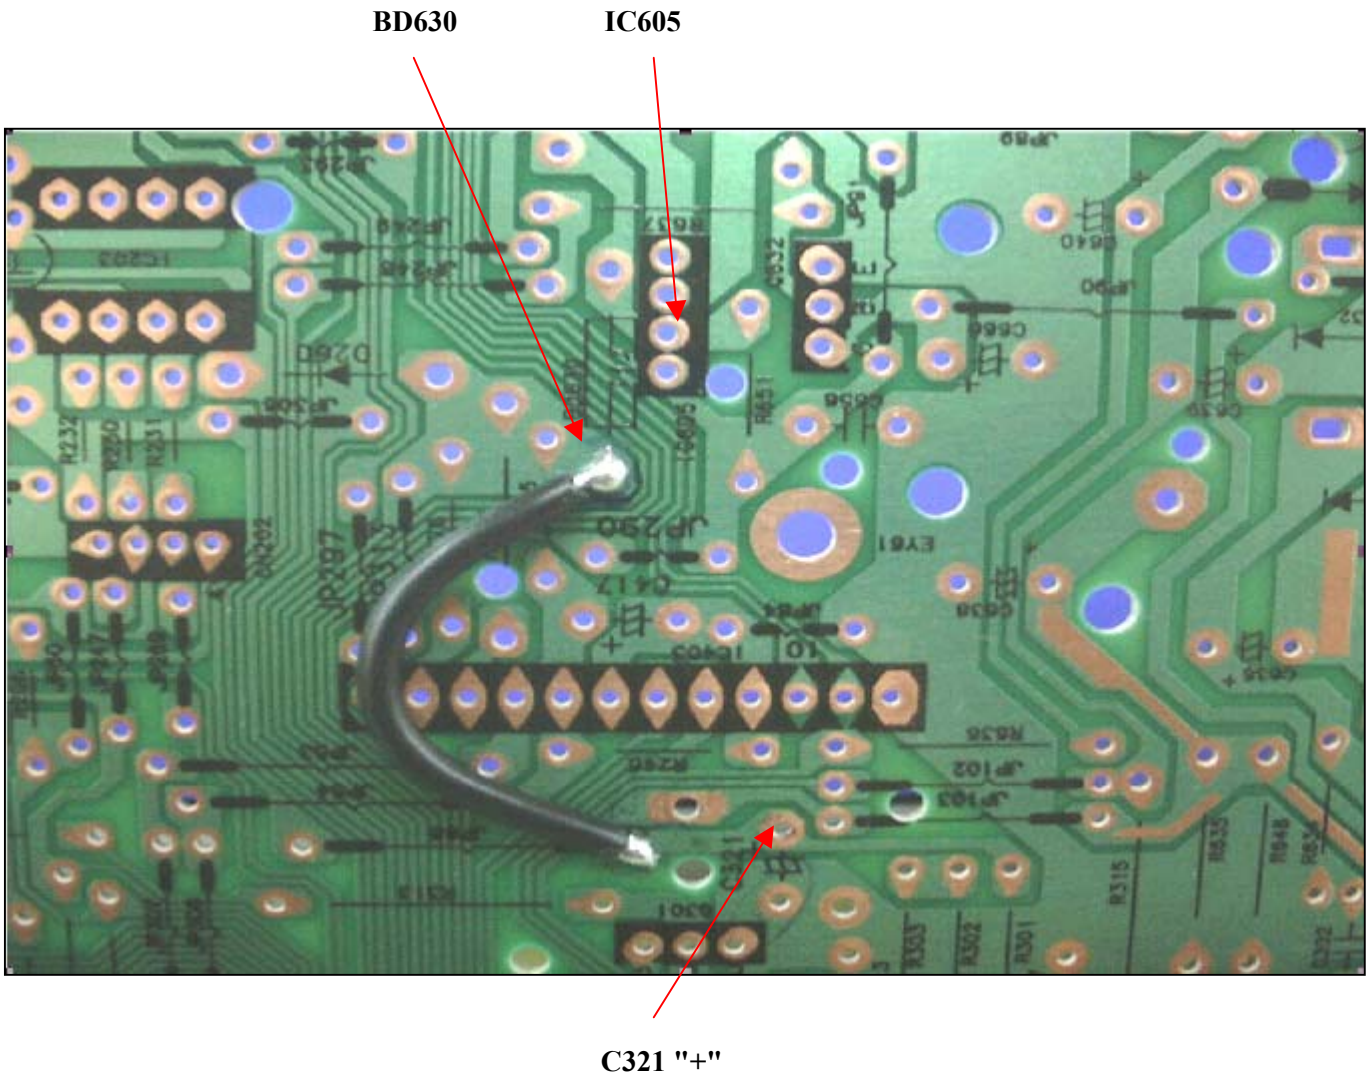
A. Countermeasure for V-position shift

Solution: To correct the vertical position shift, add a jumper wire from BD630 to C321 “+”. Change the value of R301 from 100k ohm to 220k ohm. Remove jumper wire connecting IC261 #13 and JP68.
 To correct the horizontal size increasing symptom, change the type and tolerance on both R286 and R289 from Carbon 5% to Metal 1%.

1. Add jump wire on the back side of PCB

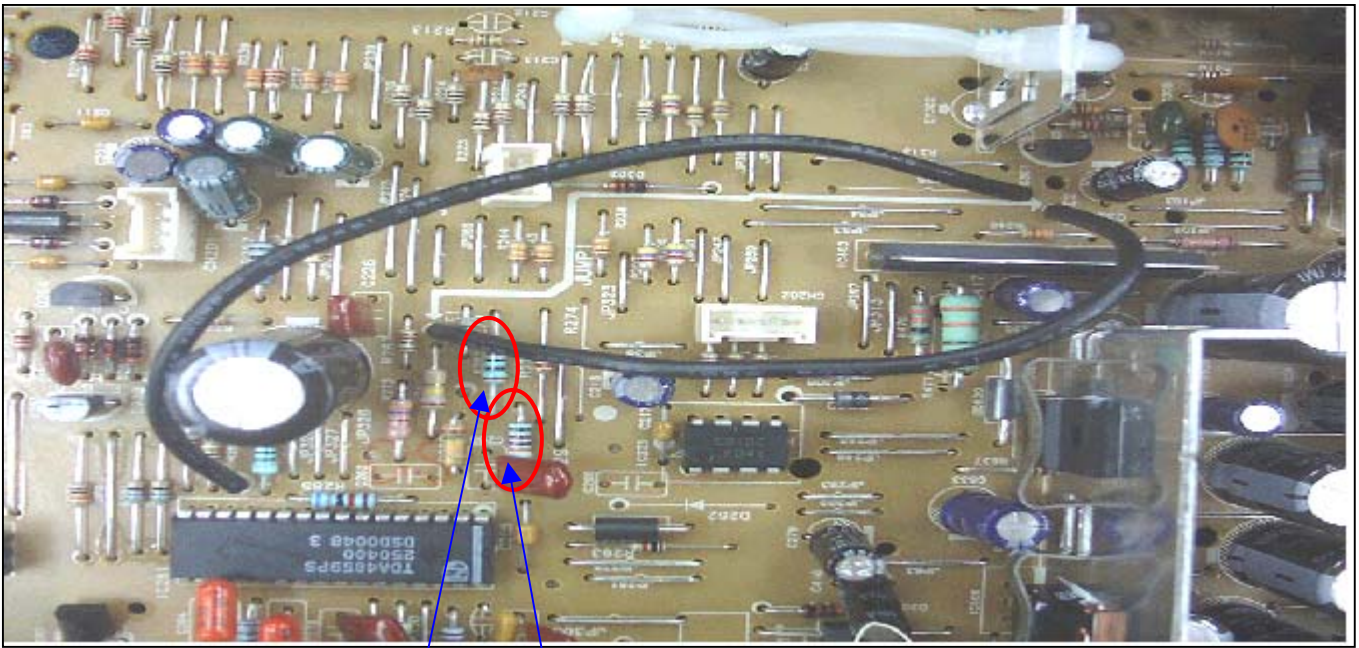
R286 **R289**

Background: The PG17NS and PG19NS may have symptoms of the vertical position changing and horizontal size increasing.

B. Countermeasure for increasing H-size

ORIGINAL			NEW	
Location No.	Part No.	Description	Part No.	Description
R301	2004-000193	R-METAL, 100k, 1%	2004-000560	R-METAL, 220k, 1%
R286	2001-000395	R-CARBON, 180k, 5%	2004-000398	R-METAL, 180k, 1%
R289	2001-000354	R-CARBON, 150k, 5%	2004-000327	R-METAL, 150k, 1%
