SERVICE BULLETIN

Product: CRT MONITOR
Model: AQ17HS/IS, AQ19IS/MS
 SyncMaster 700IFT, 750P, 900IFT, 950P

Bulletin No.: MON02-001 (01-C/M-E0050)
Bulletin Date: October 24, 2001
ECN Date: October 24, 2001

SUBJECT: DY-Wire Clamp Change

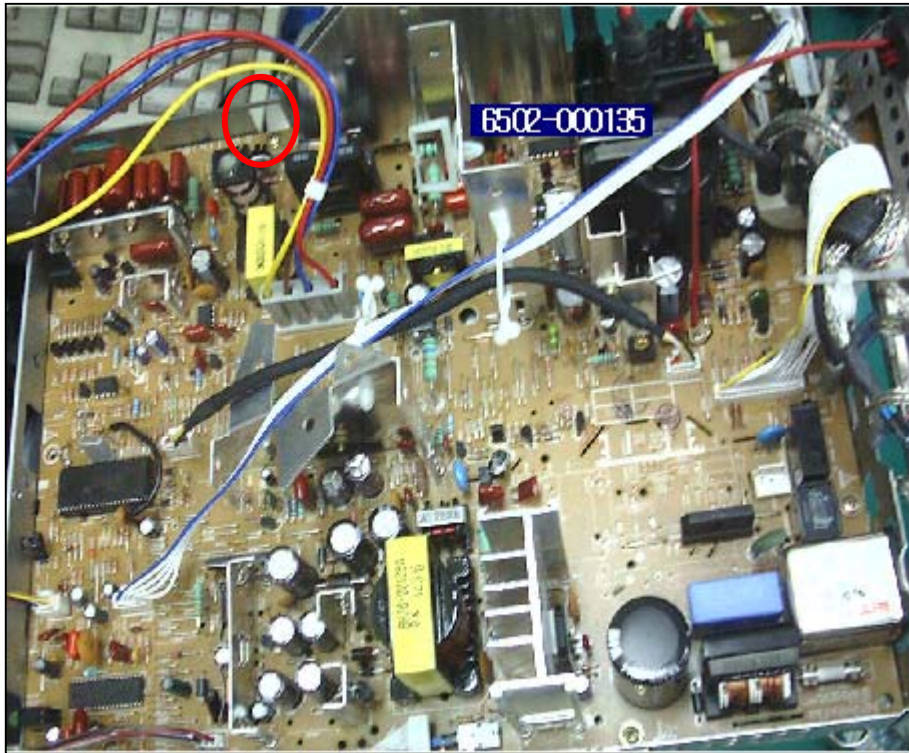
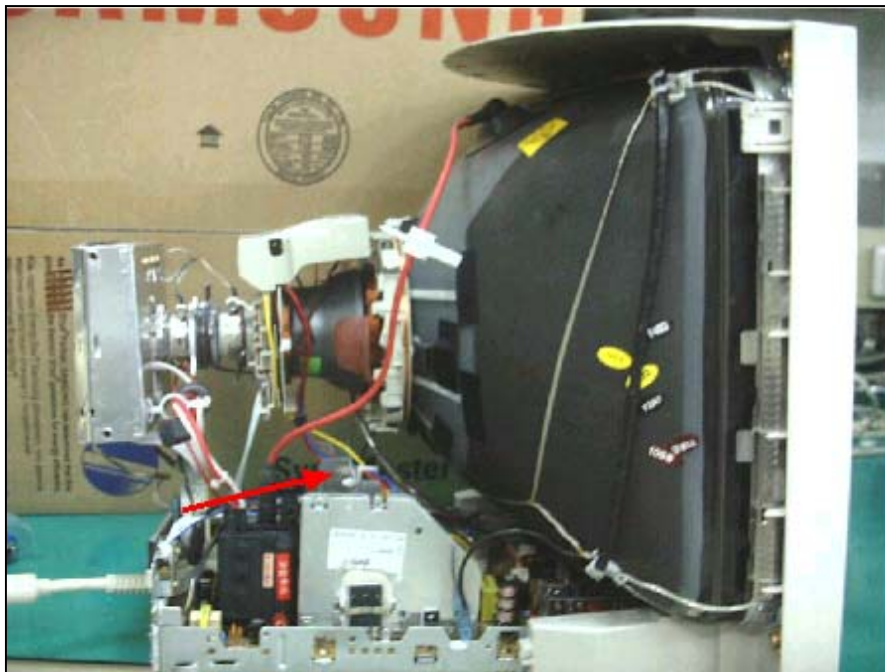
BEFORE CHANGE

Cause: The DY-wire can touch the sharp edge of the high voltage FET heat sink. This can cause the wire shield to peel off thus causing an arc.
