SERVICE BULLETIN

Product: CRT MONITOR _____ **Bulletin No.:** MON02-010 (02-C/M-E0081) _____
Model: AQ19LS, AQ19JS _____ **Bulletin Date:** August 28, 2002 _____
ECN Date: August 28, 2002 _____

SUBJECT: Main PCB and Chassis Frame _____

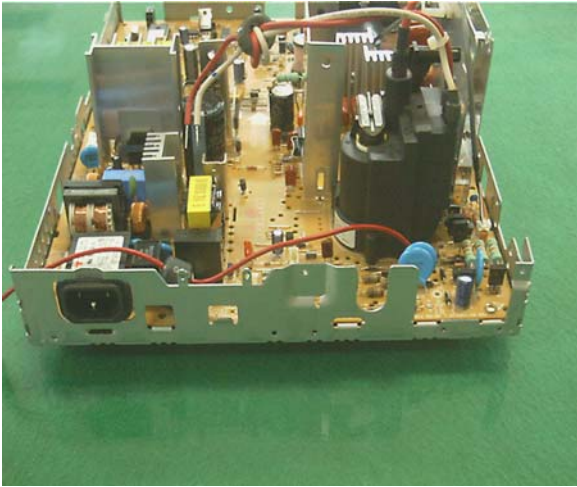
Main PBA

Background: The main PCB touches the metal chassis frame guides. Although the PCB is covered with protective paint, it may cause failures to R513 and R570.

Cause: The protective paint wears out with PCB version range MP 1.2 ~ MP 1.4 with a production date of October 2001 ~ August 2002. Permanent solution : Change PCB pattern from ver 1.4 to ver 1.5 (Sep.2002~)
