SERVICE BULLETIN

PRODUCT: Computer Monitor
BULLETIN: Monitor 95-005
MODEL: Samtron SC-428PS

SUBJECT: Vertical Deflection Circuit Improvement

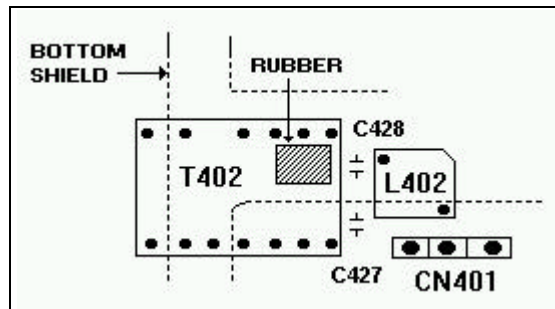
BACKGROUND: A whistling sound is created from harmonic noise generated between T402, L402, and the main PCB near the Flyback Transformer.

SOLUTION: Add a piece of rubber to insulate the main PCB solder side from the bottom metal shield. See Illustration below showing the section of the PCB where the rubber will be located.

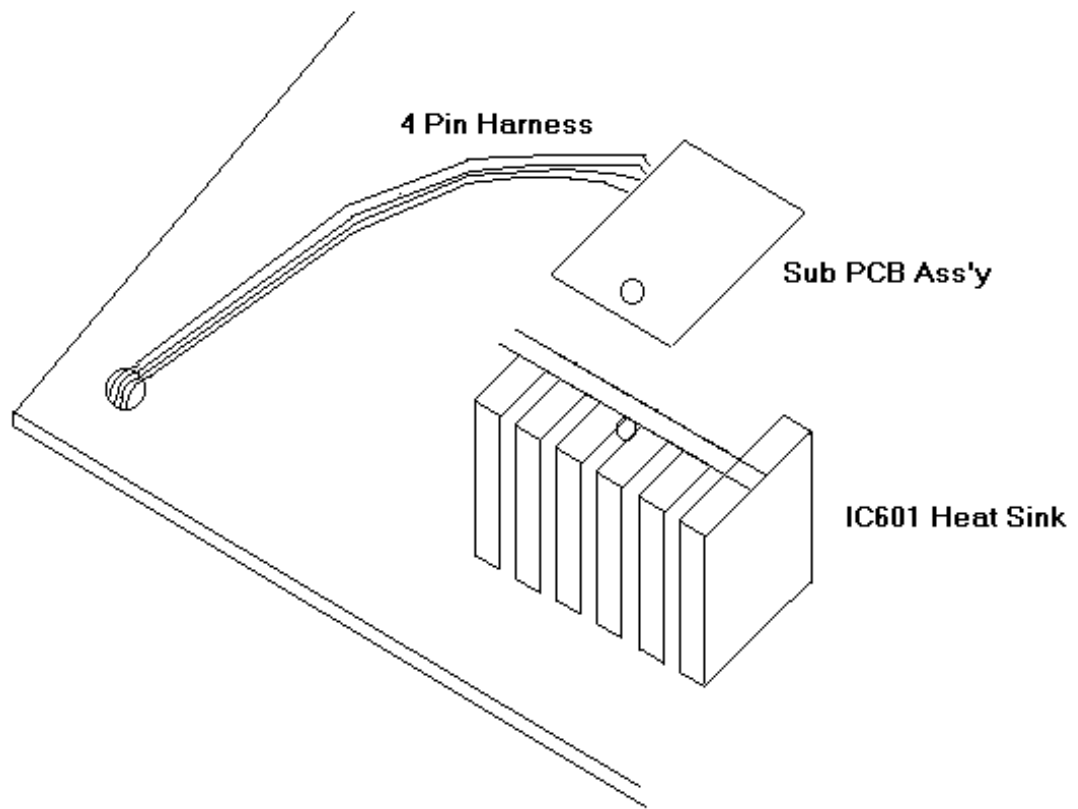
Figure 1

SUBJECT: Q407 Failure Causing No Raster or Small Horizontal Size

BACKGROUND: Q407 fails due to a transient pulse and current when mode switching from DOS to Windows. This occurs with a Matrox video card installed in the computer.

SOLUTION: Add a sub-PCB assembly as in figures 1 and 2 and a snubbing circuit for the horizontal output as in figure 3.
