SERVICE BULLETIN

PRODUCT: COMPUTER MONITOR
BULLETIN: MONITOR 95-007
MODEL: CQB4147

SUBJECT: No Raster

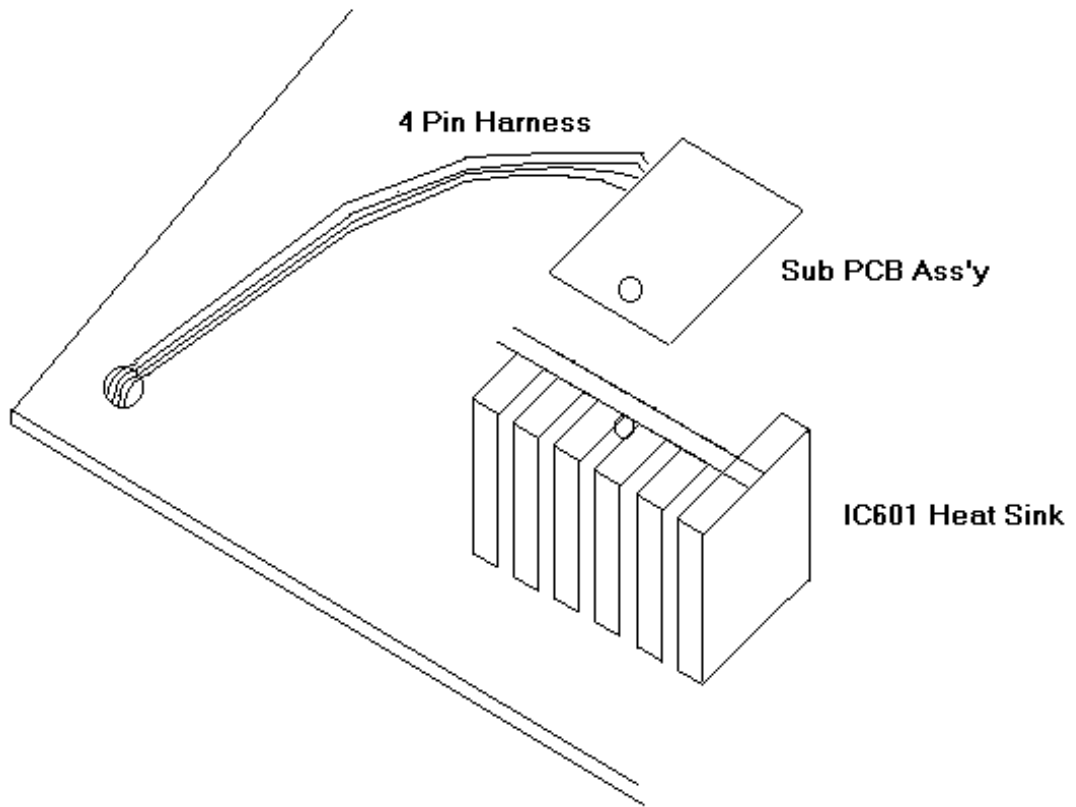
Figure 1

SUBJECT: Q407 Failure Causing No Raster or Small Horizontal Size

BACKGROUND: Q407 fails due to a transient pulse and current when mode switching from DOS to Windows. This occurs with a Matrox video card installed in the computer.

SOLUTION: Add a sub-PCB assembly as in figures 1 and 2 and a snubbing circuit for the horizontal output as in figure 3.
