SERVICE BULLETIN

PRODUCT: Computer Monitor
BULLETIN: MON 97-001
MODEL: CQB4147

SUBJECT: Reduce Q404 Failure Rate Causing No Raster

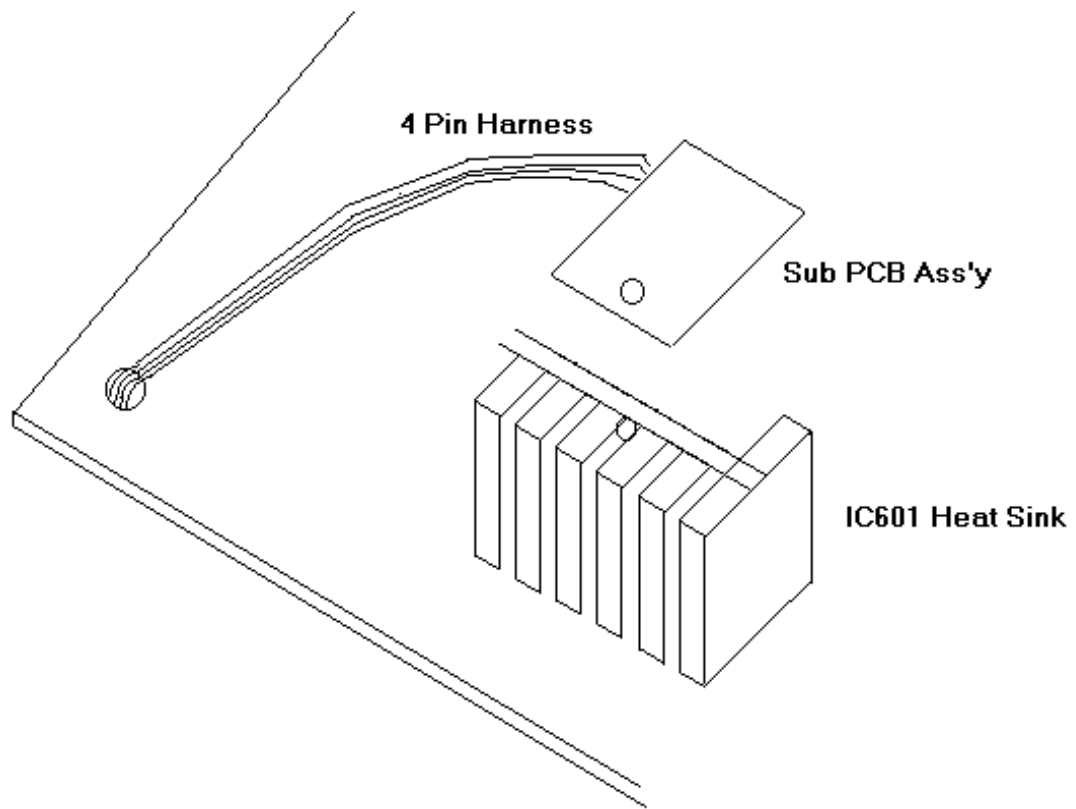
Figure 1

SUBJECT: Q407 Failure Causing No Raster or Small Horizontal Size

BACKGROUND: Q407 fails due to a transient pulse and current when mode switching from DOS to Windows. This occurs with a Matrox video card installed in the computer.

SOLUTION: Add a sub-PCB assembly as in figures 1 and 2 and a snubbing circuit for the horizontal output as in figure 3.

Top View of the Main Board
