SERVICE BULLETIN

PRODUCT: Computer Monitor

BULLETIN: MON 97-005

SUBJECT: Q407 Failure Causing No Raster or Small Horizontal Size

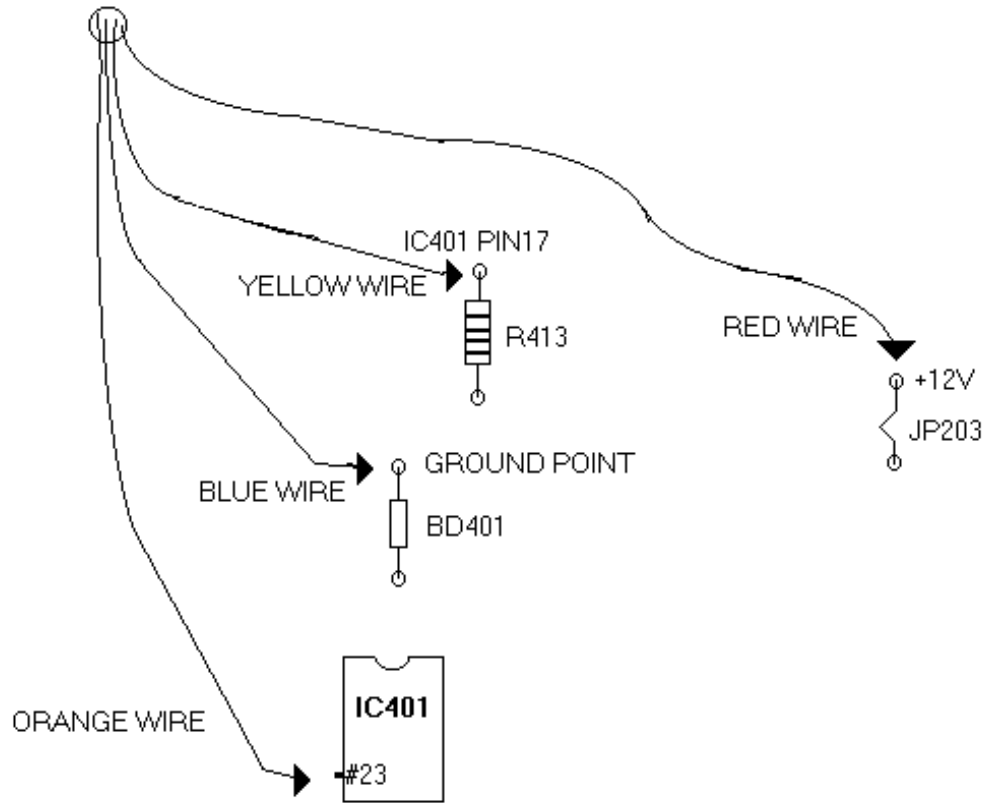
Figure 2

BACKGROUND: Q407 fails due to a transient pulse and current when mode switching from DOS to Windows. This occurs with a Matrox video card installed in the computer.

Bottom View of the Main Board

SOLUTION: Add a sub-PCB assembly as in figures 1 and 2 and a snubbing circuit for the horizontal output as in figure 3.

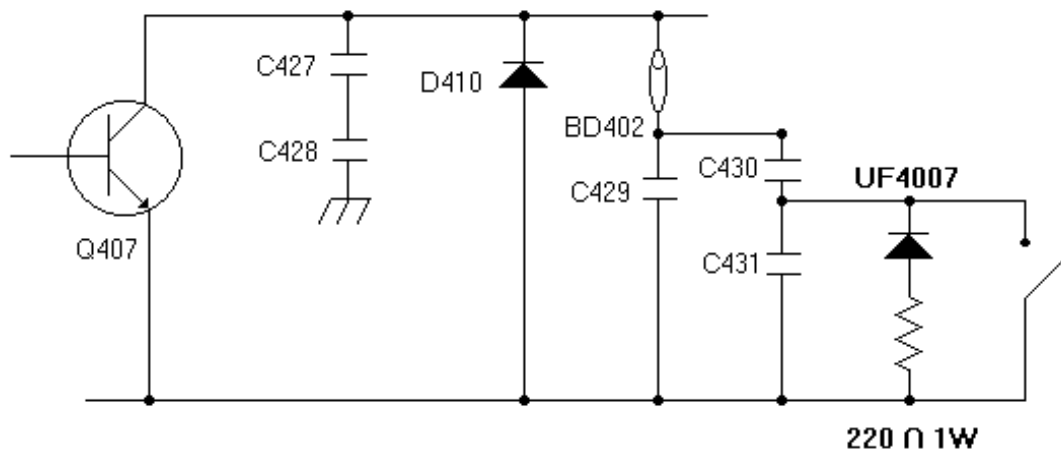
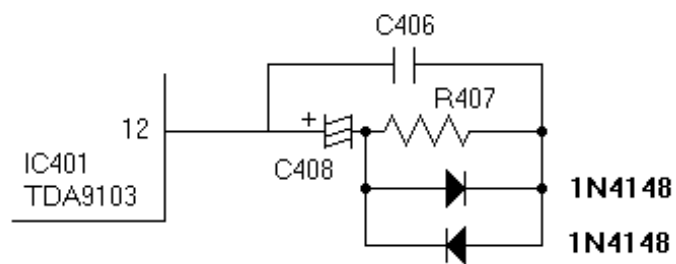
Figure 3

Snubbing Circuits
