SERVICE BULLETIN

Product	:	PEGASUS-SERIES	Bulletin No.	:	00-C/M-E0013
Mode I	:	S/M950P,750P,7001FT,9001FT	Bulletin Date	:	13. DEC. 2000
Buyer	:	All subsidiaries	ECN Date	:	13. DEC. 2000
SUBJECT	:	TROUBLE SHOOTING FOR PEGASUS SERIES

Background: Please refer to attached trouble shooting guide for pegasus-project

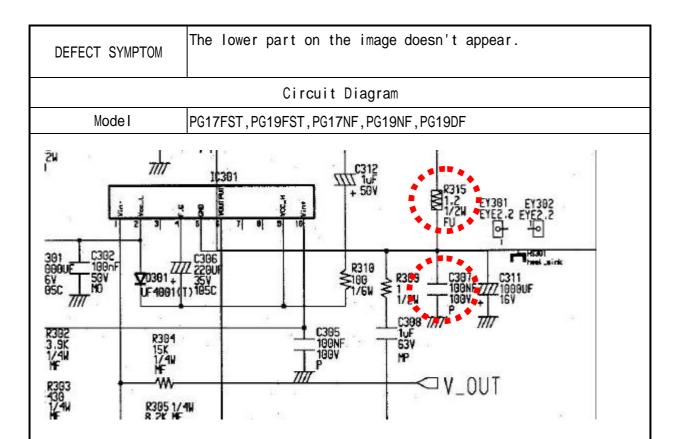
Location	Description	Parts Number
C307	Ceramic 104Z, 50V	
R315	1.2,1/2W

1. Check the C307, R315 whether a defective parts or not.

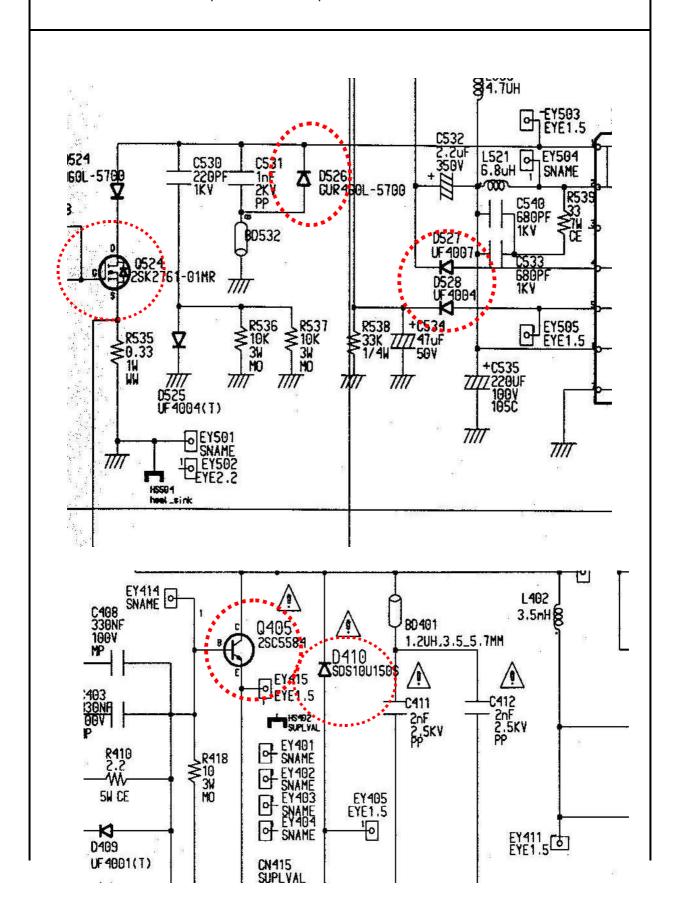
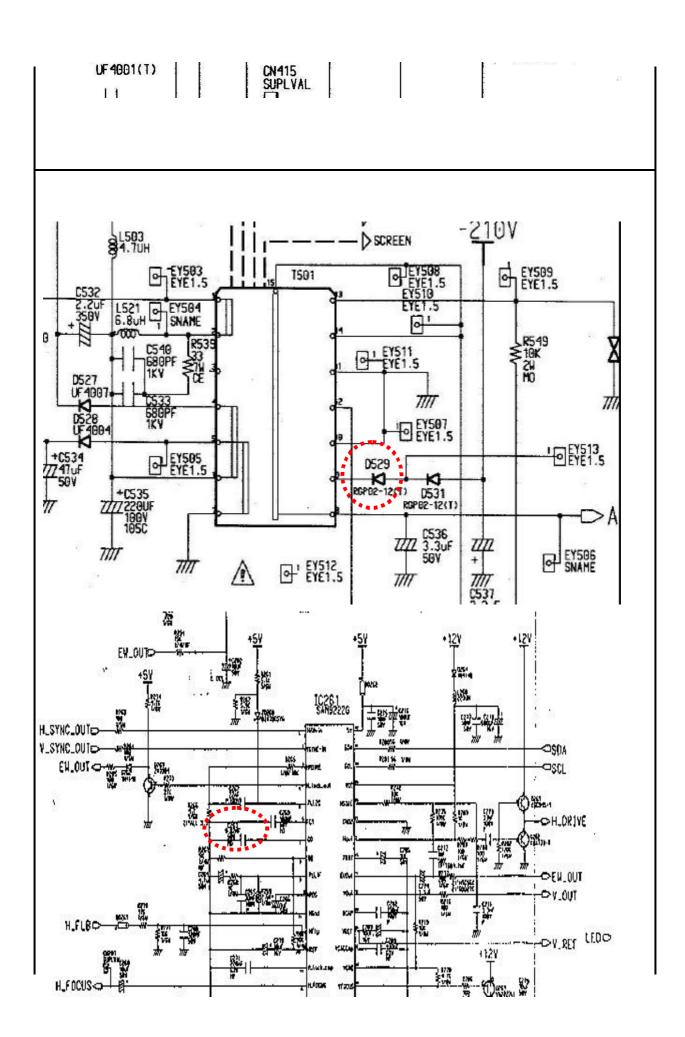
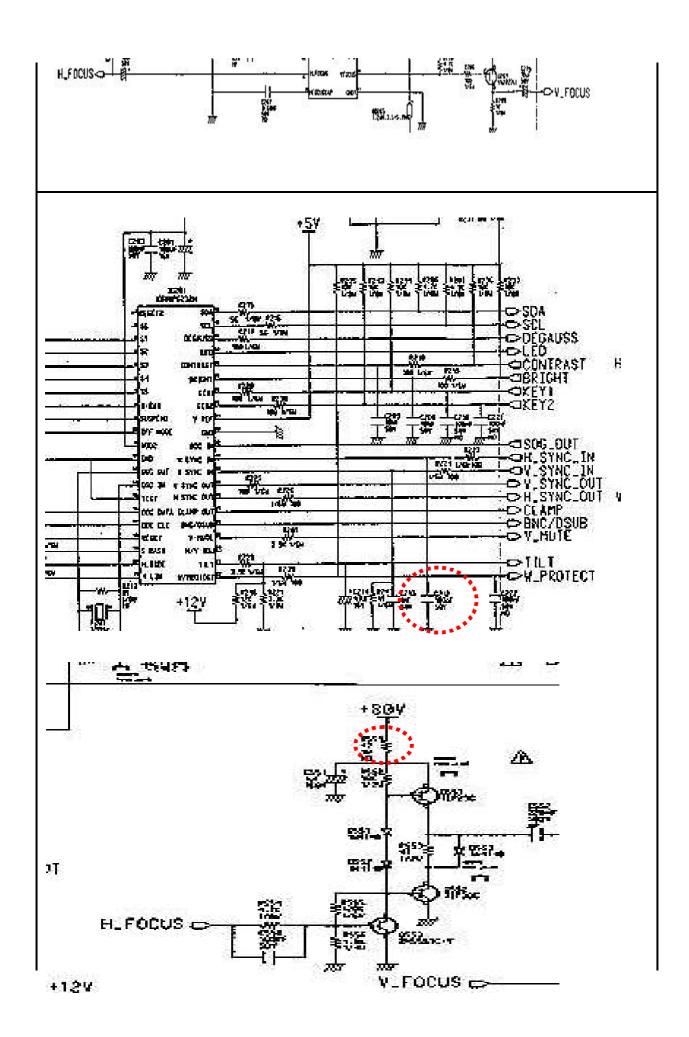
Defect Symtom	No Raster
	Circuit Diagram
Mode I	PG17FST,PG19FST,PG17NF,PG19NF,PG19DF
7777 5.6K 125W CT	SSB CS3B CS3B

No raster is occurred by various reasons.

1. In case the parts at a secondary circuits is shorted or semi-shorted by damaged parts or soldering short, between lead of parts, the OCP (over current protection) function in IC601 operate to protect a primary and secondary circuit from too much load (current)

As a result of OCP operating, it bring the SMPS circuit to a halt and then cut-off the output DC voltage which supply a secondary circuit with current

2. In case the parts or pattern on the route for H/V-sync from PC or others is damaged by electronic over stress or soldering short, poor connection for each of connector.

DPMS Mode is operated owing to cut-off the H-sync or V-sync.

3. When the high voltage circuit operates abnormally, it generates a high voltage higher than normal level.

Above condition increases X-Ray emission on the surface of CDT and causes hazard for a customer

To prevent a customer above matter, High voltage protection circuit exist. If the H/V protection function operates, the volatge of +30V line goes up and then the 1 pin output of IC501 goes to high level.

The 1 pin of IC 501 connects with 7pin of micom IC201.

The Micom operating act to halt mode in according to 7pin's voltage goes to high level, and so No raster occurs.

4. If the CDT is failed by inner floating substance or neck cracking, DY short, No Raster is occurred by operating OCP function.

1. Check the Q405, Q403 whether a poor condition or not.

Q405 : Horizontal Output TR, Q403 : Horizontal current control TR

2.Check the Q524, D526, D529, D527, D528

Q524 : High Volatage output TR, D526 : Damper Diode

3.Check the IC501

Check using oscilloscope for IC501,9pin whether a output waveform or not.

If not, check the parts as follow.

-> C525, Q521, Q522, Q523, R523, C522

If it can't find any defective parts, Replace the FBT

- 4. Check the C181, Replace the C181 in case you can't check it.
- 5. Check using DVM R551 whether a poor condition

6.Check the C263 connected 7pin of IC261, it may be occurs a image jitter or no raster if the capacitor has a poor characteristic.

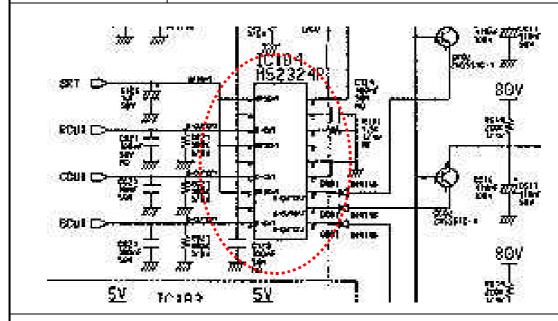
Defect Symptom	Change suddenly a image brightness in case the brightness
bereet dymptom	is changing use the control button

Location	Description	Parts Number
IC104	KA2506

- 1.Check the IC104, KA2506
- 2. Check a bad soldering whether around on the G2 GT-PIN

3. The wholly re-check the soldering and connector condition on the PBA.

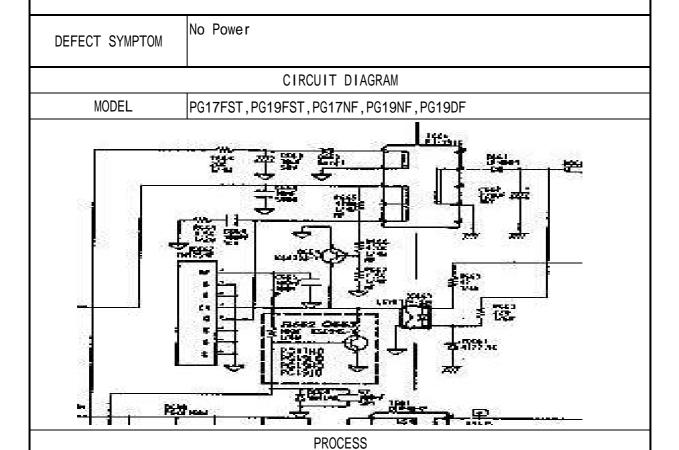
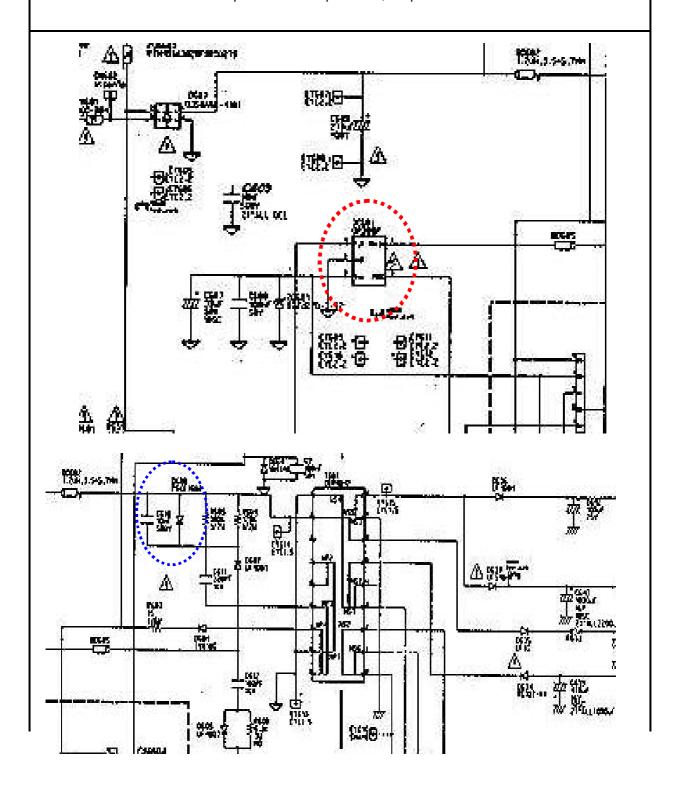
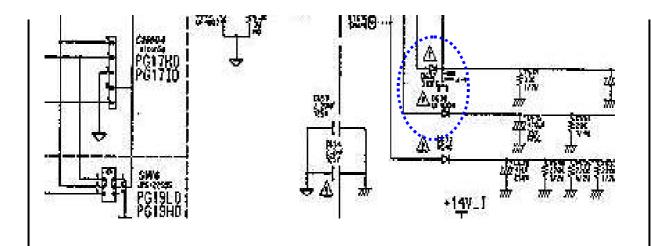
Location		
R666, R665	Res 470K, 1/4W	
IC662	TNY254P	
D632	Diode 31DF6	
D608	P6KE160A	
IC601	DP308P

- 1. Check using DVM R666, R665 whether a short or open condition
- 2.Check D632, D608 whether a poor condition.

- 3. Check using DVM between 1pin and 2pin of IC601 whether a low impeadance.
- 4. Check the secondary rectifier circuits as follow.
 - -> D632, D636, D637, D634,
- 5. If it can't find a bad parts above process, replace IC662 or T601.

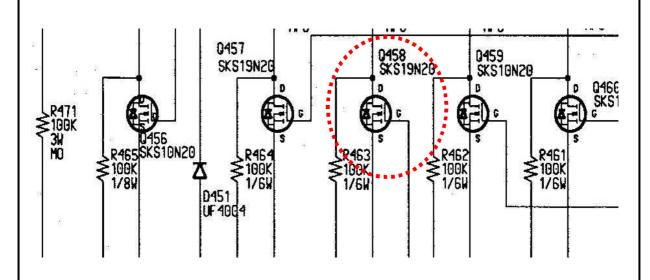
Bad a horizontal linearity

Location	Description	Parts Number
Q458	SKS10N20

If above the parts has a defective condition, the linearity characteristic should be get worse.

In case above capacitors has a poor characteristics, a distortion occur a porton of image

1. Check a parts as follow.

- -.Q462, Q456, Q457, Q458, Q459, Q460
- -. Q451, 452, 453, 454, 455, 461

- 2. Check capacitors around S-correction circuit as follow.
 - -. C460, 452, 454, 455, 456, 457, 452, 451

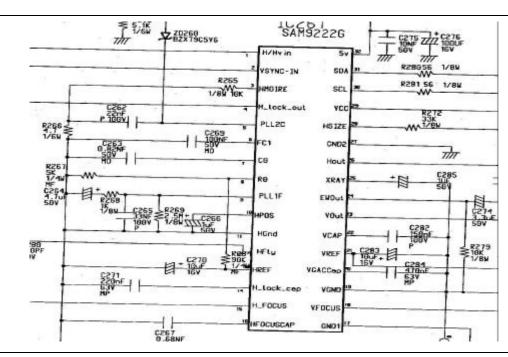
Image Shaking and get curved.

Location	Description	Parts Number
IC261	SAM9222G

- 1.Check IC261 and replace it.
- 2.Check a soldering condition around the IC261

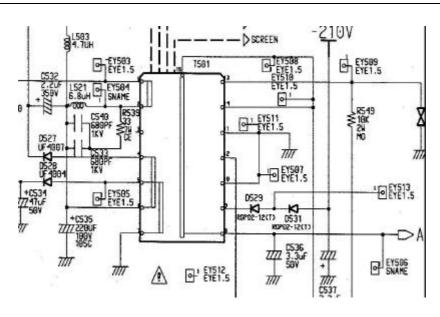
Image Shaking

· · · · · · · · · · · · · · · · · · ·				
Location	Description	Parts Number		
T501	FBT

- 1.Check Q524 ,If it has a short or open, Replace it.
 Check a soldering condition for Q524
- 2.Check Q522,Q523 ,Q521
- 3. Check a 9pin of IC501 whether a exisiting output waveform.
- 4. If not, Check C525, D522, D530

Replace IC501 in case output waveform from the 9pin of IC501 doesn't exisiting although C525,D522,D530 and soldering condition around IC501 is good.

5. If above all of parts has maintain a good characteristic, Replace the FBT.
