# SERVICE BULLETIN

Product : 24" LCD monitor

Model : SyncMaster 240T

SUBJECT : Countermeasure of 240T noise

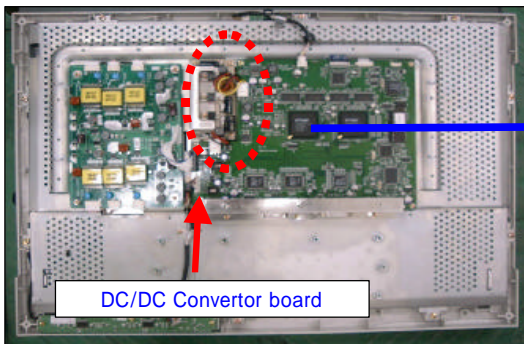
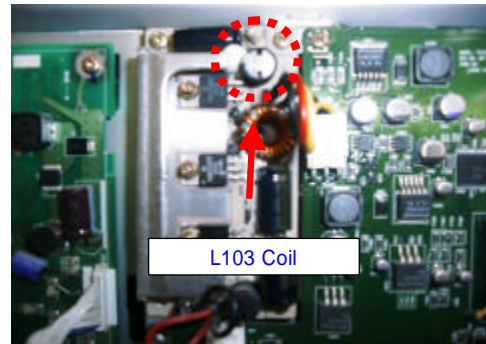
Cause : The noise comes from L103 coil on DC/DC board. So we short the coil,  
and checked the signal wave, we conclude that there are no problem.

1. Open the Back cover of the monitor, and find the L103 coil on the DC/DC Converter board.
