SERVICE

Product: LCD Monitor Bulletin No.: 02-C/M-E0094

Model: GD15*/GD17* Bulletin Date: 07.Nov,2002

SUBJECT: EEPROM deleted when monitor turn off, on without signal

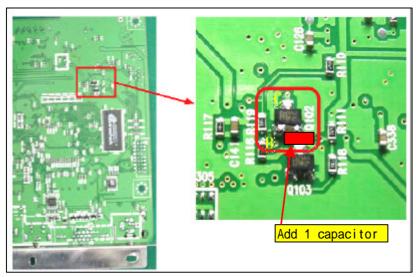
Add I capacitor on the bottom side of main board

-. Communication error when monitor turned off with no signal condition.("Check Signal")

Bottom side of main board Add I uF capacitor between B and E of Q102 Be careful not to short B and E
