SERVICE BULLETIN

Bulletin No. : 02-C/M-E0061

Model : GH15 LCD monitor.

SUBJECT : SIDE GASKET POSITION CHANGE.

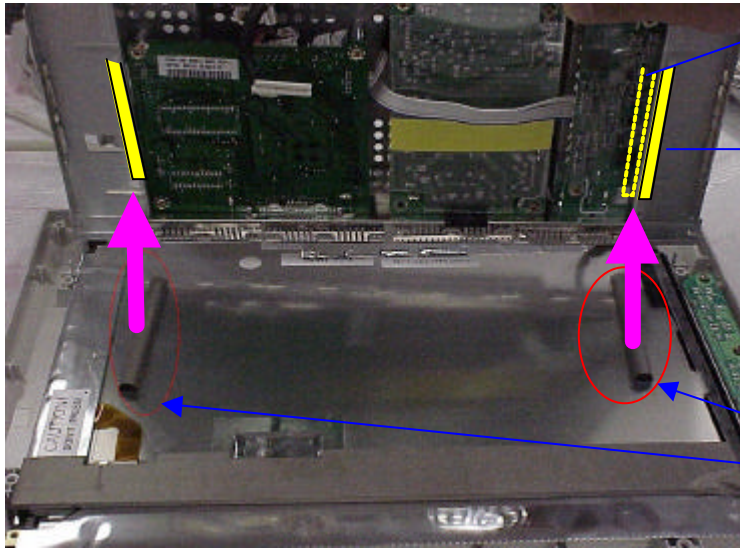
If this gasket attached wrongly, it may touch with main PCB and cause some problem.

such as OSD broken or Full white display, No raster, menu function does not operate etc...

Poor position
Touch with PBA => Cause Problem

Solution Open back cover and remove cables and metal braket.

and check gasket position, if gasket touch with main board then, remove 2 gaskets and attach on metal braket. Check again wheter symptom disappeared.

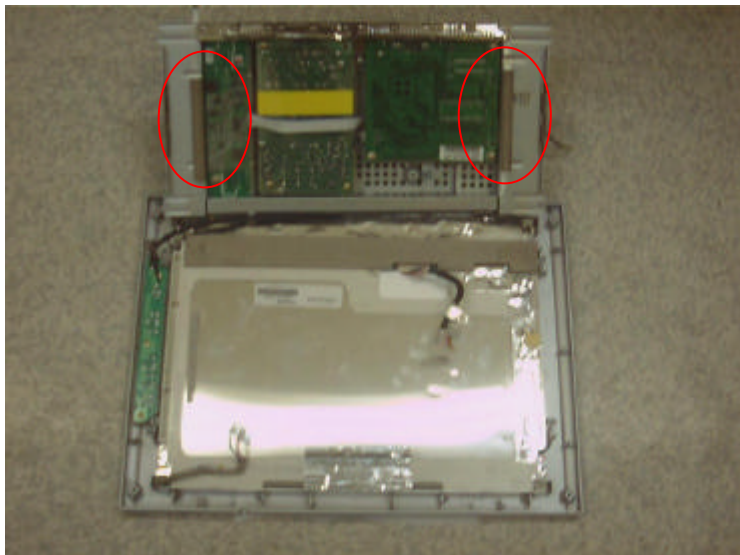
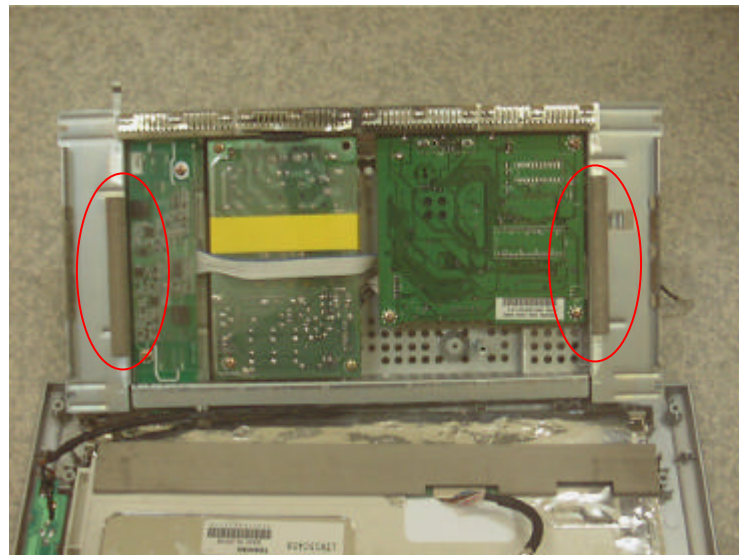
Samsung changed gasket attaching point from LCD panel to metal braket to prevent this problem.

Original Contact point

Gasket
