MODELS	56FW53H	59ESD7H	66FW53H	66FW54H
	66ESD7H	76FW53H	76FW54H	28HW53H
	66GF63H	66GF64H	76GF64H

Reference JR29042003-3
Revision 2

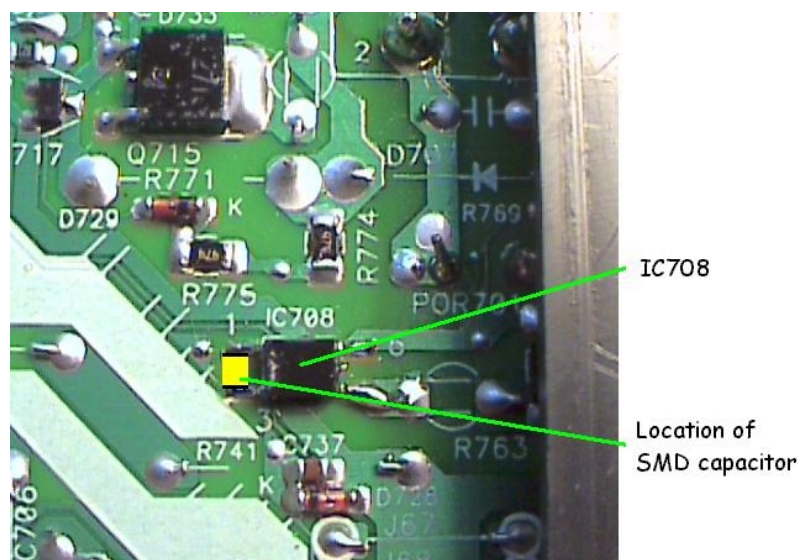
Erratic remote control operation has been traced to a number of components in the power supply. Normally the faults encountered are no remote control operation or intermittent control of the volume, either increasing dramatically or rising slowly with the OSD visible. D729 can cause these problems, but it is more common for noise to enter IC702 and spurious remote control commands to be outputted to the microprocessor. To prevent this happening fit a 470nF, 16V SMD capacitor across the input of the optical diac – pins 1 and 3 of IC708 (see picture below). The Sharp part number for this capacitor is VCKYTV1CF474Z. This capacitor was fitted during production of all GF and HW models.

Location of SMD Capacitor on IC708

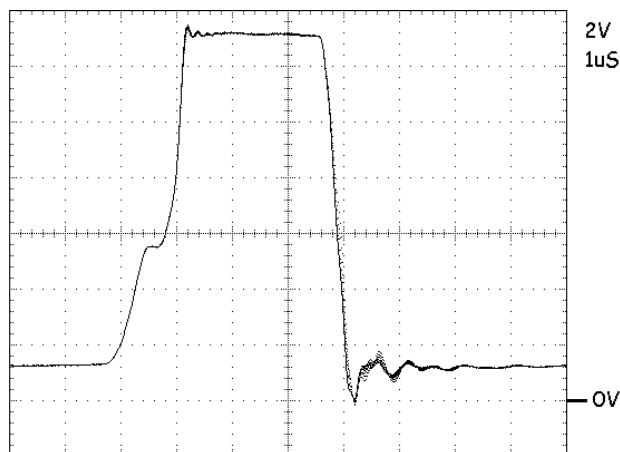
Q701 Gate Waveform and IC702 Voltage Table

Note that the above waveform has been taken on the primary side of the power supply. It is therefore essential that an isolation transformer be used in conjunction with the set. This will ensure safe connection to the primary side reference. This waveform will also change in pulse width depending upon the load demanded from the power supply. The greater the load the longer the on time. The FET will switch on at about 4.5V, this is indicated as a short levelling off period on the upward ramp.
