<b>MODELS</b>	<b>56FW53H</b>	<b>66FW53H</b>	<b>66FW54H</b>	<b>76FW53H</b>
	<b>76FW54H</b>	<b>59ESD7H</b>	<b>66ESD7H</b>	<b>66GF63H</b>
	<b>76GF63H</b>	<b>76GF64H</b>	<b>28HW53H</b>	<b>32HW53H</b>

### Faults in the East/West Circuit

Reference AVW 06062003 - 1  
Revision 1

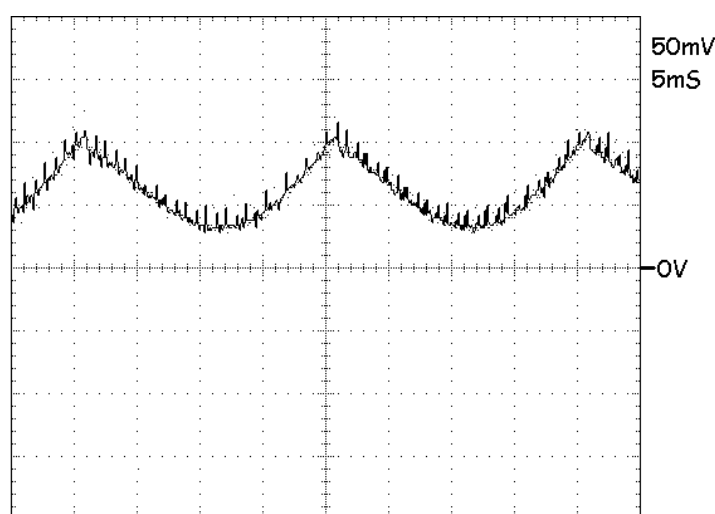
When fault finding in the east/west circuit, it is important to ascertain in which part of the circuit the fault lies. Check the control output of IC801 – pin 32. There should be a parabola waveform on this pin at a base frequency of 50Hz. It will change wave shape depending upon the amount of correction applied, so it is important to enter the service mode and ensure that none of the adjustments are at minimum or maximum.

If this waveform is present, and changes as adjustments are made, then the fault will lie in the drive or output circuitry. Faults in this area include:

1. R519 going high or open circuit – it is a 100k $\Omega$  connected to the 150V supply.
2. Q506 going short, open or overheating – change L603, L604, D502, D503, D504, D516 and C528.
3. D603 and D604 going open or short-circuit.
4. Dry joint on C601 and/or C610.

If the waveform is not present, or is severely distorted, or the adjustment range is poor, then the fault could be caused by the memory IC – IC1003 or the VDP - IC801. It is recommended that if this is the case, then the NVM is blanked or reflashed first. If this does not cure the problem, then it is probable that IC801 is at fault.

Sometimes it will not be possible to set the geometry correctly in all modes after blanking the NVM. In this case it will be necessary to ensure that the EPROM (IC1002) is correct (see CTV2001 05 04). When the correct EPROM is fitted, the NVM will have to be blanked to enable the correct information to be downloaded into it. Replacement EPROM's have been produced so that minimal geometry adjustments are required. If the picture geometry is very poor after following the above procedure, the fault will be elsewhere in the east/west circuitry.
