TELEVISION TECHNICAL BULLETIN

MODELS	56FW53H	66FW53H	76FW53H	66FW54H
	76FW54H	28HW53H	66GF63H	66GF64H
	76GF64H

Horizontal Output Transistor Failure

Reference JR07012002-1

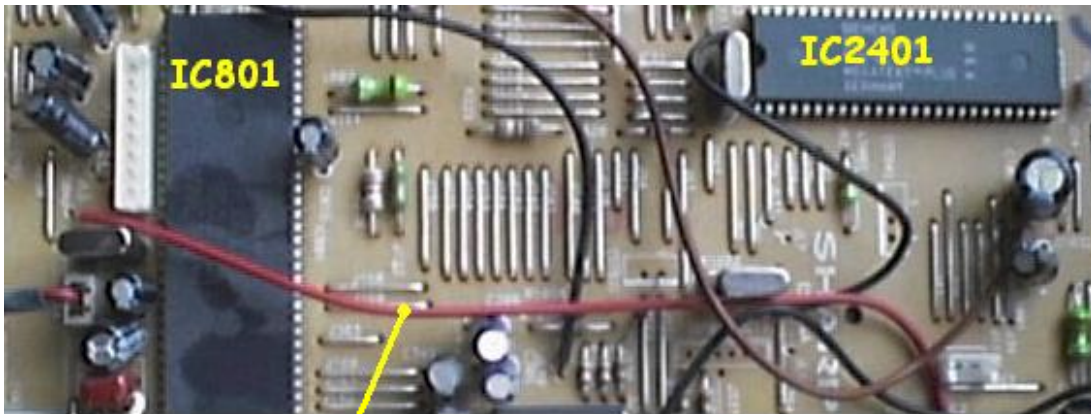
Location of Link Wire JL2

Sometimes it will appear that there is no horizontal drive signal, even though the microprocessor has gone through the boot sequence. In this situation, it is possible to release the horizontal mute to enable the horizontal stage to start. There are a number of ways that this can be achieved, one is to short out the base/emitter junction of Q607, and the other is to temporarily isolate link JL2. If this link is removed, it is vital that it is replaced after completing the repair as failure to do so will result in premature failure of the line stage.

This is JL2. It connects pin 57 of IC1001 (HOUT) to the base of Q607. If the wire is removed, line drive will always be present to the output transistor
