TELEVISION TECHNICAL BULLETIN

<u>MODELS</u>	51CS03H	59CS03H	66CS03H
	51CS05H	59CS05H

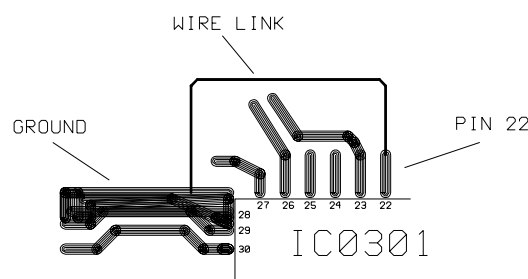
SYMPTOM When used in a hot environment a bleeping sound may be heard from the speakers or there is intermittent sound loss.

CAUSE Pin 22 of IC301 floating.

Location of wire link on component side of PWB

ACTION Insert wire link between pin 22 of IC301 and ground as indicated in the diagram below.

To make the insertion of this link easier remove X301, fit wire, then replace X301.
