## TELEVISION TECHNICAL BULLETIN

**MODELS**      66FW53H                      66FW54H                      76FW53H                      76FW54H

Reference UK003400X

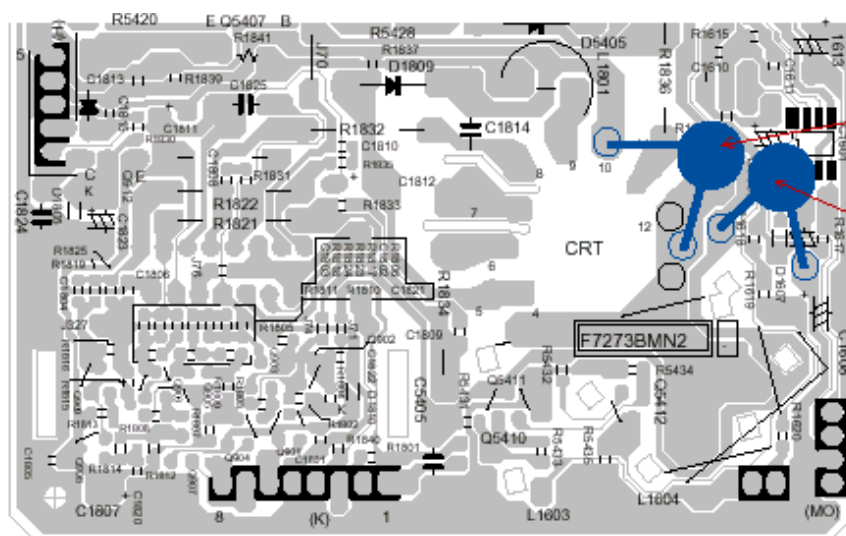
**SYMPTOM**    NVM corruption.

**CAUSE**        Arcing can occur on the CRT base panel (PWB-B) caused by CRT discharges.

**C1827: Pin 10&12  
CRT Socket.**

**C1826: Q5405 &  
Q5411 collectors  
track.**

**ACTION**        Add capacitors C1826 and C1827 as shown in the picture below.
