## TELEVISION TECHNICAL BULLETIN

<b><u>MODELS</u></b>	<b>56FW53H</b>	<b>66FW53H</b>	<b>66FW54H</b>	<b>76FW53H</b>
	<b>76FW54H</b>	<b>59ESD7H</b>	<b>66ESD7H</b>

### Faults experienced on the DA100 (50Hz) Chassis

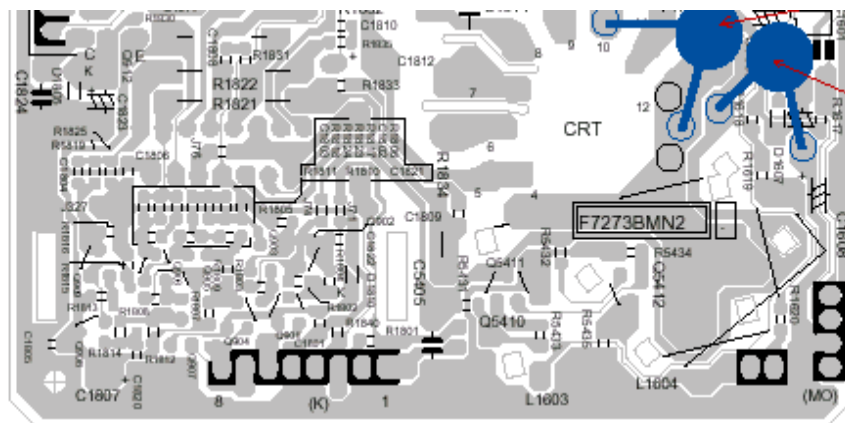
**SYMPTOM** NVM corruption.

**CAUSE** Arcing can occur on the CRT base panel (PWB-B) caused by CRT discharges.

**CRT Socket.**

**C1826: Q5405 & Q5411 collectors track.**

**ACTION** Add capacitors C1826 and C1827 as shown in the picture below.
