MODELS DV5932H DV5935H DV5937H DV6635H

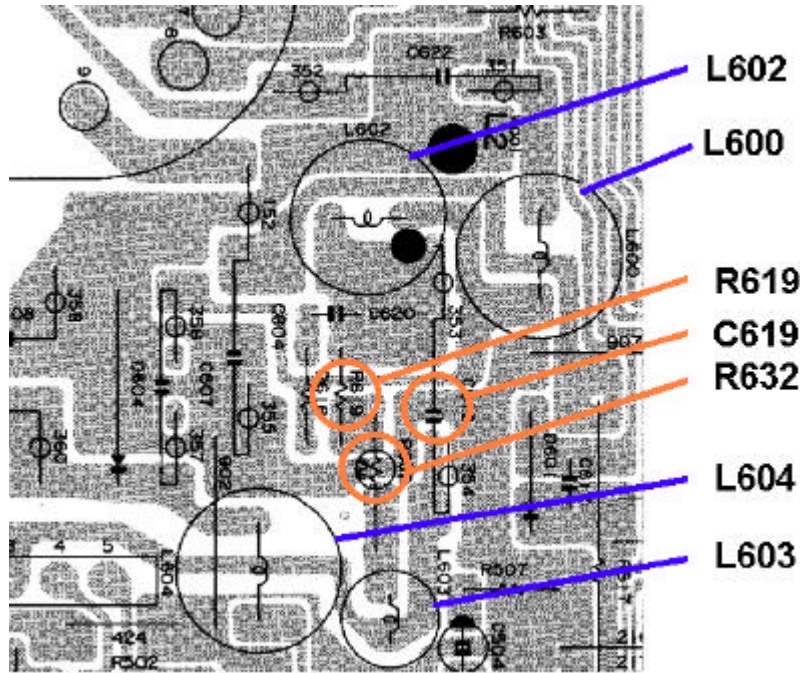
Component Locations on Mother PWB

SYMPTOM In some instances it is possible for C619 and associated line scanning coil earth return components to fail. This may result in a hole being burnt in the PWB.

CAUSE Failure of L603 and C619.
