**MODELS**      DV5932H                      DV5935H                      DV5937H                      DV6635H

**SYMPTOM**    Failure of C619.

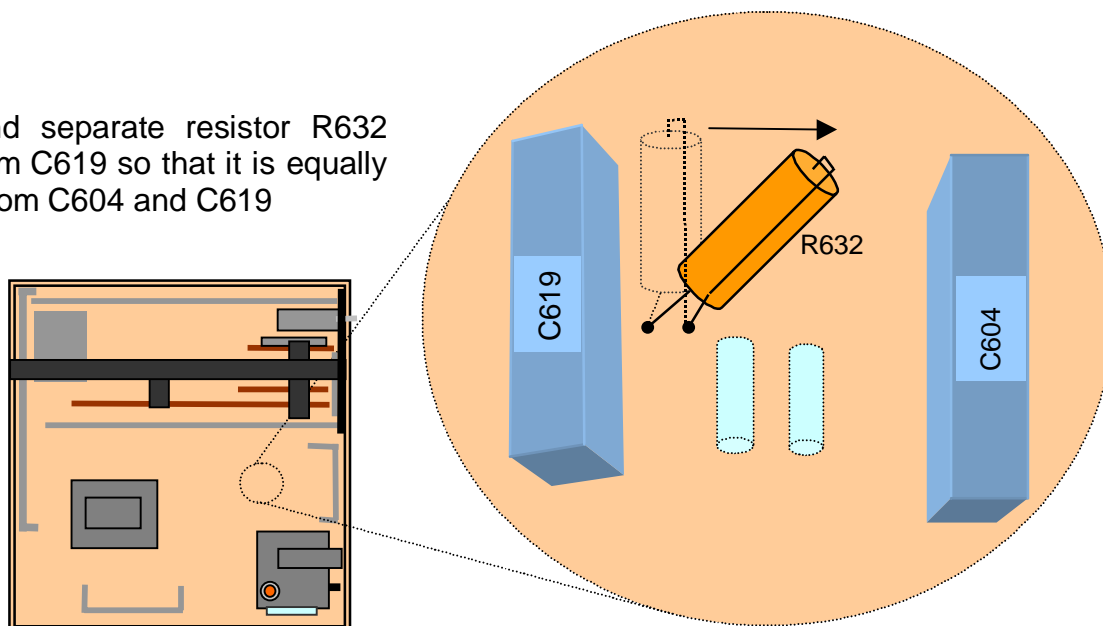
**CAUSE**        R632 mounted too close to C619.

**ACTION**        Replace C619 as necessary and move R632 as shown in the diagram below.

Bend and separate resistor R632 away from C619 so that it is equally distant from C604 and C619
