BULLETIN NO.: 08 - 80

SUBJECT: CR-2020

BULLETIN NO.: 07-81

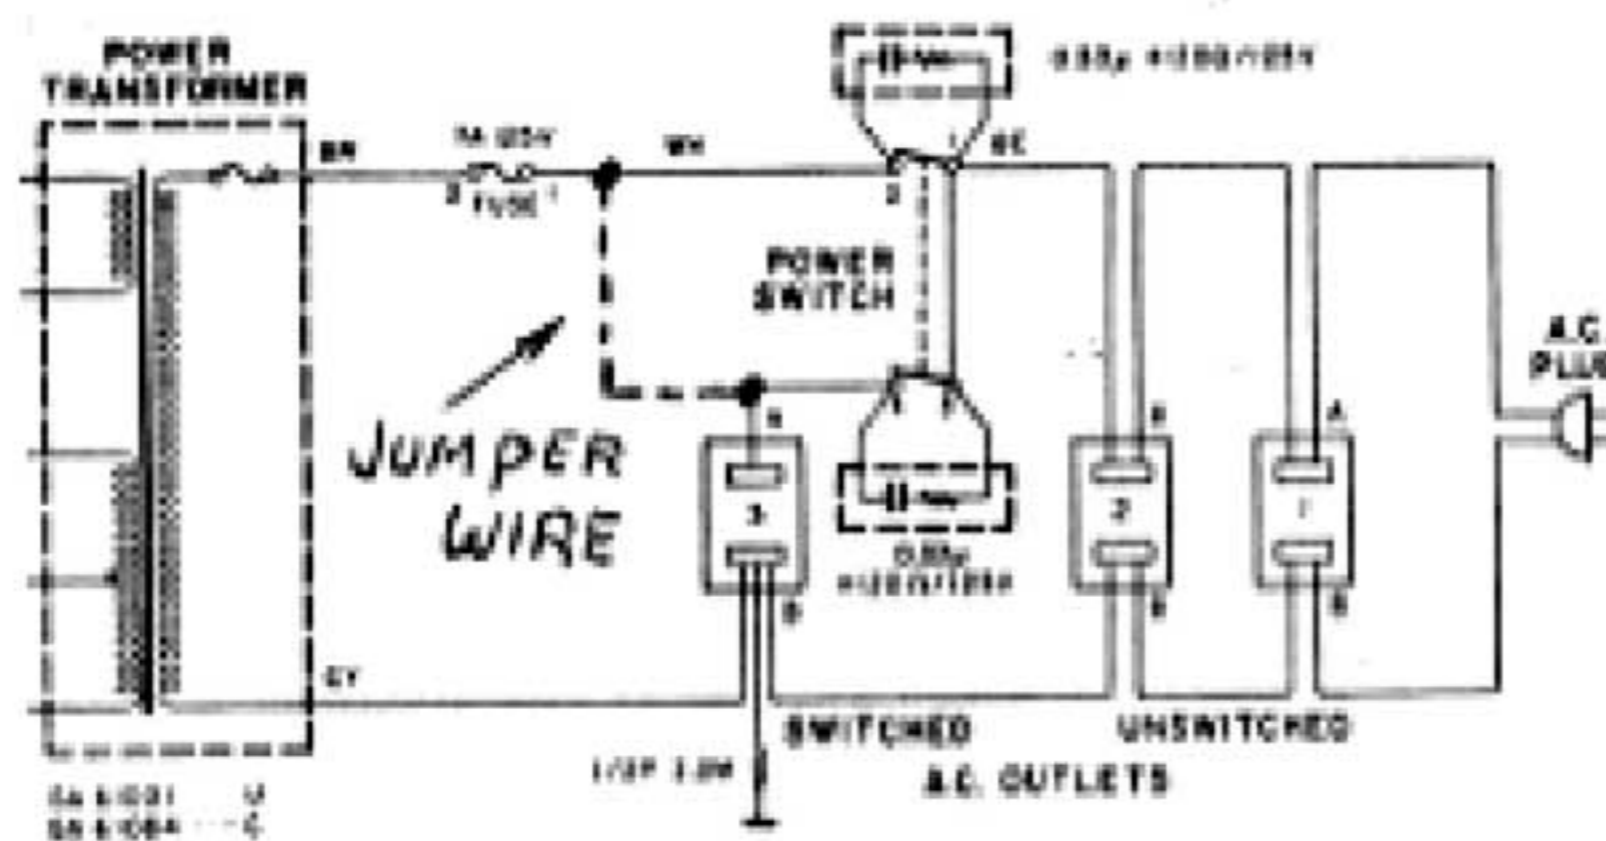
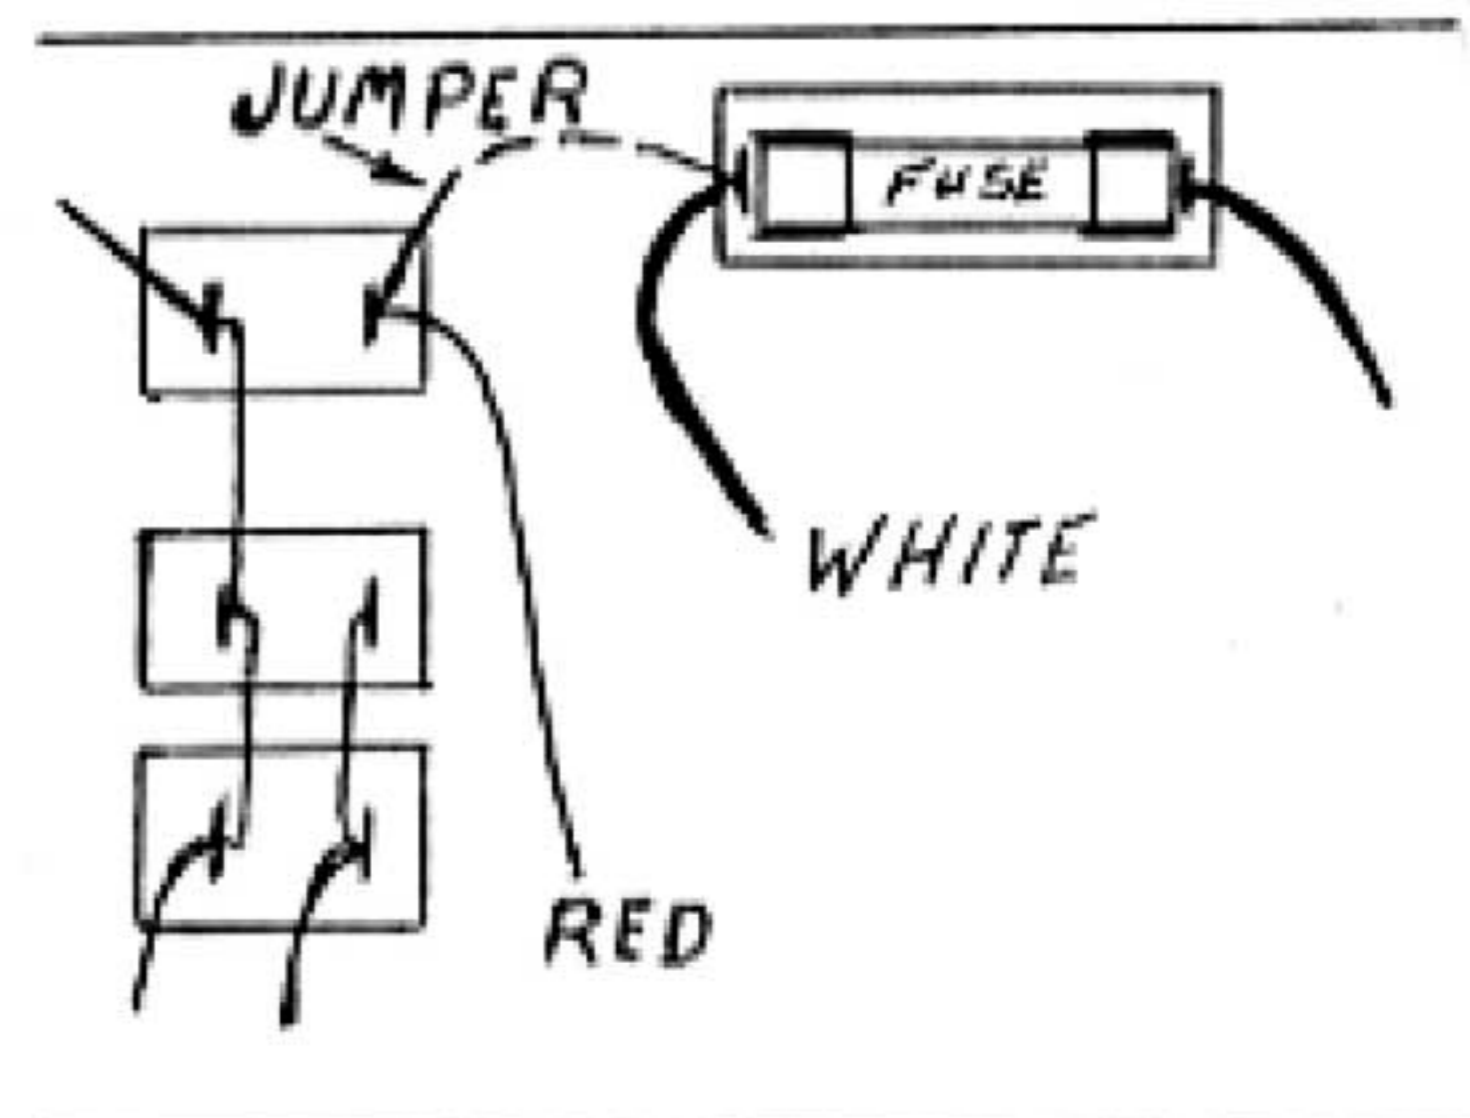
Problem: Power switch failure.

Cause: Pitting and burning of switch contact due to high current spike when set is switched off. (Back E.M.F. from power transformer).

Remedy: Replace power on/off switch (KA200630).  
Install a jumper wire between the fuse holder (white wire) and the switched AC outlet (red wire).

Install the jumper wire on all units received for service that have not been modified.

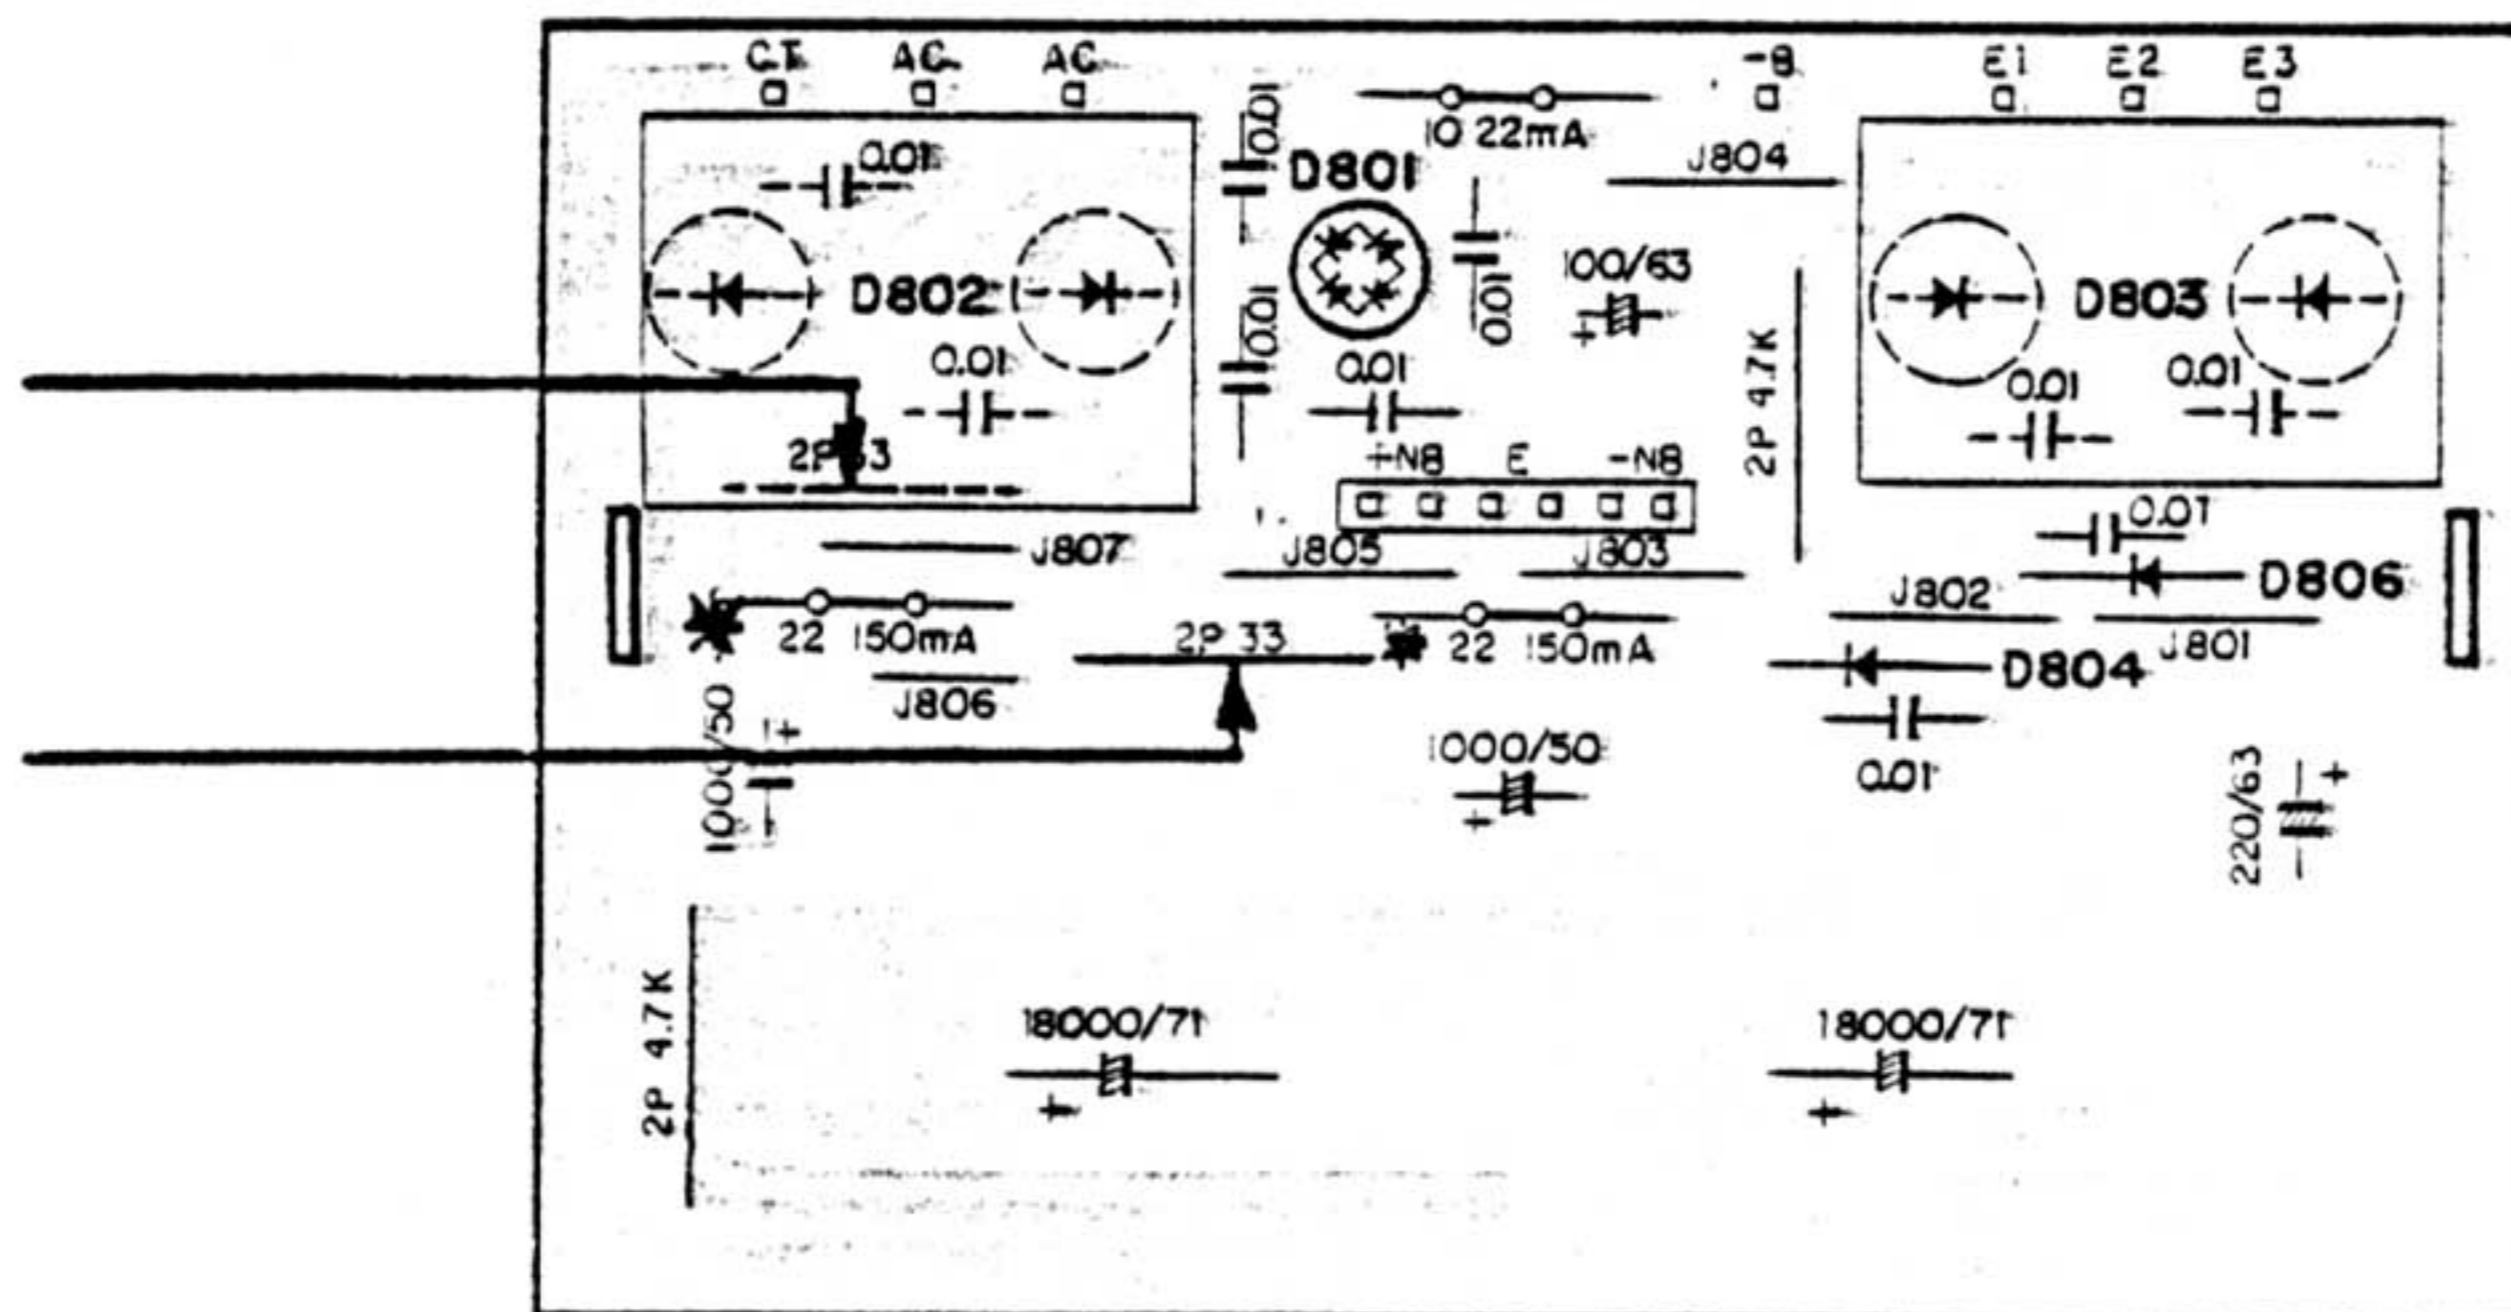
### ELECTROLYTIC CAP. C. BOARD

Problem: Intermittent power supply.  
Receiver goes on and off, speaker relay clicking.

Cause: R 801 and R 802 (33 ohm) in electrolytic capacitor circuit board get hot and unsolder themselves.

Remedy: Remove both resistors and install new 33 ohm, 3 $\frac{1}{4}$  watt wire wound resistors.

Mount the resistors approximately  $\frac{1}{4}$  inch away from the circuit board.

We suggest to use Ohmite #4374. These resistors are available from Yamaha Canada Music, Parts Department.

\* Also replace the 22 ohm 150 mA fuse resistors with Ohmite #4369 22 ohm 3 $\frac{1}{4}$  watt resistors.
