S55/S56/S57 (Bluetooth)

Level 2.5

Repair Documentation

V 1.0

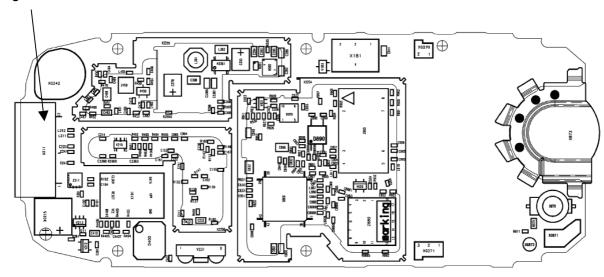
Figure 1: S55/S56/S57 board I/O connector

- Charging problems.
- Problems with external loudspeaker or microphone when using a car kit.
- Problems with accessories connected at the I/O connector.
- Problems with SW booting

Visually check the bottom connector. Watch for dry joints:

Use hot air blower remove defective I/O connector. Avoid excessive heat! Watch surrounding components!

Resolder new I/O connector afterwards.

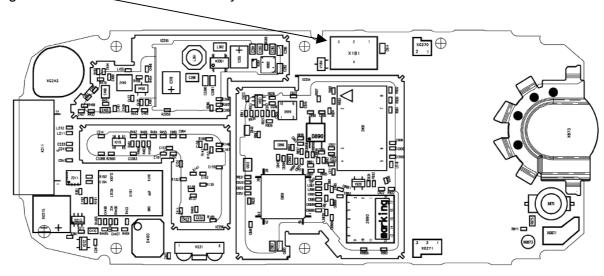
Figure 1: S55/S56/S57 board Battery connector

Visually check the status of the Battery connector. Watch for oxidation and dry solder joints.

Use hot air blower remove defective Battery connector. Avoid excessive heat!
Watch surrounding components!

Resolder new Battery connector afterwards.

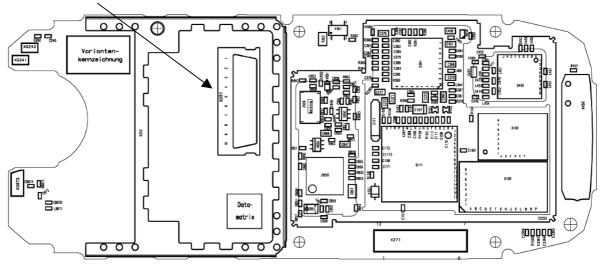
Figure 1: S55/S56/S57 board Display connector

4.1 Affected U	nits			
4.1.1 Type:		S55/S56/S57		
4.1.2 Affected II	MEIs / Date Codes:	All / All		
4.1.3 Affected S	SW Versions:	All		
4.2 Fault Desc	ription			
4.2.1 Fault Sym	ptoms for customers:			
Display problems, lil	ke missing lines or columns or	n the LCD or display contrast problems.		
4.2.2 Fault Sym Display tests failed.	4.2.2 Fault Symptoms on GSM Tester:			
Display tests lalled.				
4.3 Priority:				
	Mandatory			
$\overline{\checkmark}$	Repair			
	Optional			
	Not Yet Defined

Visually check the status of the Display connector. Watch for oxidation

Use hot air blower remove defective Display connector. Avoid excessive heat!
Watch surrounding components!

Resolder new Display connector afterwards.

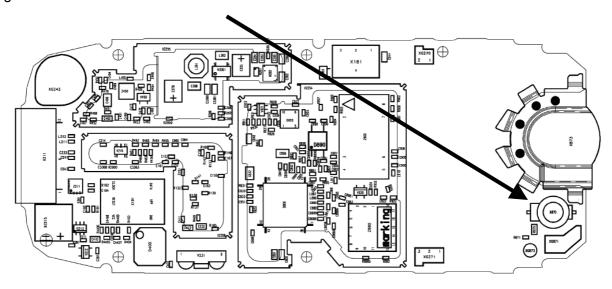
Figure 1: S55/S56/S57 board Antenna connector

Output power problems on the external and internal antenna No location update possible

The Antenna Connector is a mechanical switch operated by the RF plug of a car kit. Normally the RF signal goes to and comes from the internal antenna. Whenever an RF plug is plugged into the antenna connector the connection to the internal antenna is opened and the connection to the external antenna socket is made. When the antenna connector is blocked without RF plug the connection to the internal antenna is also opened. See drawing below.

5.3 Pr	iority:
	Mandatory
$\overline{\checkmark}$	Repair
	Optional
	Not Yet Defined
5.4 Re	epair Documentation:
5.4.1 D	escription of procedure:
5.4.1.1	Diagnosis:
	e output power of the handset with the LSO test program. Especially watch the antenna power!
5.4.1.2	Repair by component change:
Avoid exc	air to remove defective antenna connector. cessive heat! urrounding components!!
Resolder	new module afterwards
5.4.1.3	Repair by Software booting:
Not poss	ible!
5.4.1.4	Test:
Retest ha	andset after repair.

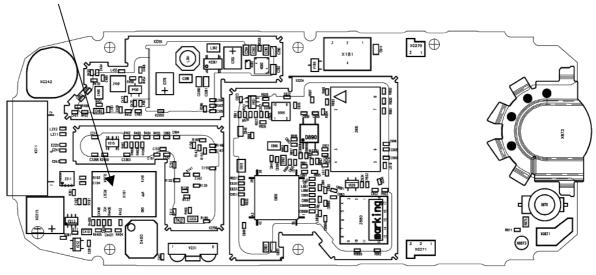
Figure 1: S55/S56/S57 board Card Reader site

Visually check the Card Reader. Watch for dry joints:

Use soldering iron to remove defective component. Avoid excessive heat! Watch surrounding components!

Resolder new Card Reader afterwards.

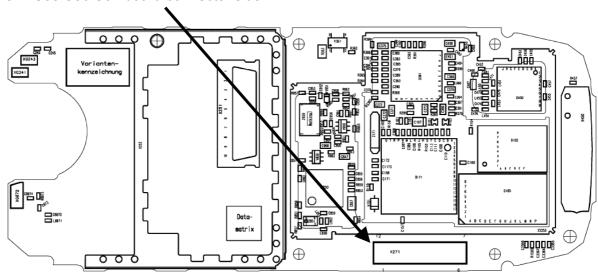
Figure 1: S55/S56/S57 board connector side

Visually check the status of the board connector. Watch for oxidation and dry solder joints.

Use soldering iron to remove defective diode. Avoid excessive heat! Watch surrounding components!!

Resolder new connector afterwards.

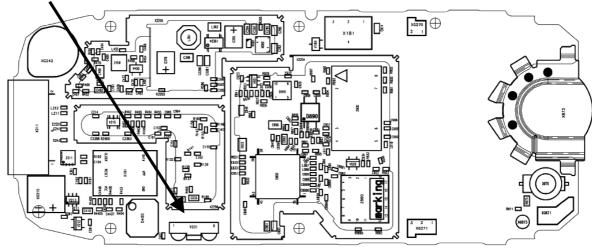
Figure 1: S55/S56/S57 IRDA side

8.1 Affected Ur	nits				
8.1.1 Type:		S55/S56/S57			
8.1.2 Affected IM	IEIs / Date Codes:	All / All			
8.1.3 Affected S	W Versions:	All			
8.2 Fault Desci	ription				
8.2.1 Fault Symp	otoms for customers:				
No infrared connection	on possible				
	B.2.2 Fault Symptoms on GSM Tester: This fault cannot be detected with a GSM Tester				
8.3 Priority:					
	Mandatory				
$\overline{\checkmark}$	Repair				
	Optional				
	Not Yet Defined

Use soldering iron to remove defective diode. Avoid excessive heat! Watch surrounding components!!

Resolder new connector afterwards.

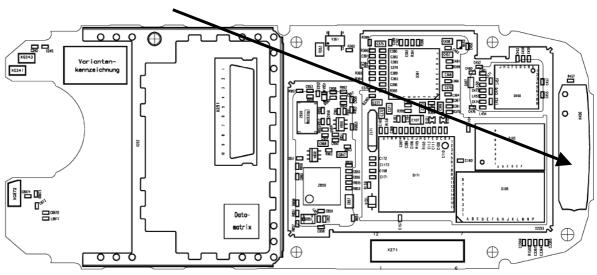
Figure 1: S55 BLUETOOTH Bluetooth antenna side

Check the output power of the handset with the Bluetooth tester. Watch the antenna power!

Use soldering iron to remove defective antenna. Avoid excessive heat! Watch surrounding components!!

Resolder new antenna afterwards.
