S/1 NEWS is published monthly by Bob Sullivan, WØYVA/4, Post Office Box 6216, Arlington, Virginia 22206. Subscription rate is \$6.00 per year. Foreign subscriptions by air are \$11.00 per year.

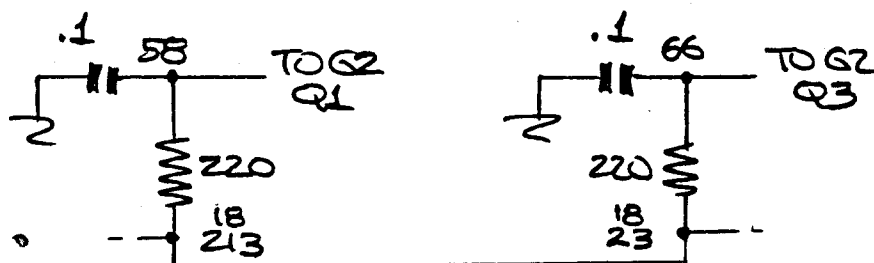
Finally Carl notes that a problem concerning motorboating on low signal levels on the 80 and 160 meter bands was traced to feedback through the AGC circuits on the front-end board, A2. This was cured by installing .1uf capacitors from pins 58 and 66 to ground (to foil on the board). The 220-ohm 1/4-watt resistors are run between the harness and these pins as shown below:
