38Hot Volt-Nuts > Solartron 7081 Repairing (continue)

Solartron 7081 Repairing (continue)

2012-01-08

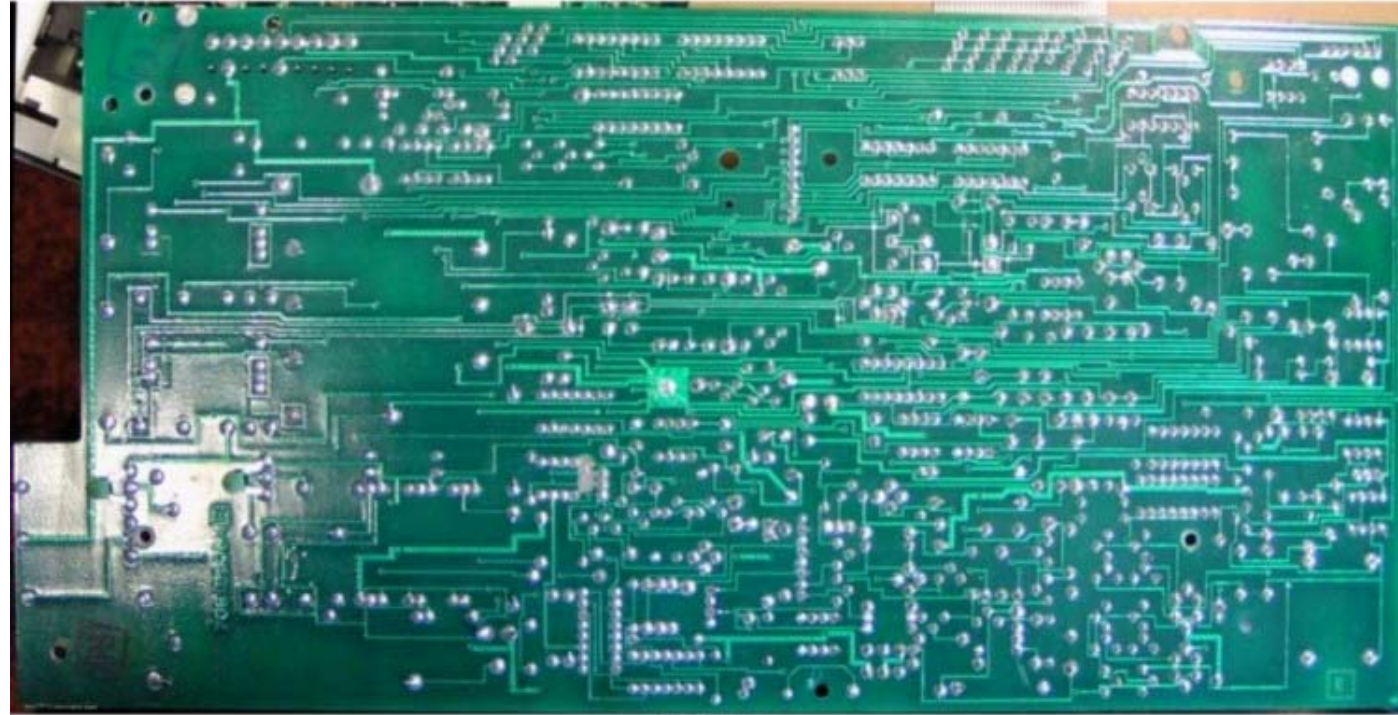
BEFORE

Three month ago I was purchase a Solartron 7081 DMM. It's one of the first model, dated Apr. 1984.
1) My tests showed a huge input bias current and suspiciously large noise. After 8 hours of heating at 25 Celsius degrees input current was 330 pA causing a zero shift in the short-circuited input – 12 uV. After checking each critical item in the input circuits (attenuator, DC ranging, input amplifier with MDM channel) and installing the PTFE bushings and insulators input bias has been reduced down to 1-2 pA!

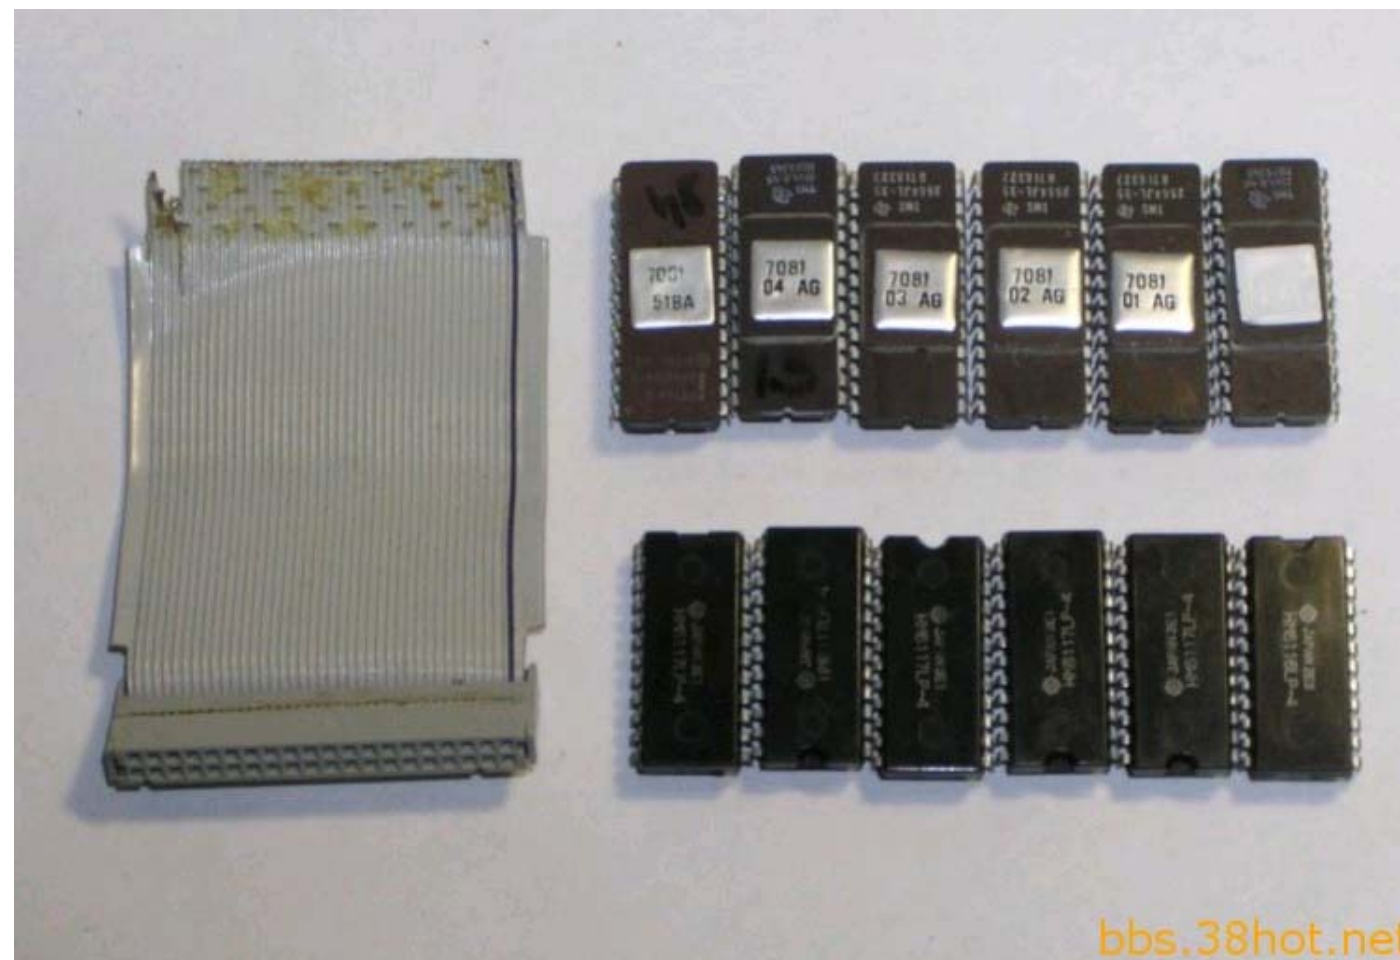
2) After six weeks my Solartron 7081 became very ill: no LED signs, no display, no life at all. I'm spent amount of time to research Earthy Logic and Processor boards, I/O and memory map, disassemble some of the early ROM procedures, emulate 7081 firmware via 6809 CPU emulator, change RAM/ROM chips decoding structure to replace the old and rare 2564 and 6117 chips and adopt PCB for new 28F010 and 6264 ones. I'm recompiling all of the 2564 ROM contents (1984 year) to the linear block and add to it recompiled ROMs content by Dave Partridge (1986 year) and flash its to the one 28F010 EEPROM. Now the DMM came to life again and I'm continue to research the ADC and analog subsystem. This is the replaced parts, including old and broken boards interconnection cable, two semi-defective RAM and ROM chips:

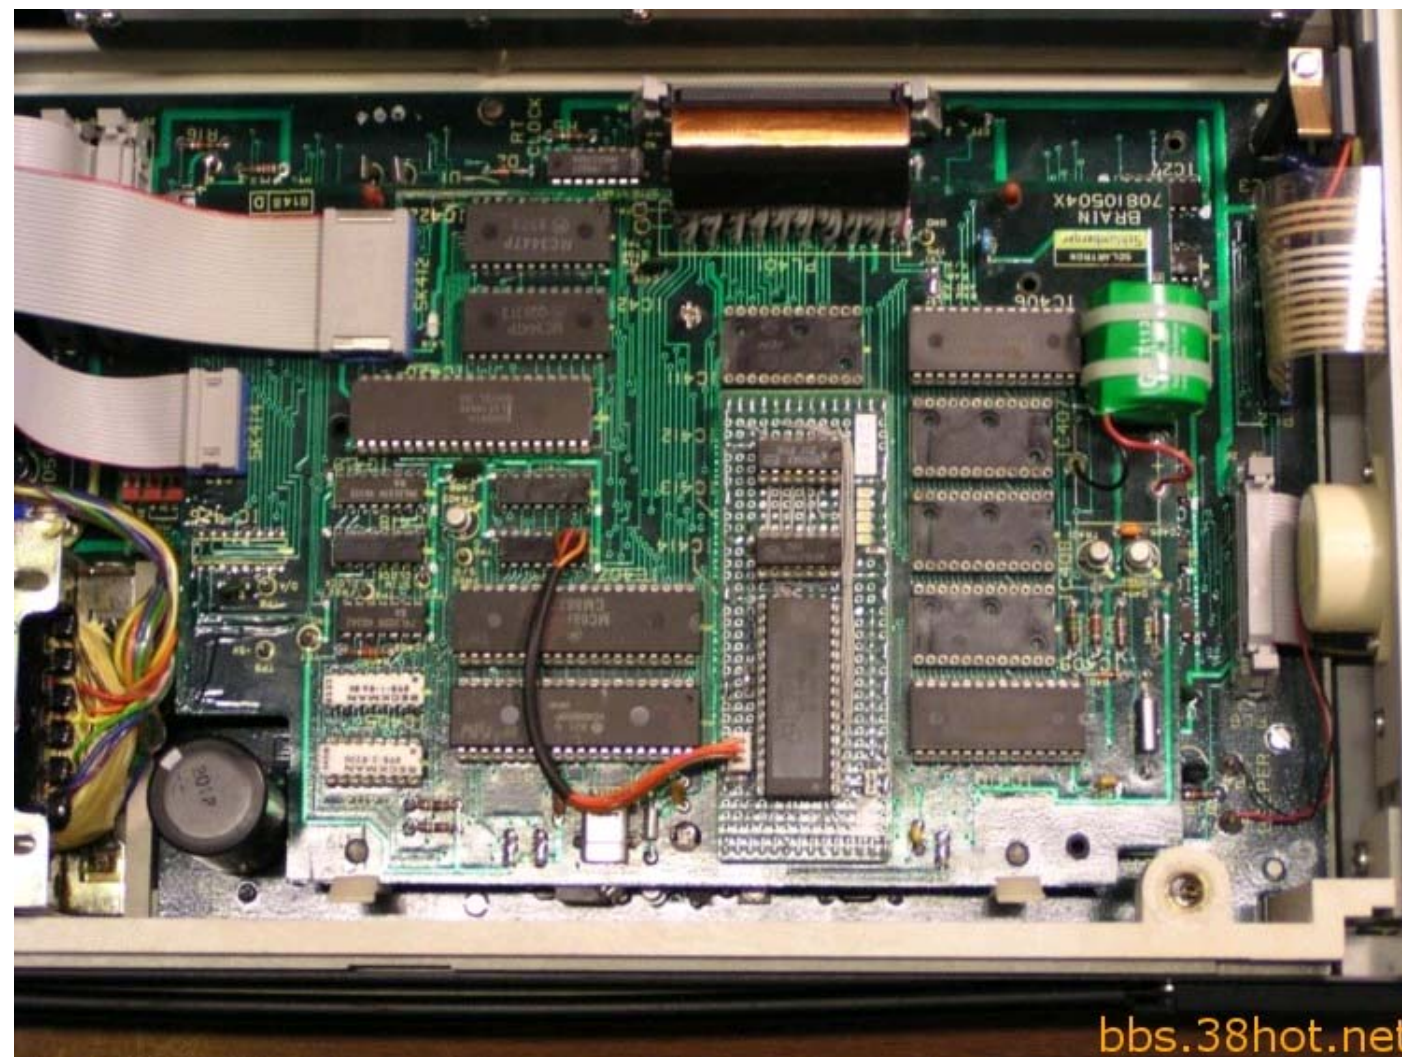
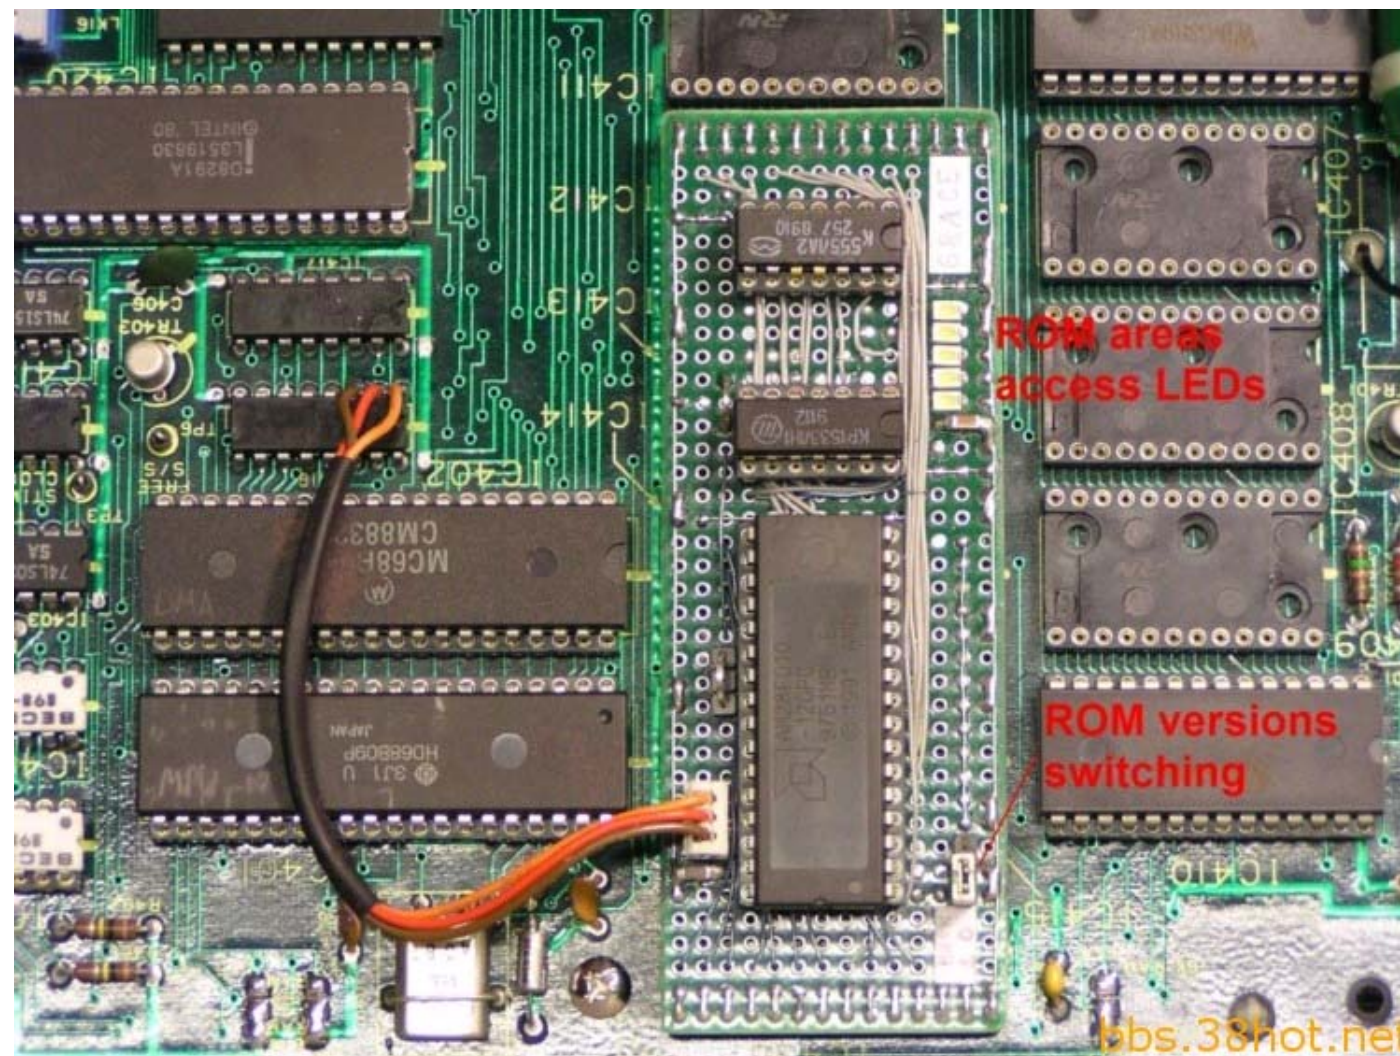
This is the new sub-PCB with two banked ROM 28F010 and address decoders:

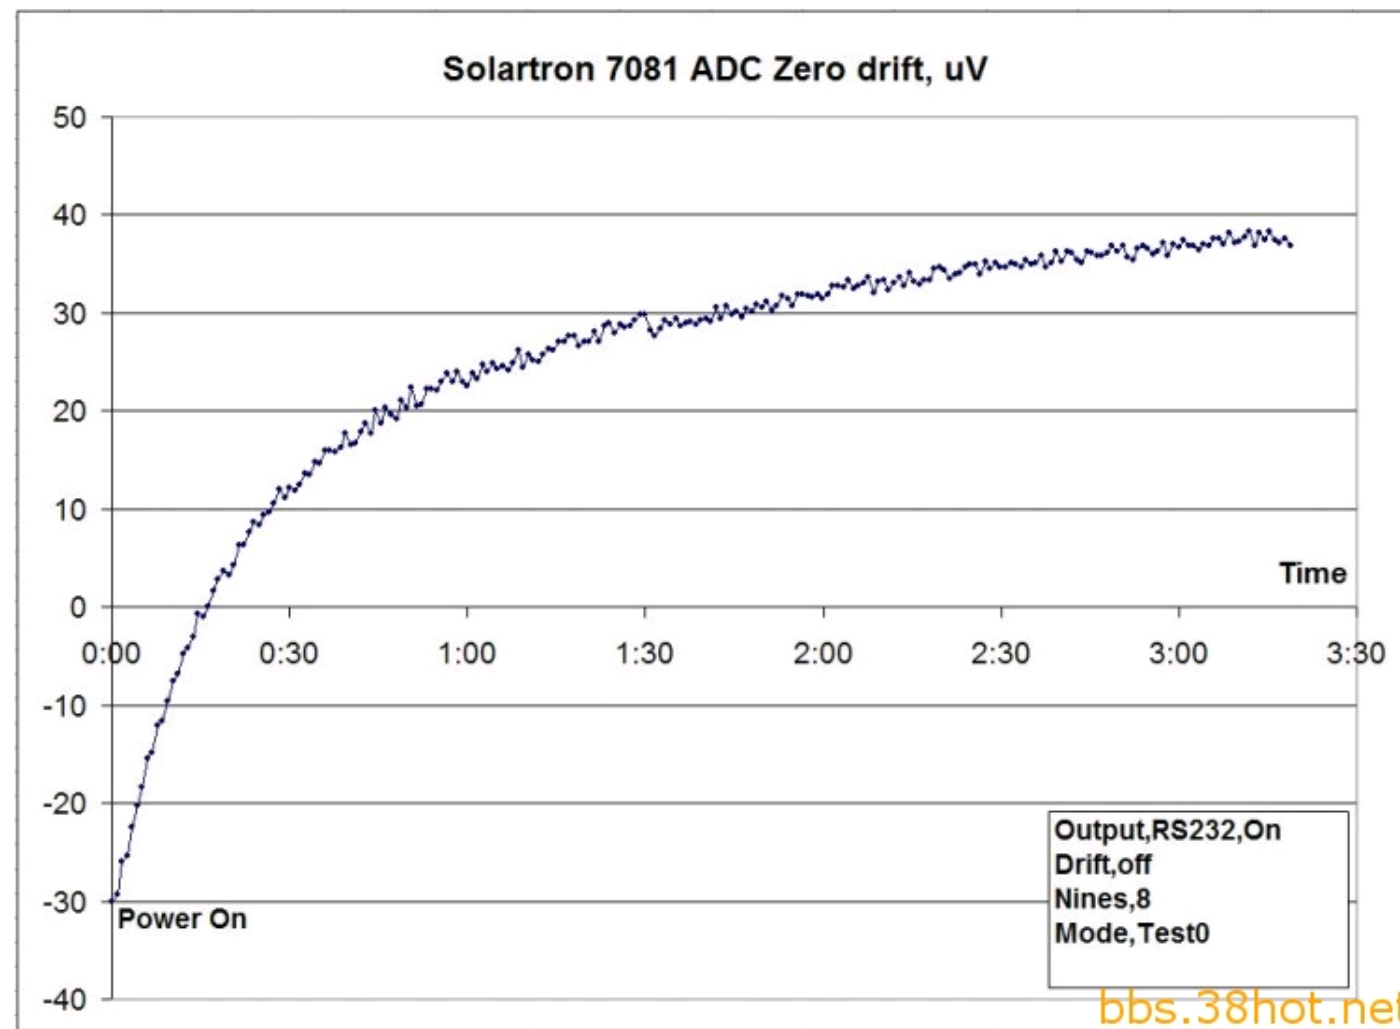
3) Next problem – extremely high ADC zero drift during 2-3 hours after the power up (up to 70 μV = 7ppm).

After the change of the integrators DC path op-amp ICL7650CPD to LTC1052CN, reference op-amps OP07EZ to selected OP97F, and after correction of the TCR of the reference divider with Cu wire the Solartron 7081 ADC zero drift was reduced to 15 uV (is equivalent to 0.1 ppm/C).

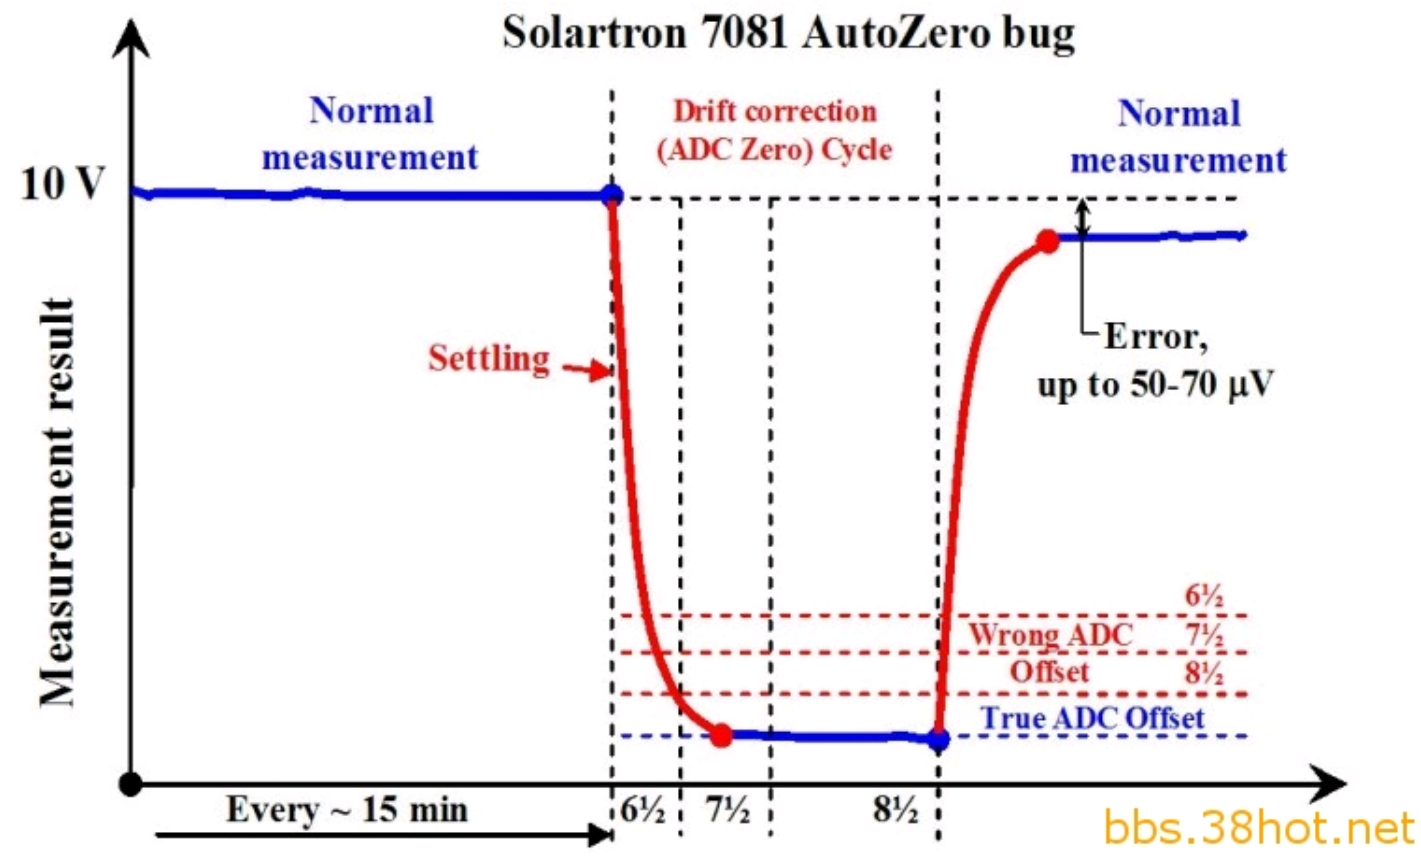
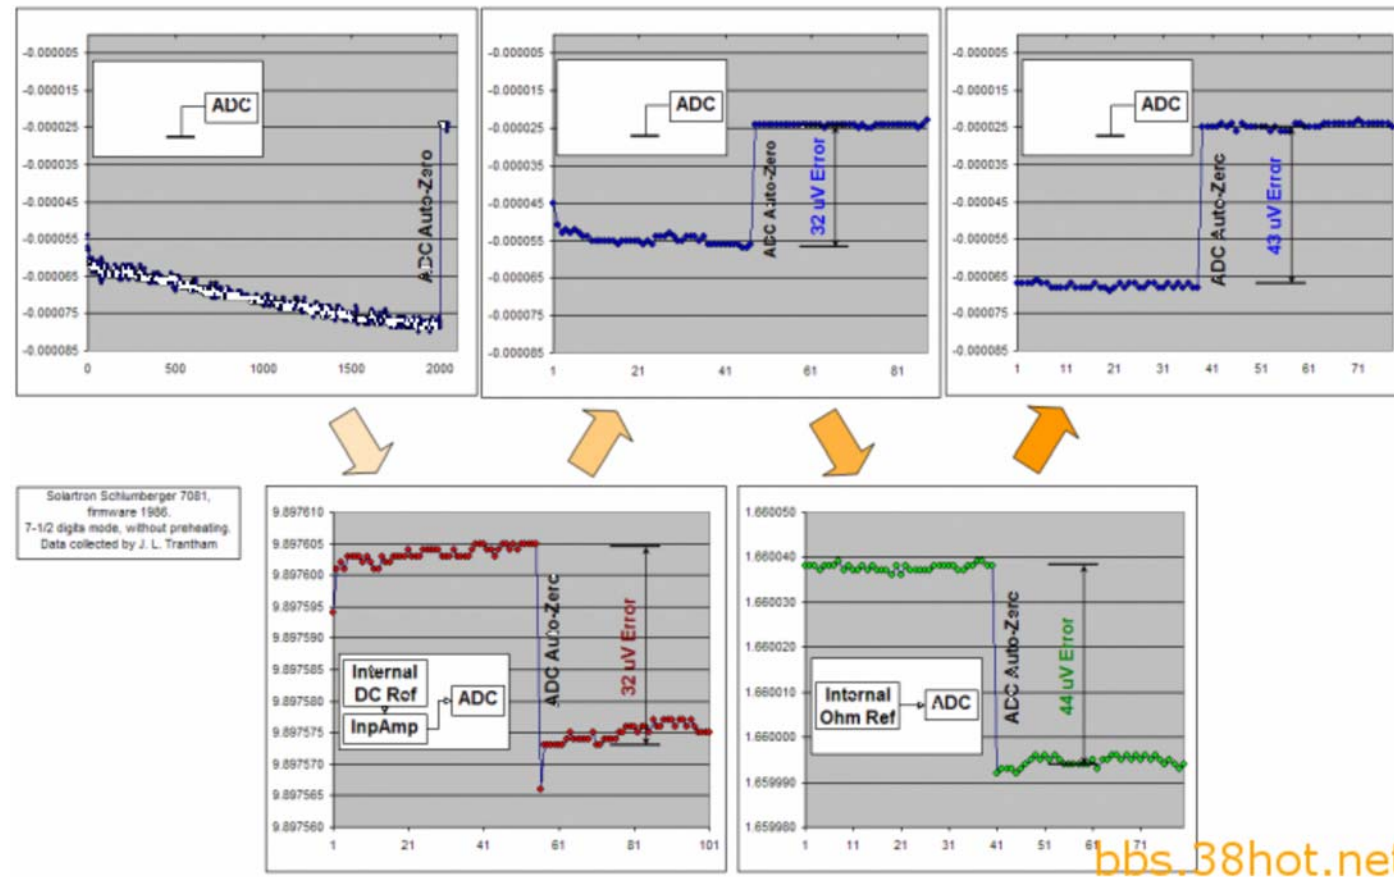
4) Finally, I've found a serious lack of the Solartron 7081 design: improper function of the periodic drift correction (ADC Zero, AutoZero), that lead to large DC voltage measurement errors (discontinuities), up to 5-7 ppm at the all ranges. The source of this problem is very simple: PWM ADC full settling time is much more than specified 13 ms. But the problem solution is hidden in the Floating Logic processor's firmware (IC803 ROM). IC803 firmware contains all of the hardware-specific delays, registers look-upables, two complicated finite-state machines, virtual software timers, software GLUGs integrator, inter-board messaging system interface, calibration NVRAM support e.t.c.

First of all I tried to build a Solartron 7081 processors IO/Memory maps and reconstruct inter-boards messaging system protocol. Then, within two weeks, I reversed the Floating Logic processor's firmware and drew one of the two Finite-State Machines. After that I wrote a patch code using the free areas at the end of the ROM space.

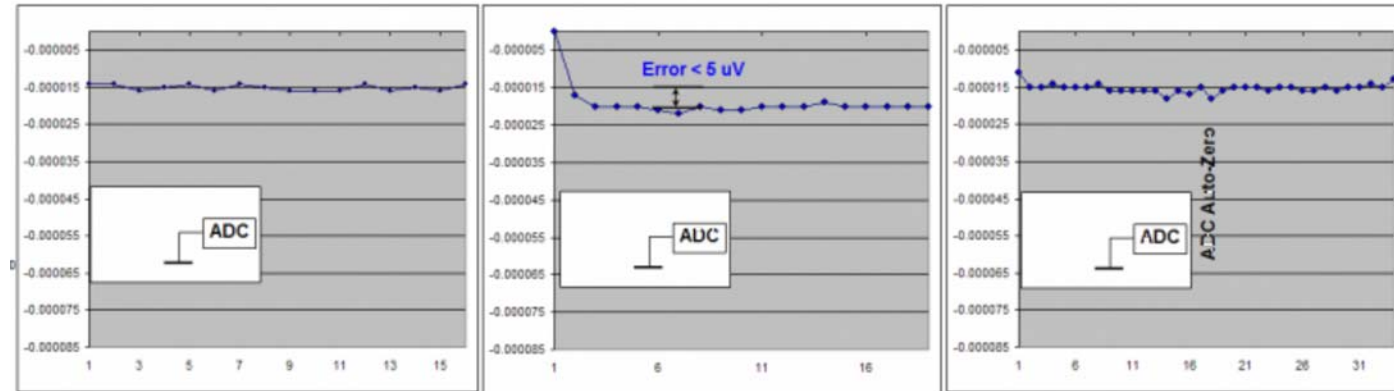
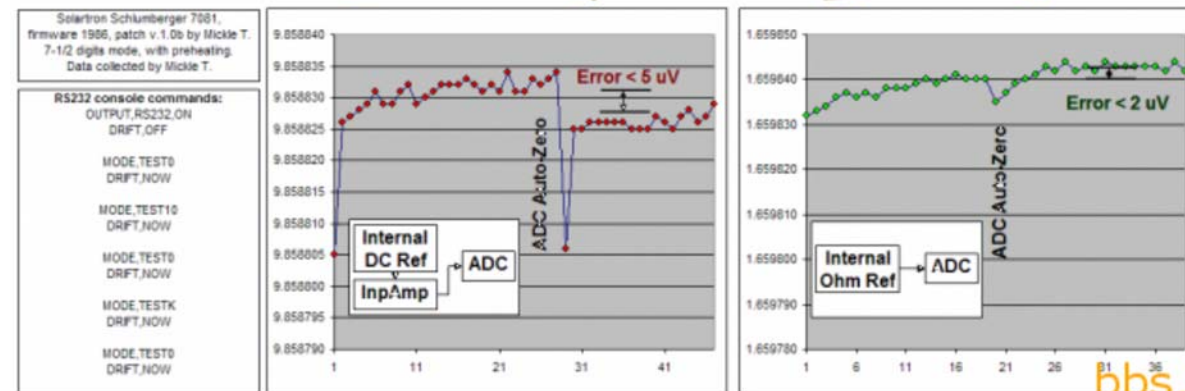
Now, the problem is solved:
