SONY® Service Bulletin

NO: CTV-98-001

SUBJECT: VERTICAL JITTER; R504 AND/OR R521 DAMAGED

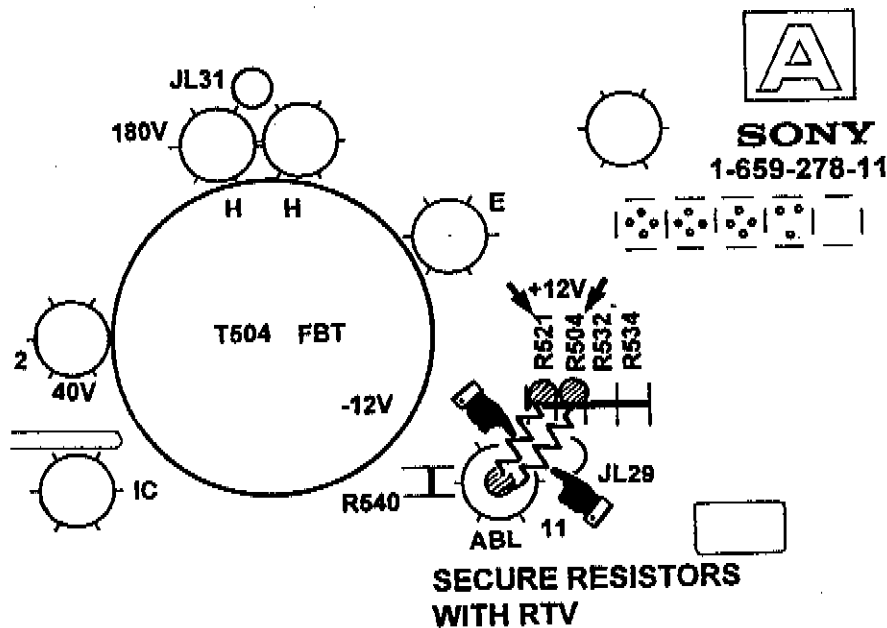
Symptom: The picture exhibits vertical jitter. This problem may occur if R504 and/or R521 are damaged.

Solution: If the above symptom is found to be caused by damaged R504 and/or R521 on the A-board, replace both resistors with the parts shown below.

REF	FORMER		NEW	
	DESCRIPTION	PART NUMBER	DESCRIPTION	PART NUMBER
R504,R521	RESISTOR, 10K, SURFACE MOUNT, 1/10W	1-216-073-00	RESISTOR, 10K, LEAD TYPE, 1/4W	1-249-429-11

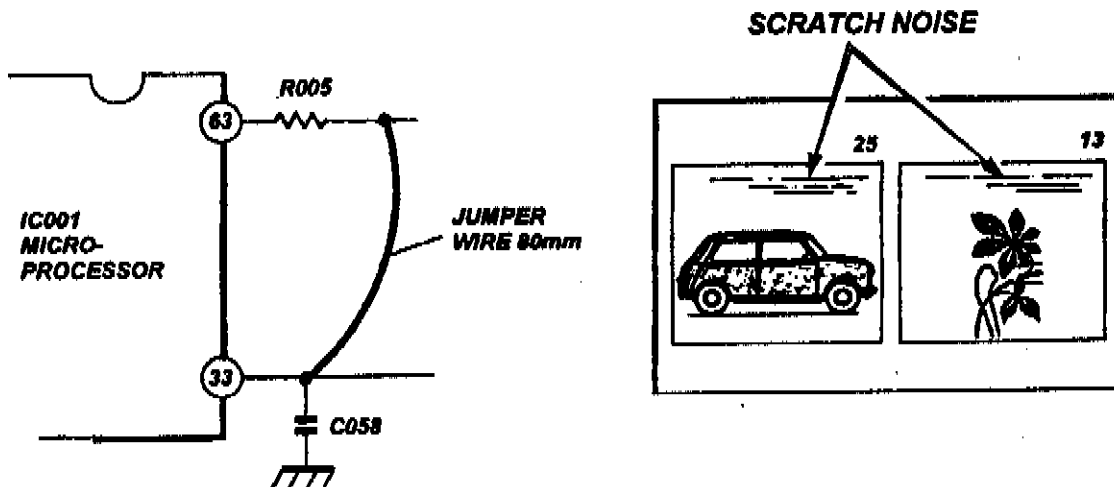
Symptom: If two different signal sources are displayed when in the PIP mode is selected, a scratch noise (lines in picture) may appear in the picture.

1. The PX board must be replaced with **PIN 1-666-471-XX**.
2. Replace the Microprocessor (-001S)CXP85856A-001S (labeled for PIP scratch Noise)
3. Modify the A board (suffix -11): connect the lands of C058 and R005 using a jumper wire (80mm)

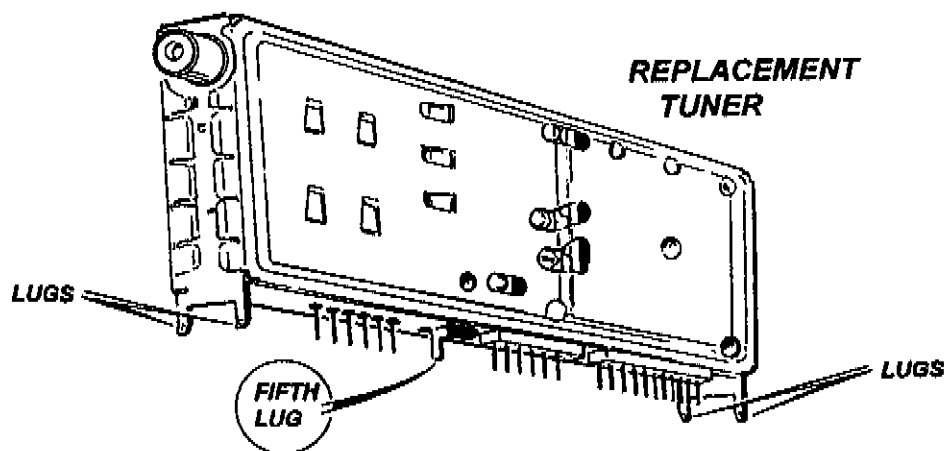
Symptom: New replacement tuner has five ground lugs compared to four on the original tuner. Board does not have a hole to accommodate the fifth lug.

Solution: When replacing the tuner with the new replacement tuner it will become necessary to remove the fifth lug, located in the middle of the tuner.

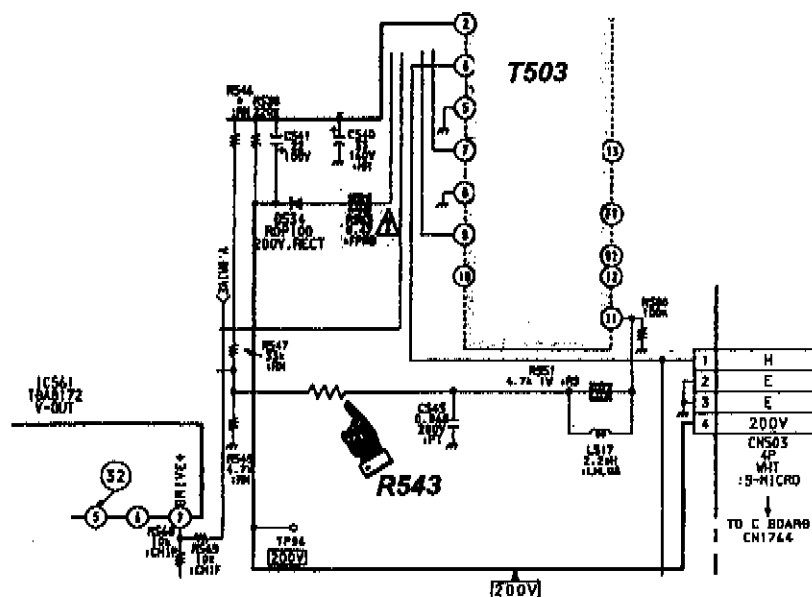
A BOARD SCHEMATIC GRID LOCATION L-20

Symptom: The part number for Ref # R543, 0.47 Ohm 1/4W, located on the A board, was not shown in the schematic or listed in the parts list.

Solution: Please add the following part number to the Service Manual.

REF	DESCRIPTION	PART NUMBER
R543	0.47 OHM 1/4W	1-249-377-11

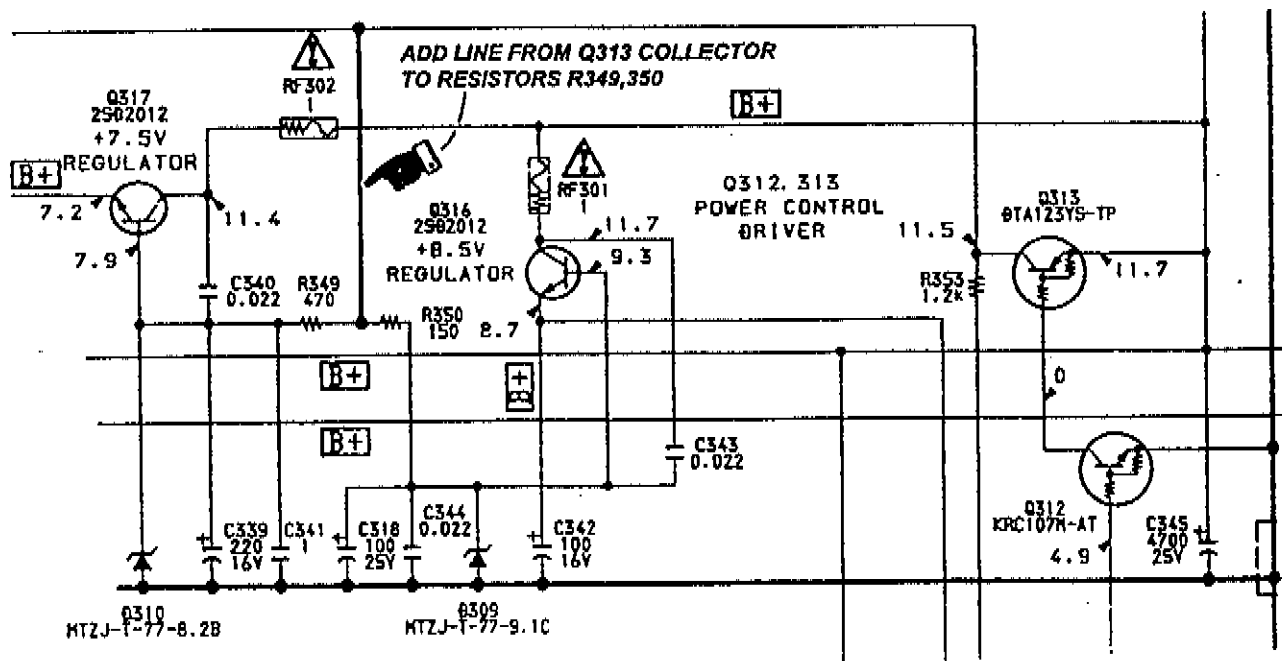
SYMPTOM: The Schematic Diagram of the main board is missing the connection between the Collector of Q313 and the resistors R349 and R350 (see page 39 sections D-15 and E-15). The Trace does show up in the physical diagram.

SOLUTION: Look at the figure below and make the necessary changes to your Manual.

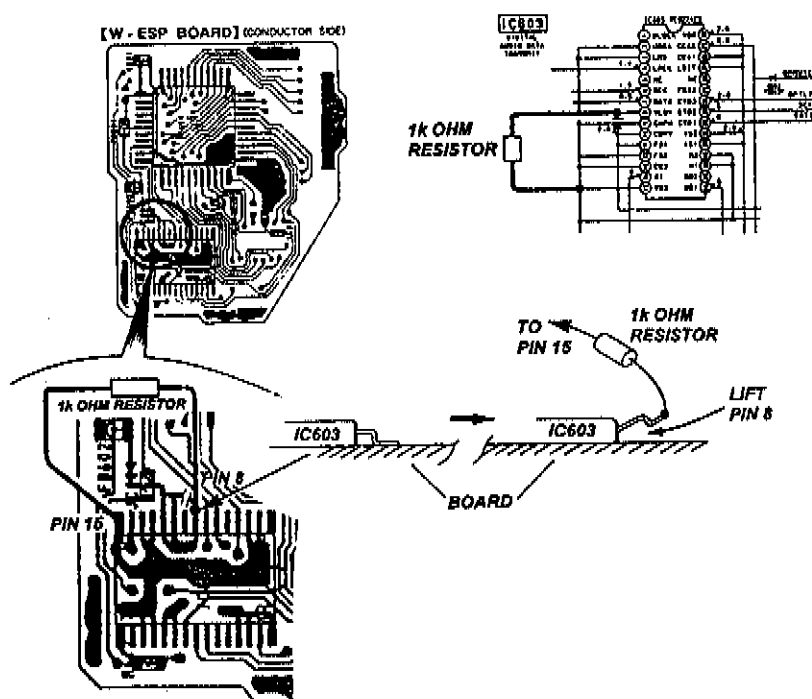
Symptom : When recording from this unit to a Mini disc of DAT player, the level meter on the record device does not respond to the input signal, and / or you are unable to monitor the recording through the record devices output (headphone or line).

Solution: Lift pin 8 of IC 603 of the W-ESP board, and place a 1 k ohm resistor between Pin 8 and Pin 15 of the IC

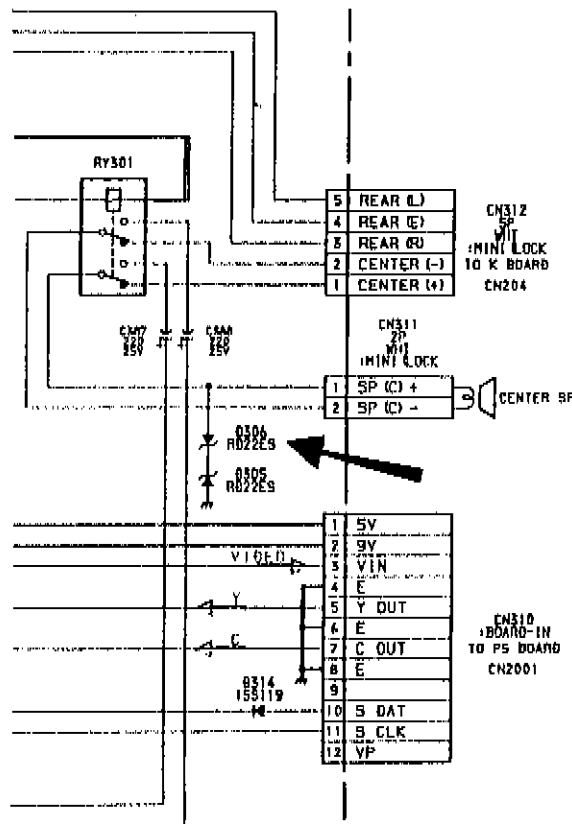
On page 53 of service manual, D304 is misprinted as D306 in the schematic diagram near the centre speaker connector CN311.

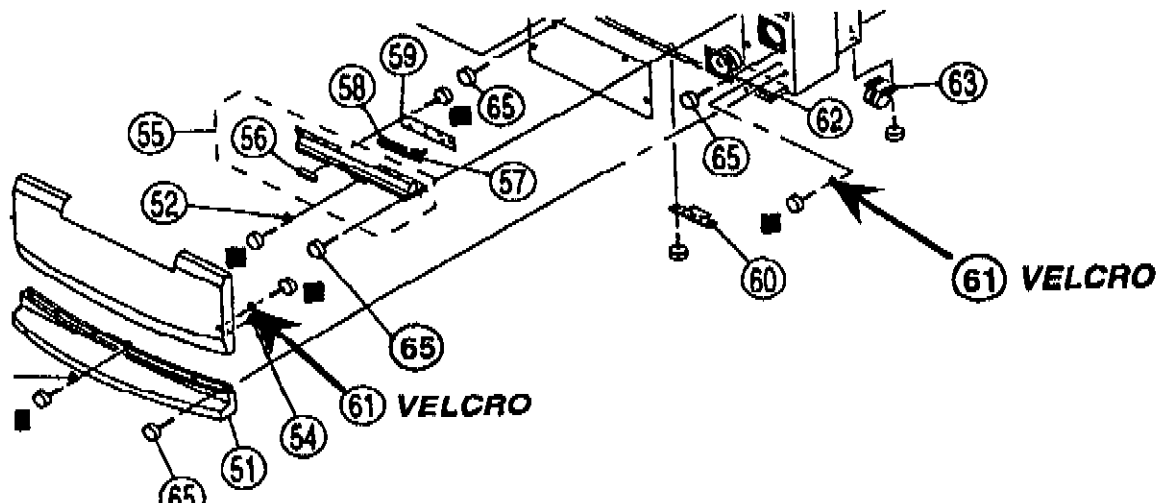
Symptom: When removing / putting speaker grille, the Velcros holding the grille may be damaged.

Solution: Replace the broken Velcro(s) with the new type Velcro as below. (The old and new ones look the same.)

4 Velcros (same type) each are used on speaker and cabinet sides respectively.

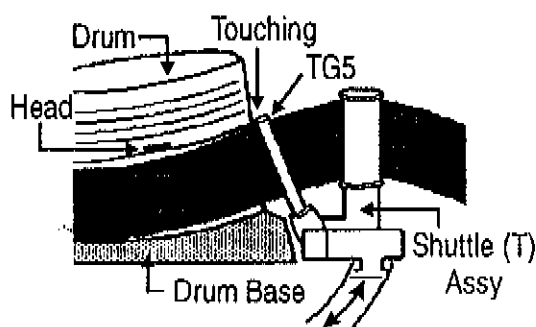
Symptom: Occasionally, for H-Mech models with Drum Base, when the tape is loading/unloading, TG5 may touch the drum causing the heads to be clogged or damaged.

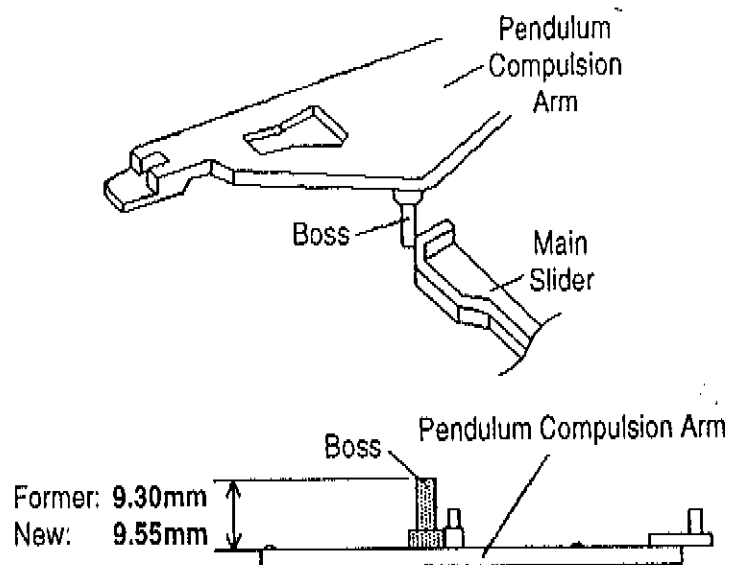
SYMPTOM: Occasionally the set does not start playing back, especially right after loading a cassette. At the same time, a reel rotation error appears on the display.

CAUSE: The "T Reel" does not rotate as the boss of the "Pendulum Compulsion Arm" blocks the "Main Slider".

SOLUTION: Replace the "Pendulum Compulsion Arm" with the new part 3-960-138-03.

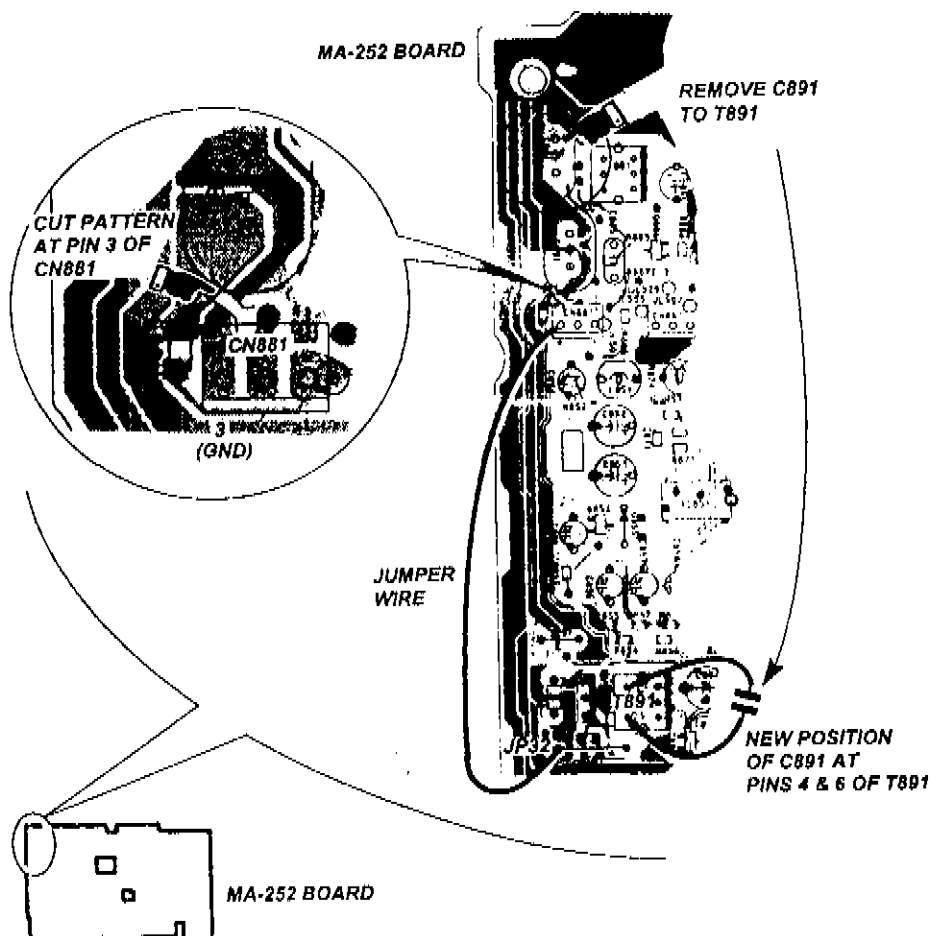
Symptom: When playback of normal audio on OA tape, a beep may be heard. This beep is caused by the difference of oscillator frequencies between the Full Erase and Audio Erase oscillators which might be recorded on tape.

1. Remove C891 and re-mount it between pin 4 and 6 of T891.
2. Cut the pattern on CN881 pin 3 (GND) and connect it to JP 32 land using a wire.

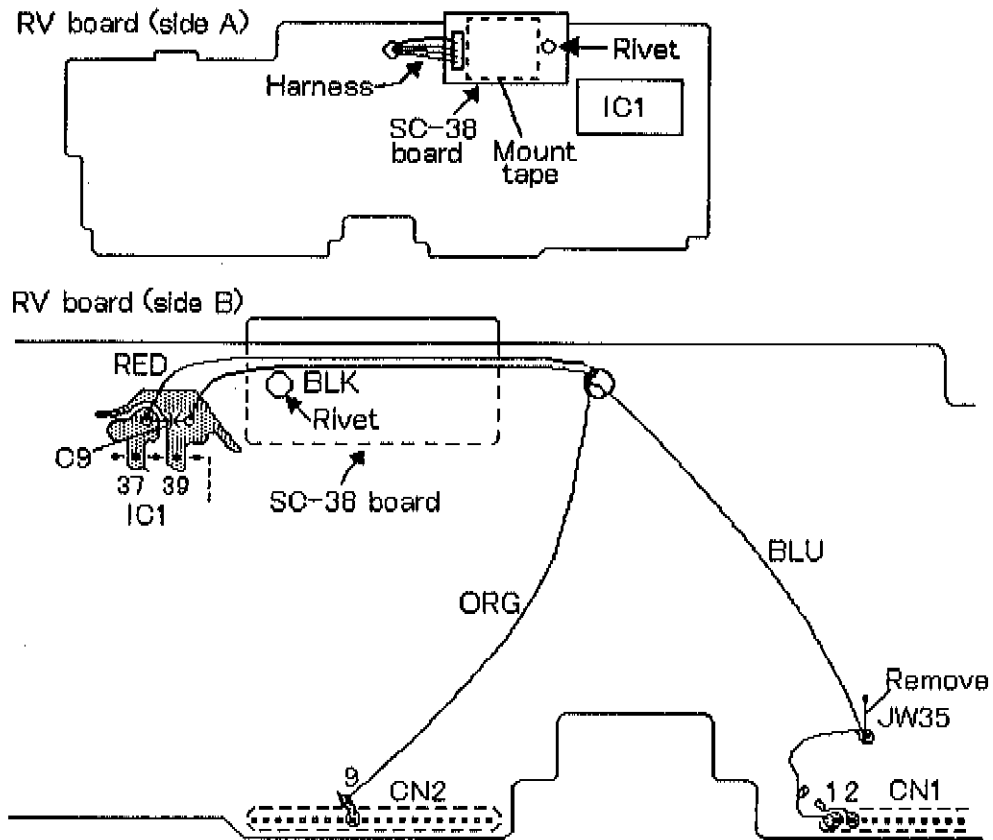
1. SLV-640HF, 740HF, 741HF, 780HF, 940HF

SYMPTOM: Occasionally the following drum servo errors may occur when recording or playing back a tape:

SOLUTION: Install the "SC-38 Service Kit" (A-7092-701-A) as shown below. The kit consists of a mounted SC-38 Board, a Harness, and a Rivet. The wires of CN001 on the SC-38 Board are coded as listed below.
