car stereo Service Bulletin No.76

Model: CDX-A10/J10

Date: April 15, 1987

Subject: Access and Alternator Noise

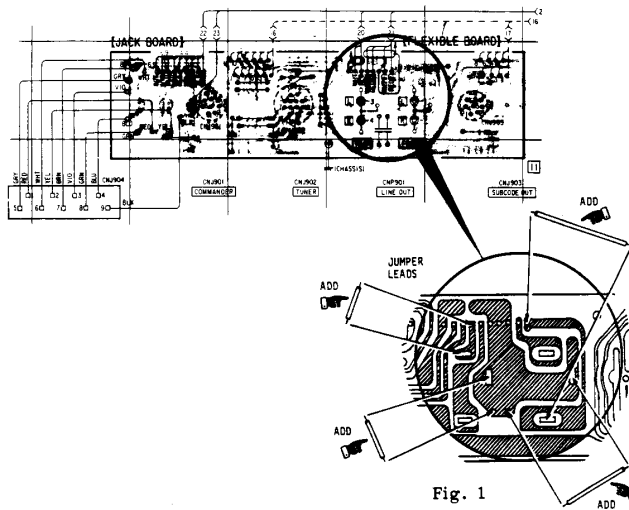
Fig. 1

1. Access Noise (Particular problem with car CD units)
"Sizzling Noise" is heard from speaker right after loading the disk or while next number searching in AMS mode.
2. Alternator Noise
The noise sounds like whistling and when the number of engine revolutions increases or decreases, the tone of the noise changes accordingly.

2. Confirm the soldering condition of the pinjack on the pinjack board. Connect the pinjack terminals and the patterns by jumper leads to ensure proper connections. (Refer to Fig. 1)

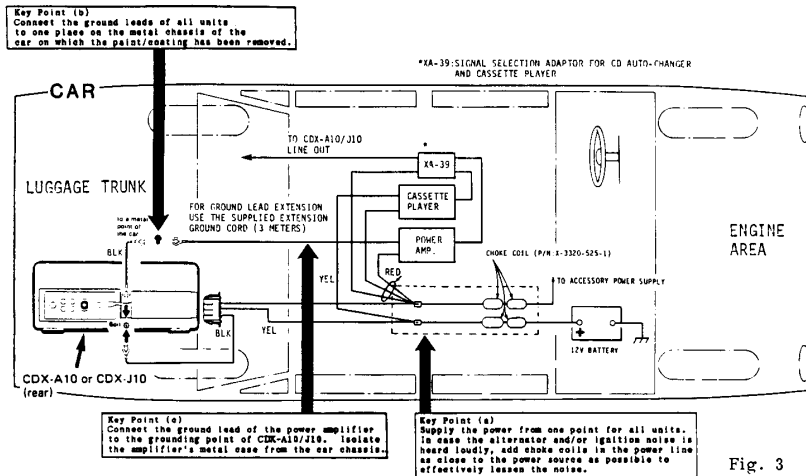
Alternator and/or ignition noise can be easily generated if the wiring for the units is not done properly. In order to minimize the noise, mount CDX-A10/J10 as shown below. Take note of the following three key points:

- a. Supply power to all units (CDX-A10/J10, POWER AMP, DECK, etc.) from the same power source point in the car. This is quite effective to reduce the impedance in the power line between each unit, so the noise can be prevented.
- b. If the ground lead of each unit is connected to various points, the noise can easily be generated due to the complicated ground loop. Connect the ground leads of all units to the same place on the metal chassis of the car. Make sure the metal is clean, ie no paint or other coating.
- c. Isolate the chassis of units (CDX-A10/J10, POWER AMP, DECK, etc.) from car chassis electrically. This is very effective for prevention of the noise, especially for a Hi-gain AMP.
