car stereo Service Bulletin No.84

Model: CDX-5, CDX-R7

Date: September 18, 1987

Subject: No Loading, No Eject

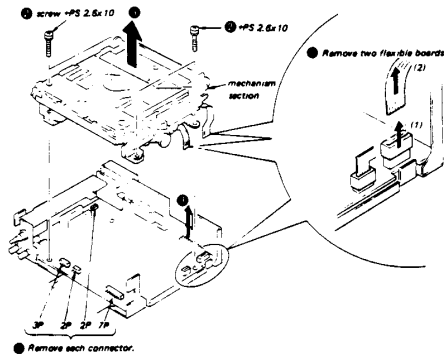
The disk cannot be loaded or ejected. The E ring disjoins due to a worn out down-gear shaft.

1. Remove the mechanism.

2. Remove the polywasher and gear (B) on the left side of the mechanism.

3. Remove the friction spring and down-gear.
